## Technical product information

<b>Topic</b>	"Drive System Fault" warning present within the DIP - Under full throttle conditions
<b>Market area</b>	Russische Föderation (5RU),Australia E04 Bentley rest Asia and Australia (6E04),China 796 VW Import Comp. Ltd (Vico), Beijing (6796),Germany E02 Bentley rest Europe (6E02),Japan E03 Bentley Japan (6E03),Korea, (South) E08 Bentley South Korea (6E08),United Arab Emirates E06 Bentley Middle East and Africa (6E06),United Kingdom E01 Bentley UK (6E01),United States E05 Bentley USA and rest America (6E05)
<b>Brand</b>	Bentley
<b>Transaction No.</b>	2067483/2
<b>Level</b>	EH
<b>Status</b>	Approval
<b>Release date</b>

### New Continental GT(C) and New Flying Spur - V8 Kovomo

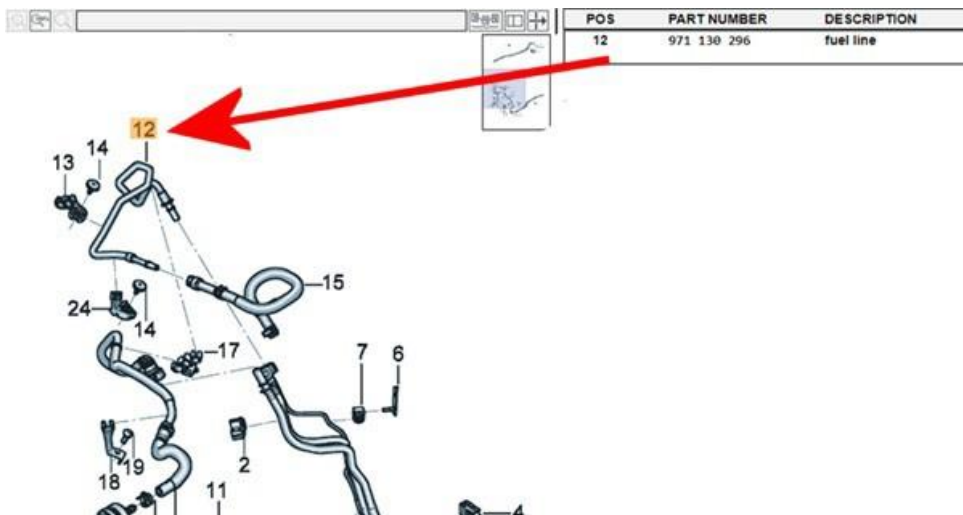
3) Referring to Figure 2 (Item 12) remove the fuel line shown

- In the event the fuel line is blocked/restricted - Replace the fuel line as shown in Figure 2 (item 12) ensuring all Rep.Gr guidelines are strictly adhered to

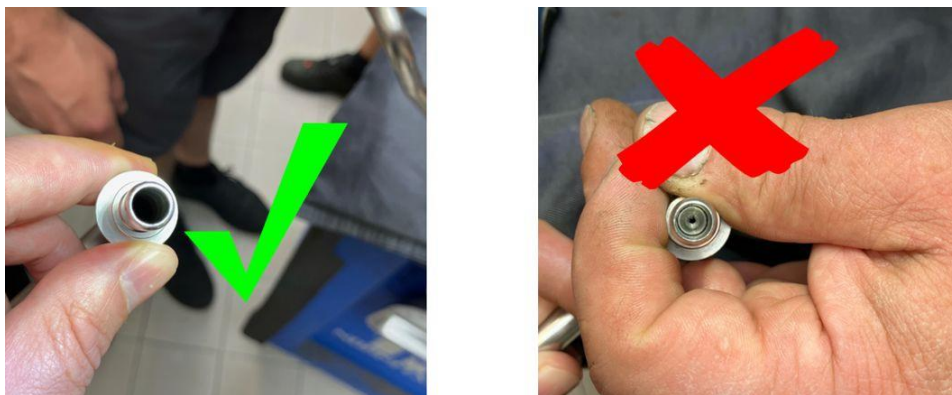
4) Referring to Figure 3 - Check to confirm if the fuel line is blocked/restricted

- In the event the fuel line is not blocked/restricted the operative should refer to Rep.Gr 20 and conduct the Low pressure fuel system - to test and provide feedback via a new or existing DISS query
