Technical Service Bulletin

Topic	PSIS 750600B0001 Seat belt pre-tensioner buckle switches - Harness modification
Market area	Bentley: worldwide (2WBE)
Brand	Bentley
Transaction No.	2037995/5
Level	EH
Status	Released for publishing
Release date	Sep 19, 2022

Wiring modification for seat belt pre-tensioner buckle switches

P.S.I.S. 750600B0001

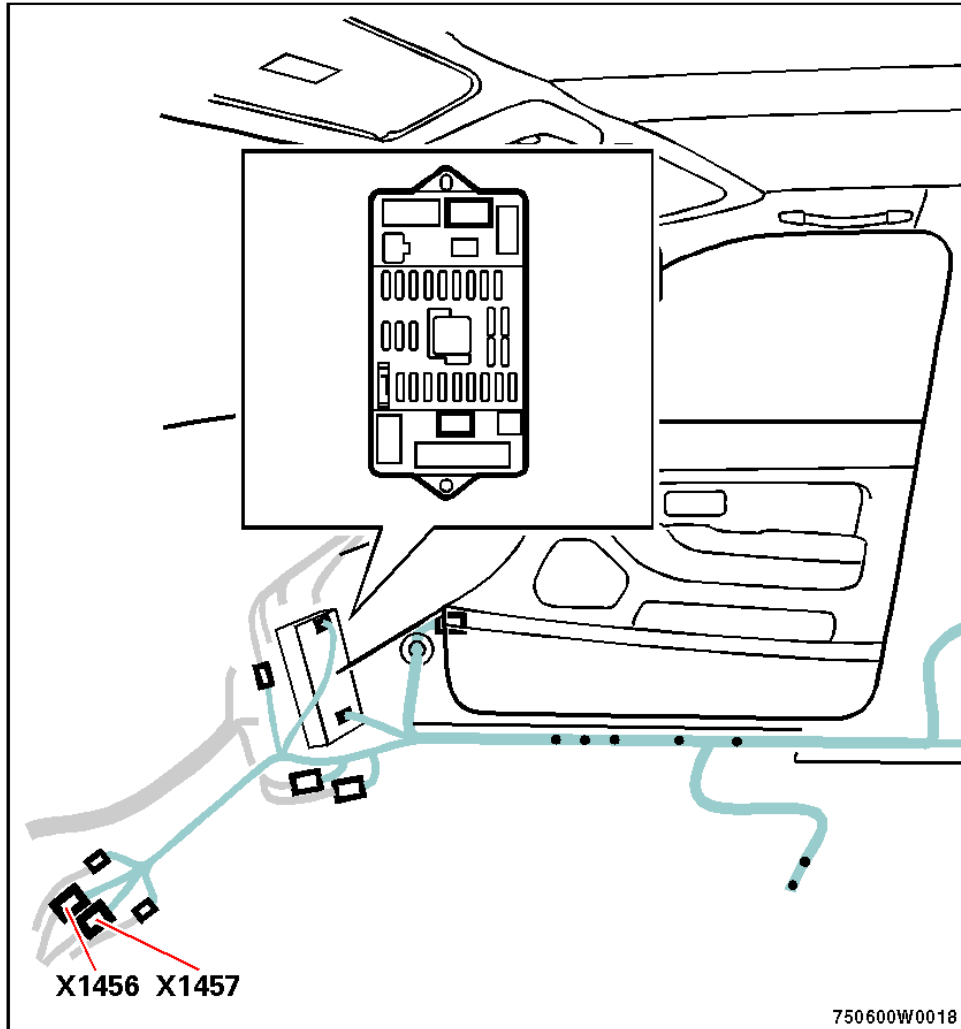
Figure 1 Right-hand drive vehicles

It has become apparent in service that an increase in the electrical resistance of the wiring for the seat belt buckle switches may be experienced in certain circumstances. This resistance increase is caused by the formation of oxides in the harness terminals of two connectors applicable to this circuit.

Because the buckle switch circuit is of a low voltage / low current type, this resistance increase can disrupt the passage of data from the buckle switch to the airbag control module. When this is detected the airbag warning light will be illuminated and the codes listed above will be stored.

1. With reference to figure 1 identify connector X1457.

2. On the female side of this connector cut the yellow cable at cavity 1. The cut should be made approximately 2 inches (50 mm) from the terminal. Strip back the insulation on each side of the cut and fit a piece of heat shrink.

3. Splice and solder together the two yellow cables from the link looms and the two yellow cables stripped at connector X1457. This splice should have two cables on each side of it.

4. Using a heat gun shrink the sleeving onto the splice.
5. Tidy up all the splices and ensure that they will not foul on the foot rest or it's mounts.
6. Clear the stored fault code with the GDS machine and exit the diagnostic routine.
