Technical Service Bulletin

Topic	Repeated traction control interventions experienced upon reaching 30km/h
Market area	Bentley: worldwide (2WBE)
Brand	Bentley
Transaction No.	2067579/1
Level	EH
Status	Released for publishing
Release date	Sep 20, 2022

New Continental GT(C) and New Flying Spur

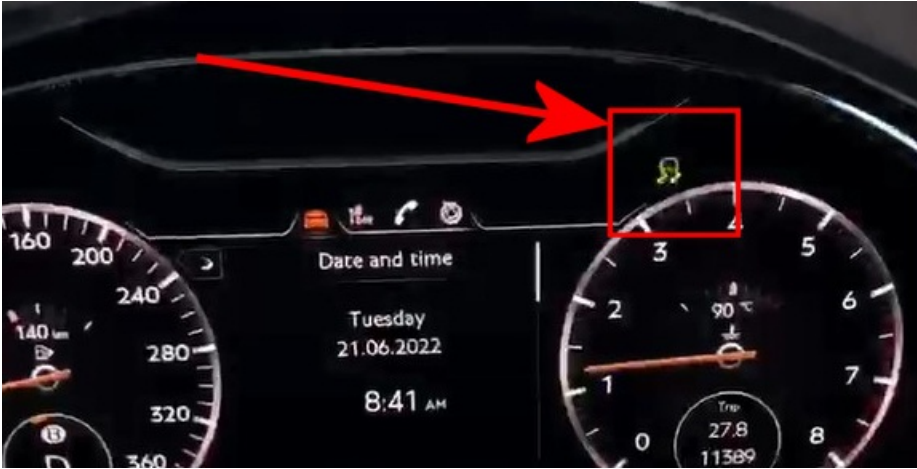
Figure 1

Repeated traction control interventions experienced upon reaching 30km/h (Figure 1)

In the event the issue is as exactly as described, refer to the instructions within the Measure section

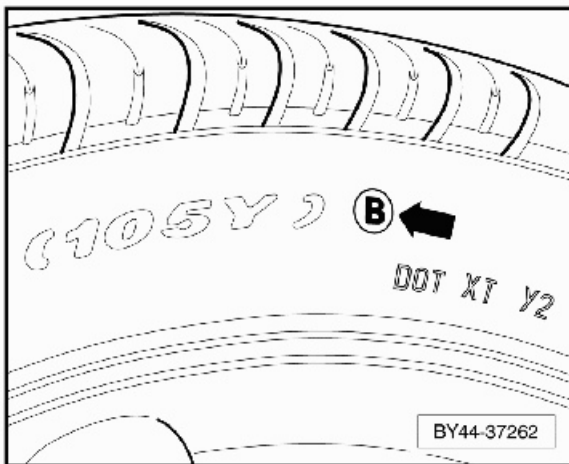
Figure 2

- Confirm the 'B' marking is evident on all tyres (Figure 2)

1) Confirm the tyre pressures (all tyres) are to Bentley specification

- Check to confirm the wheel and tyres assemblies are Bentley approved (same specification parts as per the original factory build
