Technical Service Bulletin

Topic	Seat Belt Presenter - Intermittent Operation
Market area	Bentley: worldwide (2WBE)
Brand	Bentley
Transaction No.	2034323/7
Level	EH
Status	Released for publishing
Release date	Sep 19, 2022

Front seat belt system presenter intermittent in operation

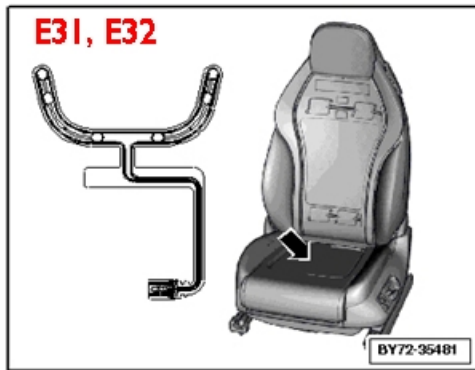
Figure 1

3. First check the occupancy sensor, E31, is function correctly (see Figure 1)

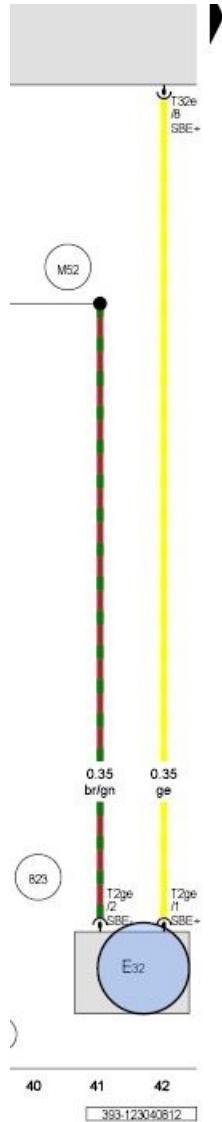
Figure 4

- If the resistance of the sensor with the seat occupied is greater than 90 Ohms then the sensor is faulty and should be replaced
- Once the occupancy sensor is known to function to specification (operation 2) then remove and discard the original seat adjustment control unit with memory (J136 Drivers, J521 passengers) and replace with the latest level part (part number 4W0.959.760)
 - The J136, J521 seat control unit is located under the seat frame reference workshop manual Rep. Gr.72 Front seat control unit (J136,J521) – To remove and fit
