TECHNICAL SERVICE BULLETIN

Shift Knob Rotates Without Brake Pedal Depressed, Transmission Remains In Park (P)

22-2343
19 September 2022

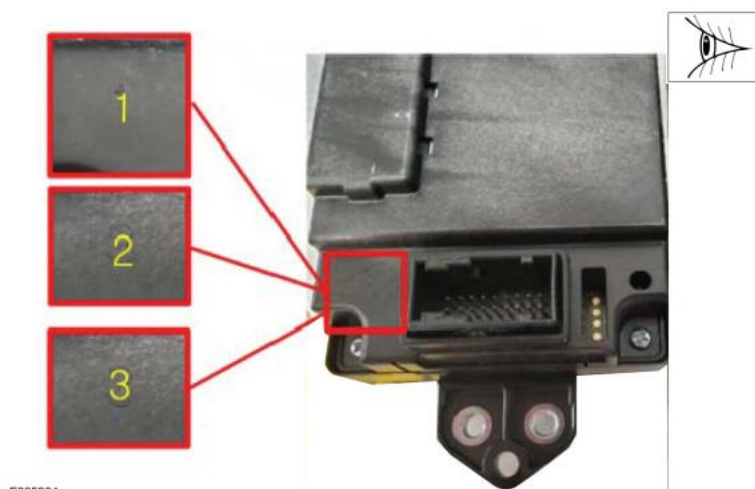
Figure 1

2. Inspect the GSM at the location identified in Figure 1.

(1). If the GSM is marked with numbers 1, 2, or 3, proceed to Step 4.

(2). If the GSM is marked with number 4 or blank, re-install GSM and proceed to Step 3.

3. Reprogram the GSM using the latest software level of the Ford Diagnostic and Repair System (FDRS). Repair is complete.

4. Replace the GSM. Follow the WSM Section 307-05.
