TECHNICAL SERVICE BULLETIN

Transmission Fluid Leak Due To A Cracked Transmission Case Or Transmission Fluid Pan

22-2356

Ford 2015-2019 F-Super Duty

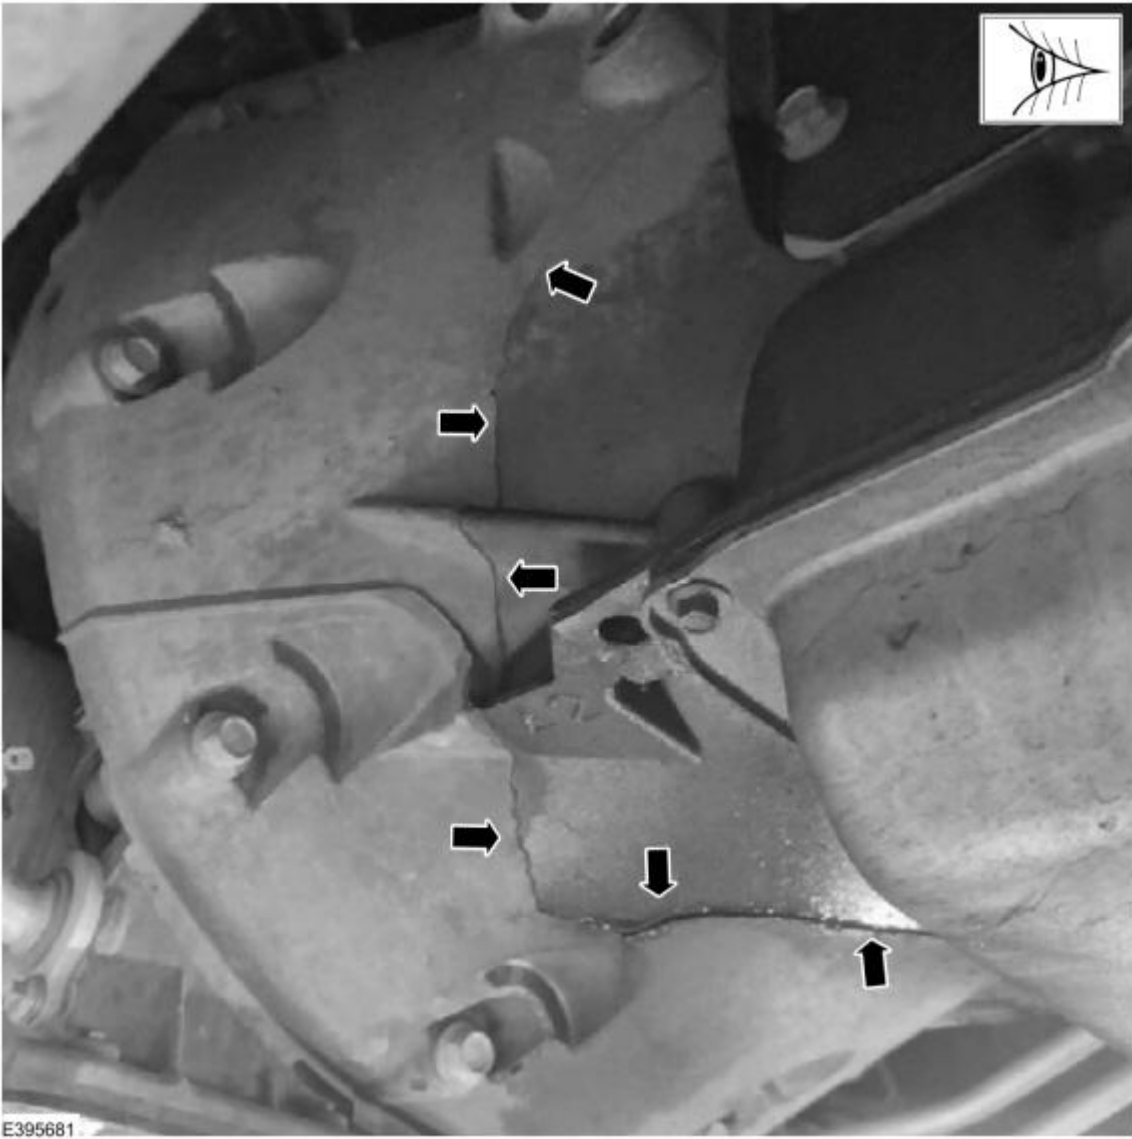
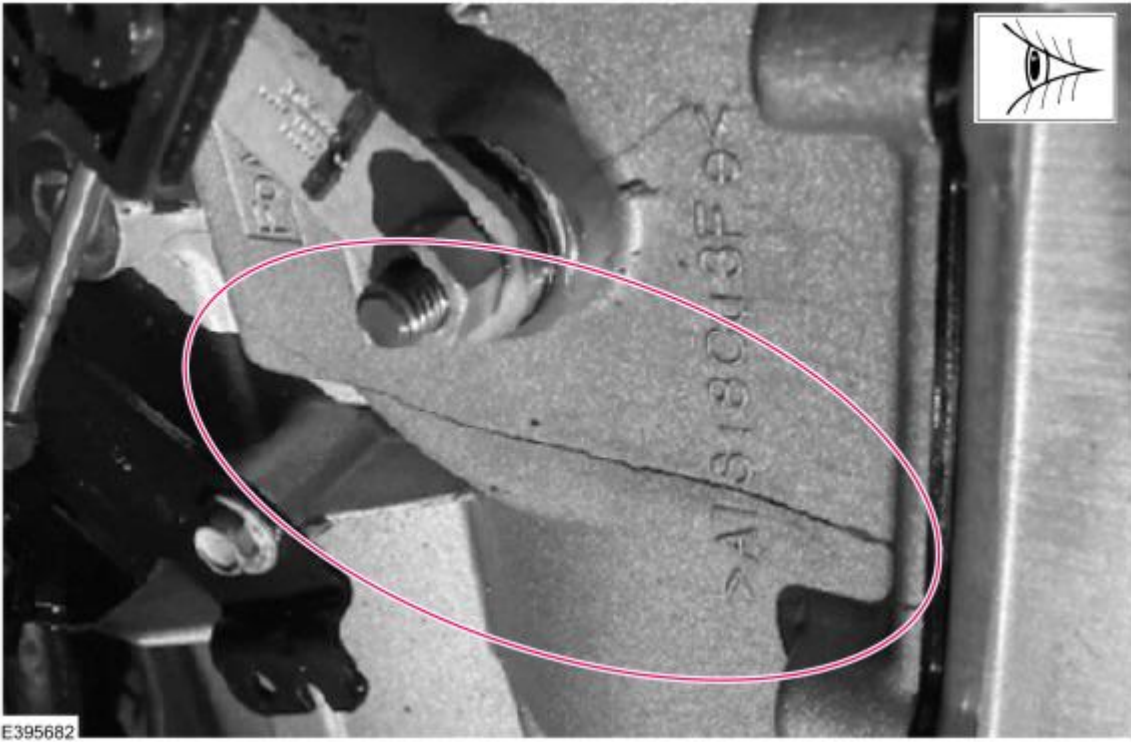
Issue: Some 2015-2019 F-Super Duty vehicles may experience a transmission fluid leak from a cracked transmission case or transmission fluid pan. This may be due to a driveline vibration condition. For vehicles that have a concern with a cracked transmission case (Figures 1-2) or fluid pan (Figures 3-4), the rear driveline imbalance most often is the root cause of this concern. To correct the condition, follow the Service Procedure to replace the rear driveline.

For vehicles that have a concern with a cracked transmission case (Figures 1-2) or fluid pan (Figures 3-4), the driveline imbalance most often is the root cause of this concern.

1. Replace the following rear driveline components with the transmission repair per Workshop Manual (WSM), Section 205-01:
 - Driveshafts
 - Rear flanges

- Rear universal joints
 - Center support bearings
 - Transfer case
2. After repair and prior to vehicle delivery to the customer, confirm all of the following are within specification.
