# SS 3109-FTL2022 New Cascadia Low Power Complaint

## **Applicable Vehicles**

This solution applies to New Cascadia vehicles built with added floor insulation typically found in data code 772-037 : BLACK MATS WITH ADDED FLOOR HEAT ANDNOISE INSULATION WITH ACCELERATOR RUB PAD. This solution could also apply to vehicles that receive aftermarket floor mats that eliminate the clearance between the throttle pedal and the floor.

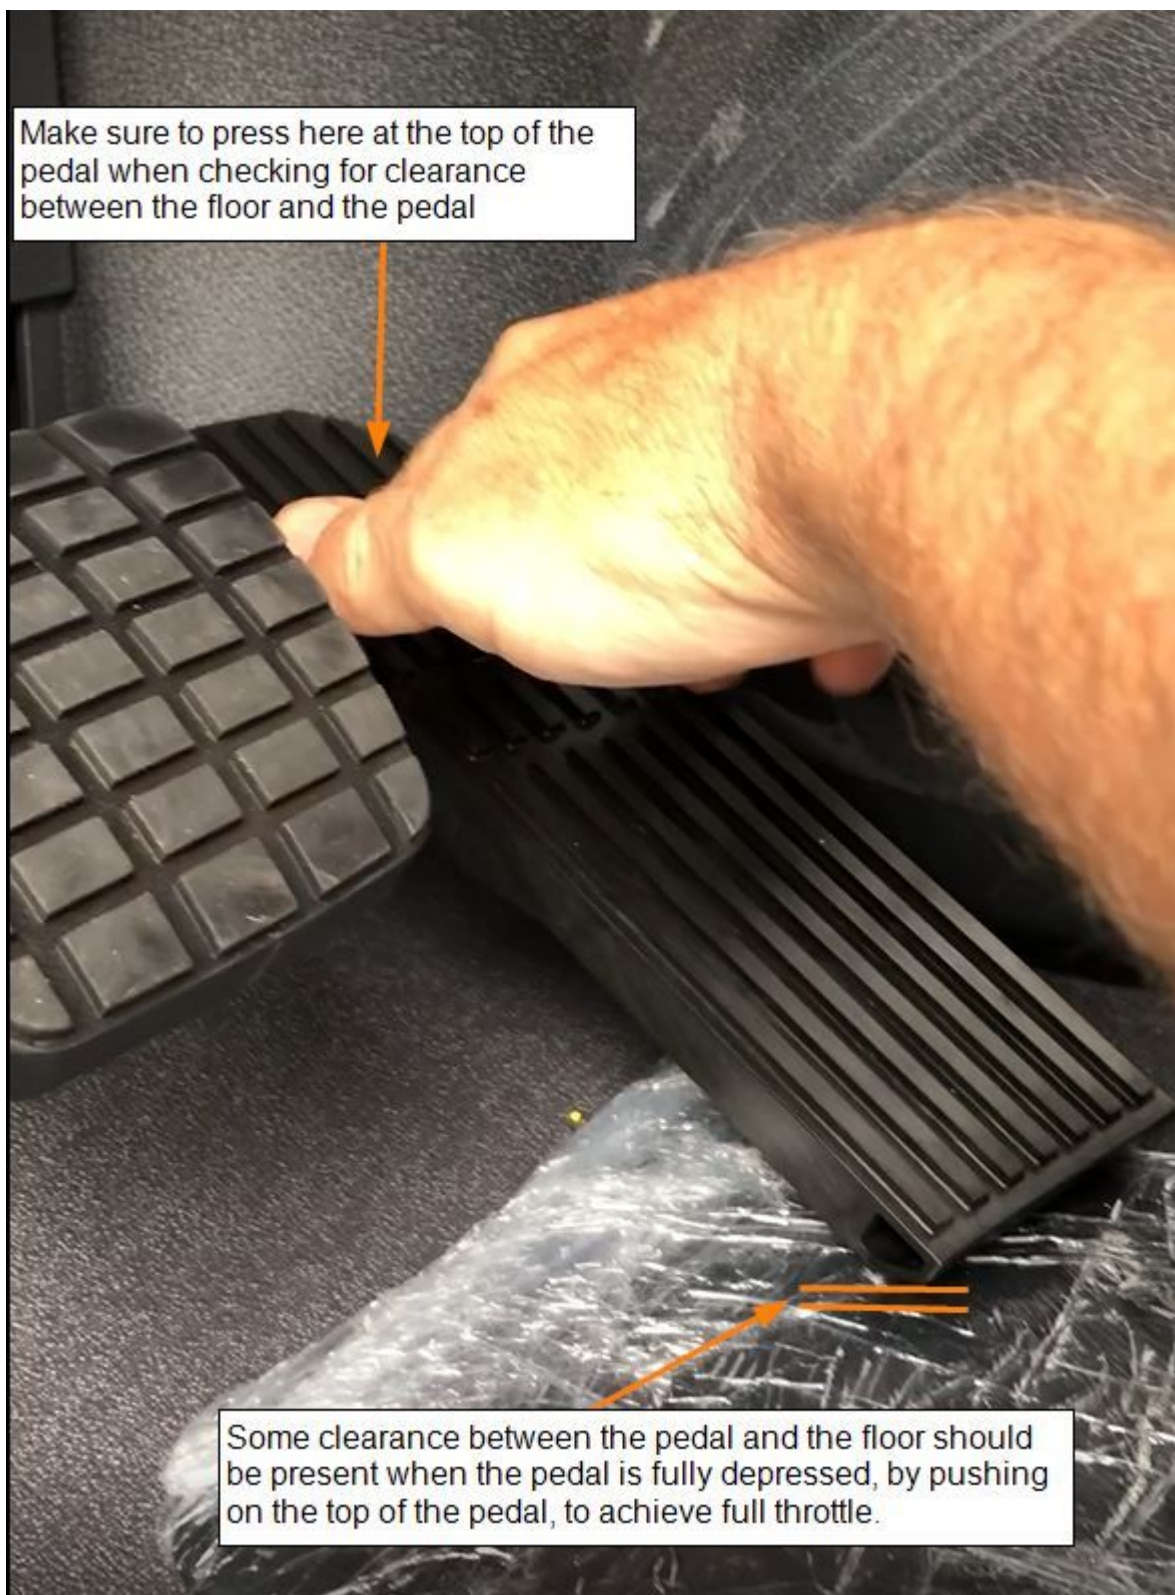
When additional floor heat insulation is ordered, the throttle pedal in some cases (when the throttle is fully depressed) may not reach 100% (full throttle). This can also occur if aftermarket floor mats are added to the vehicle.

**Figure 1** Checking for clearance between the throttle pedal and the floor in the full throttle position.

power make sure to check for clearance between the throttle pedal and the floor as displayed in figure 1. If there is still a concern with the pedal movement, monitor the throttle pedal position using the appropriate diagnostic tool (DiagnosticLink for Detroit engines and Cummins Insite for Cummins engines). While fully depressing the throttle pedal, monitor the pedal position within the diagnostic tool, the pedal position should read 100%. If an aftermarket floor mat has been added, it is best to start by removing the floor mat and testing the throttle again, fully depressing the pedal while monitoring the pedal position within the tool. If 100% throttle is achieved then no further action is required and the aftermarket floor mat should not be reinstalled. If there is no aftermarket floor mat, fully depressing the throttle pedal, the throttle pedal should display 100% when monitoring it with the diagnostic tool. If the throttle pedal does not read 100% and there is no clearance between the throttle pedal and the floor, it is recommended that the extra heat insulation be removed from the drivers station as noted in Figure 2 for left hand drive vehicles and figure 3 for right hand drive vehicles. A picture of the foil faced heat insulation that will be removed is shown in Figure 4. Upon removal of the foil faced insulation, the throttle pedal should be checked one final time for clearance between the pedal and the floor, while while monitoring the diagnostic tool when the pedal is in the full throttle position validating 100% pedal position is achieved.

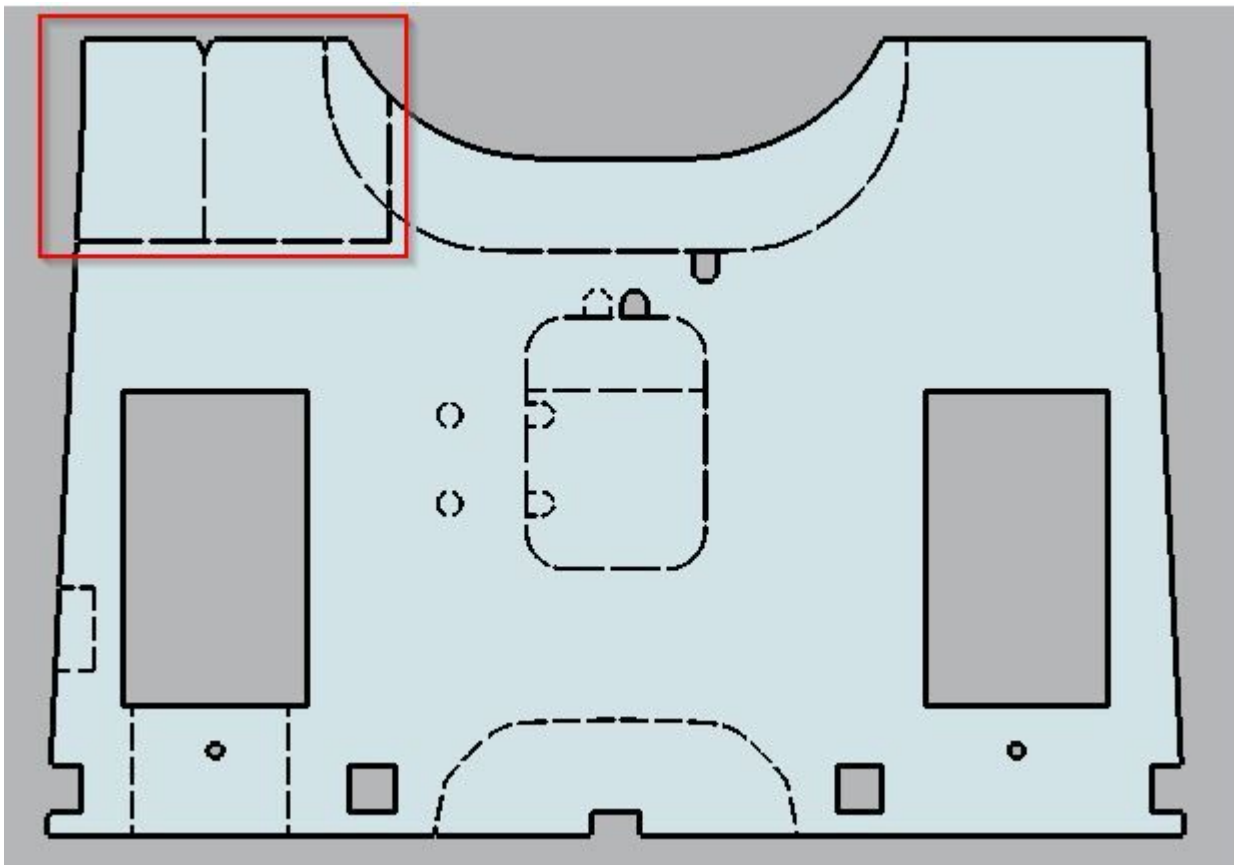
**Figure 2** For left hand drive vehicles, the added insulation marked in red box should be removed to provide addition floor clearance for the throttle pedal when needed.

Note: Vehicles receiving this added heat insulation built after mid year 2023 will be having the added heat insulation removed in the areas documented in figures 2 and 3.

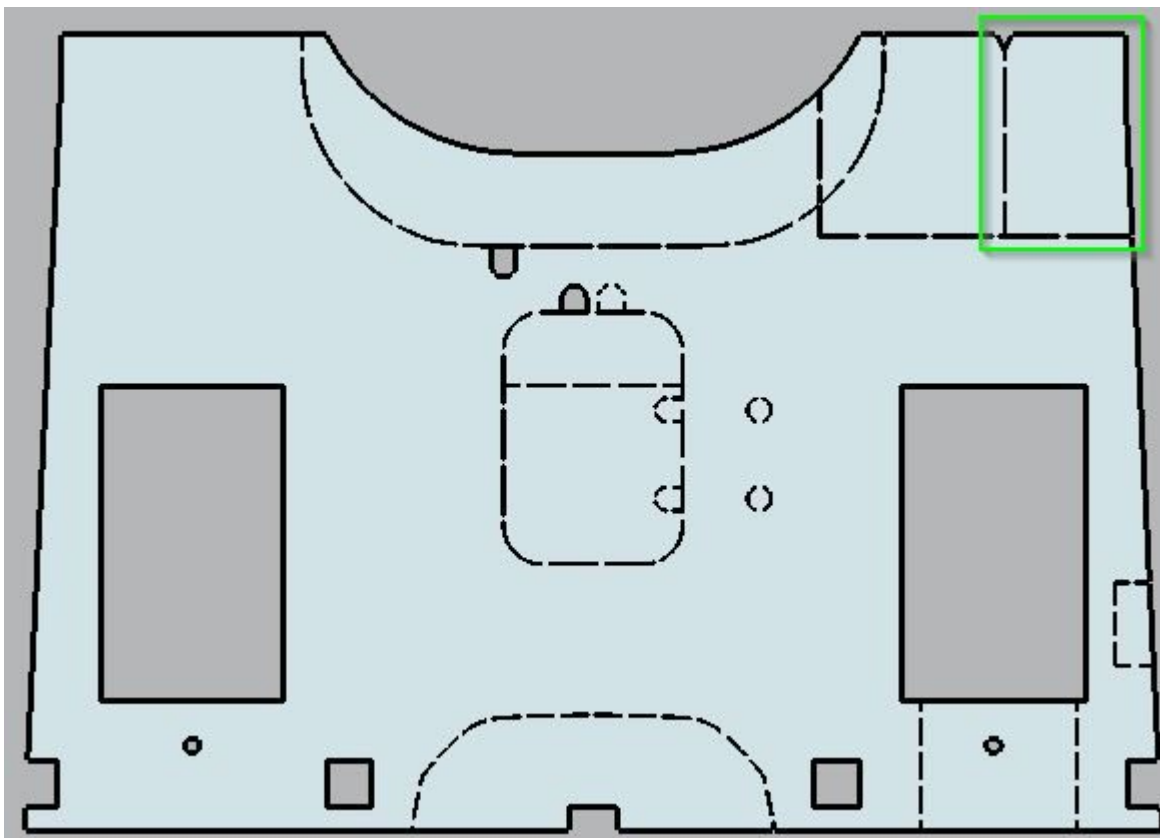
**Figure 3** For right hand drive vehicles, the added insulation marked in green box should be removed to provide addition floor clearance for the throttle pedal when needed.

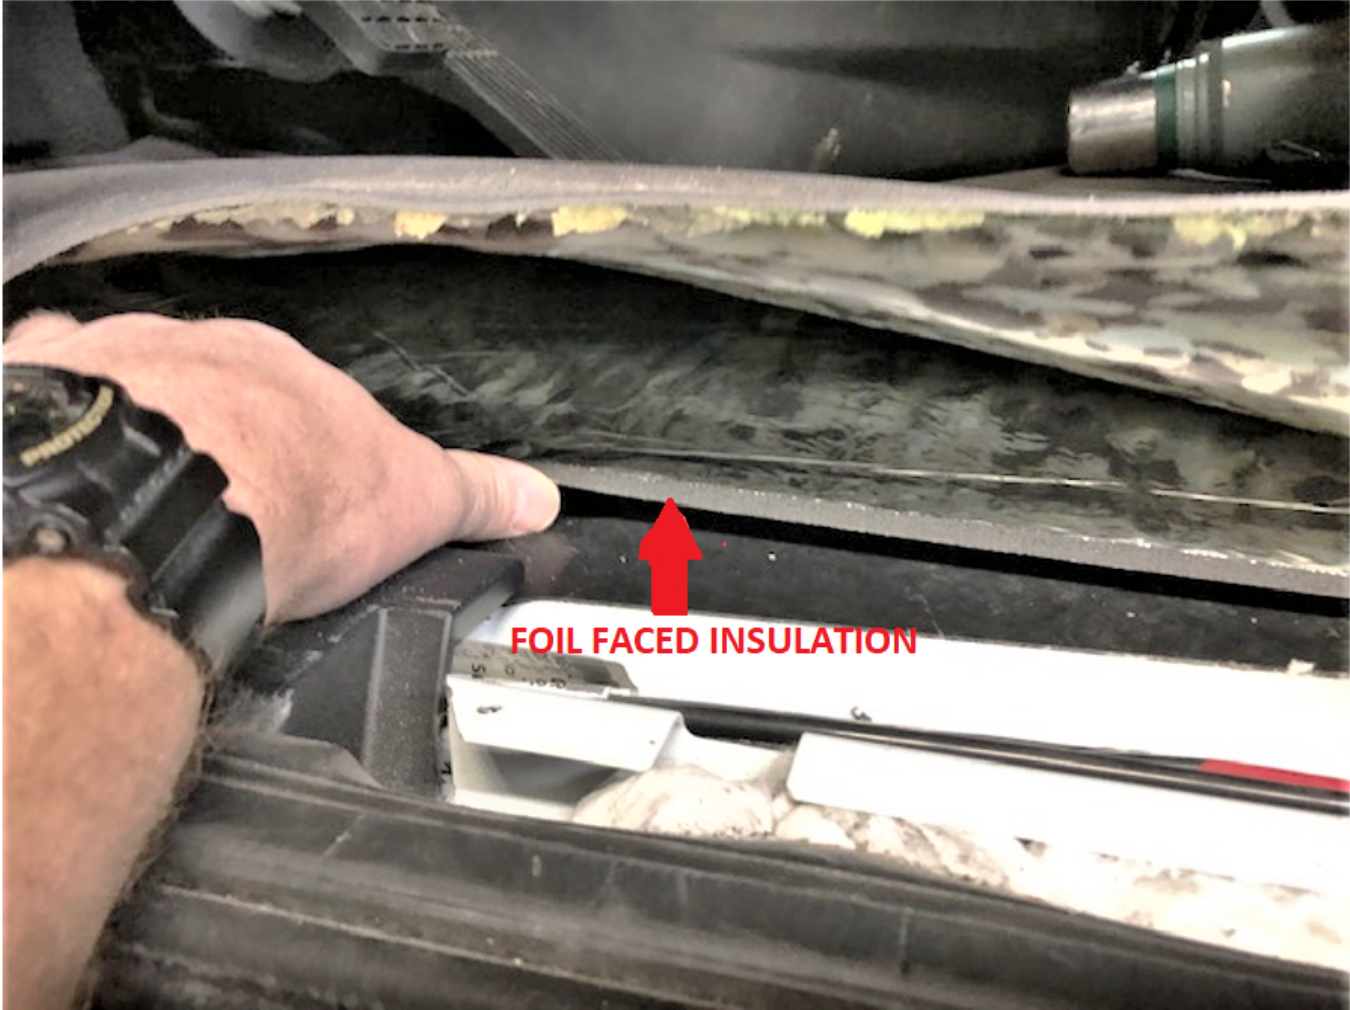
**Figure 4** Added insulation (foil faced) to be removed as documented in figure 2 or figure 3 depending on the drive position.
