Technical Service Bulletin

85 Fresh air and air recirculation intermittently inoperative

85 22 24 2068131/1 September 29, 2022.

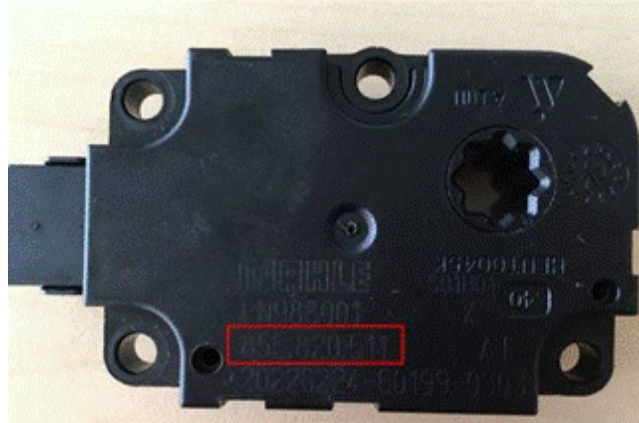
Vehicles for which this TSB appears may have been equipped with Recirculation Door Motor (V113) or Fresh Air Door Motor (V438) with part number 85E 820 511 prone to compromise the LIN communication. The motors will not move in these cases. Only control motors with part number 85E 820 511 are affected.

Figure 1. Control motor part number location.

1. Should the vehicle present with the symptom and DTC profile described in this TSB, and the part number of both control motors as labeled on the part is 85E 820 511, then replace both the Recirculation Door Motor (V113) and Fresh Air Door Motor (V438) with part number 4M0 820 511 A. Figure 1 shows the location of the part number stamp on the control motor.
