Articles Contained in this Issue

CODE	ARTICLE.....	PAGE
(00)	STIS New Releases	11-12
(01)	QMR of the Month	1-2
(01)	QMR of the Month Award Presentations	2
(12)	Diagnosing Repeat P2762 and P2757	3
(14)	Special Tools – Denso USB Cable & ECM/..... TCM Reprogramming	7
(05)	Ascent Noise from Rear Over Bumps or When Turning	9
(15)	Version 4 Eyesight and Immobilizer Registration, U1C00	10

01 TechShare QMR of the Month

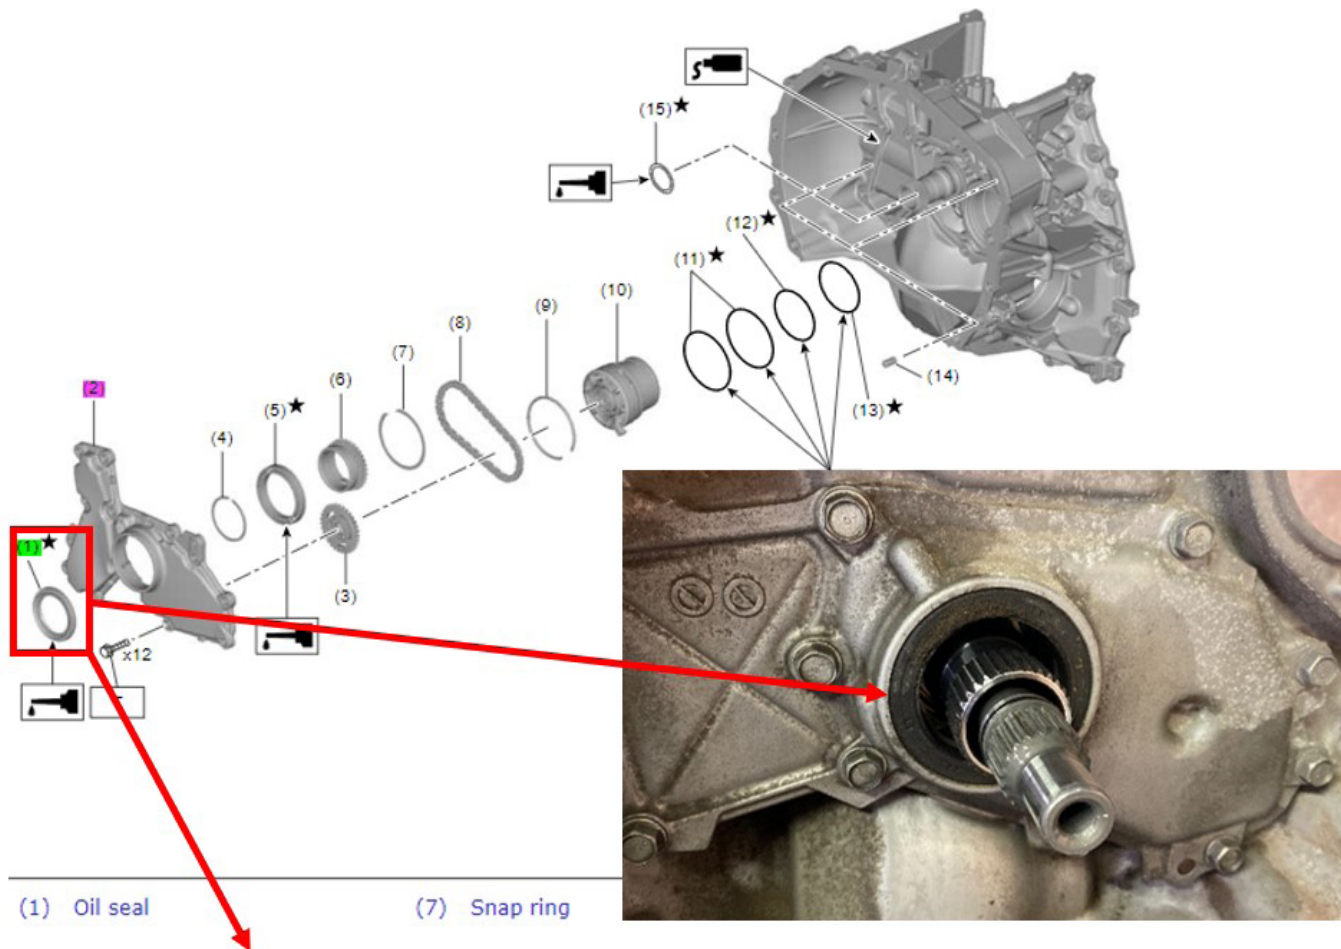
(1) Oil seal (7) Snap ring

It is important to note if the Technicians diagnosis leads to replacing the torque converter, there are several one-time use seals that need to be replaced.

Make sure to replace the oil seal (#1), O-ring (#4) and sealing ring (#5) as well as all other one-time use parts during R&R of the CVT assembly. The chain cover (#2) will need to be removed to replace the sealing ring.

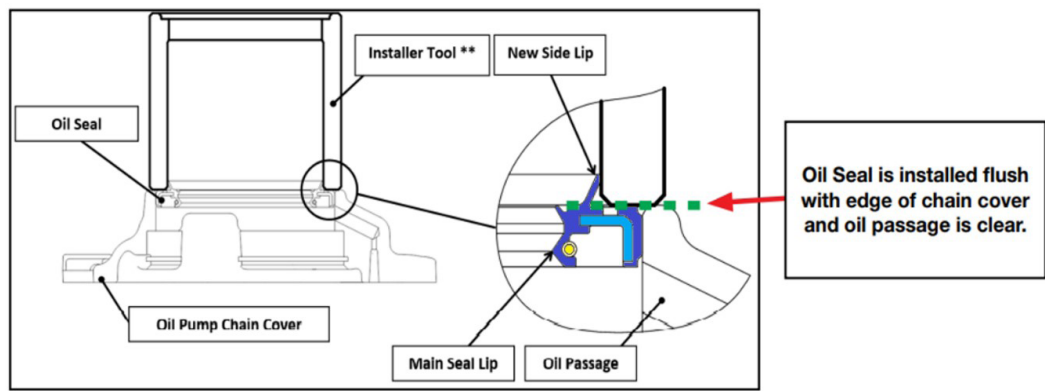
• When installing this new seal, it is **STRONGLY** recommended to use the proper installer tool ****OPTIONAL Special Tool 927890000** as shown in the illustration below. Otherwise, If the seal were to be installed too deep into the bore of the chain cover (beyond flush with the chain cover edge as shown below), the oil passage may become restricted or blocked.

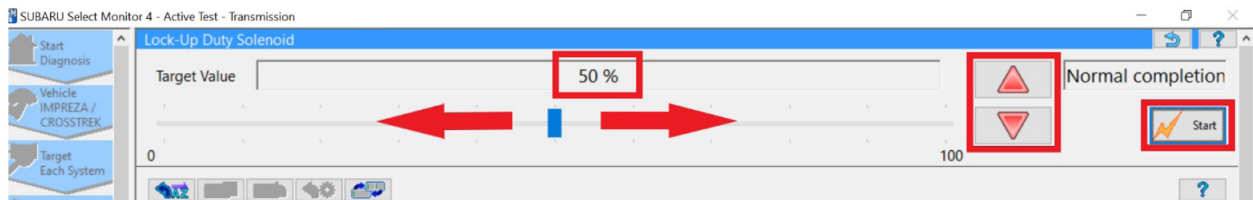
A final note: When performing the Lock-Up Duty Solenoid test in the trouble tree, the solenoid will need to be activated through the work support active test. The test does not cycle the solenoid on and off from 0 - 50%. Instead, the Technician will need to choose a duty percentage for the solenoid to activate to. Once selected and the active test started, a buzzing sound will emit from the solenoid activating. A stethoscope at the valve body cover may be needed to hear operation.

The default setting for the test will be 0%. A duty percentage will need to be selected. Then select start.

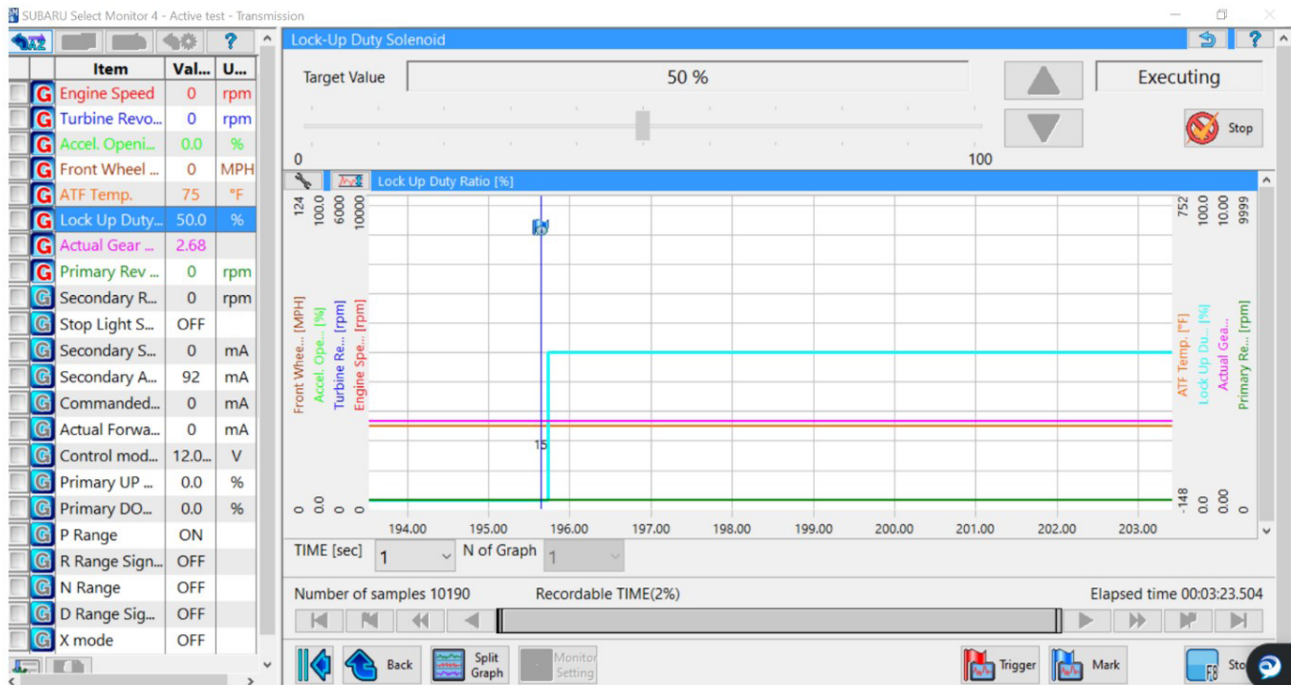
The above shows a graphed display of the solenoid activation.

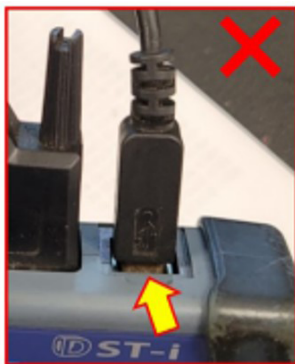
Reports from the field of no communication with control modules, software updates crashing, and error messages being displayed, has resulted in unrecoverable control modules leading to unnecessary part replacement. These conditions have been identified and are directly related to the use of aftermarket USB cables. SOA would like to remind everyone to always use Originally Equipped Denso USB Cables when using the SSM4 and DST-i box.

Corroded Connection

Shown here are examples from the field of cable conditions that could cause problems.

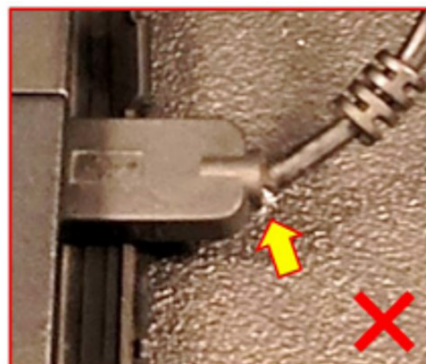
Exposed Wiring &
Incorrect Cable
