## SERVICE BULLETIN

**APPLICABILITY:** 2022MY Forester

**NUMBER:** 07-209-22R

**SUBJECT:** EyeSight® Reprogramming  
DTC B28A6 Internal Stereo Camera  
Communication 1

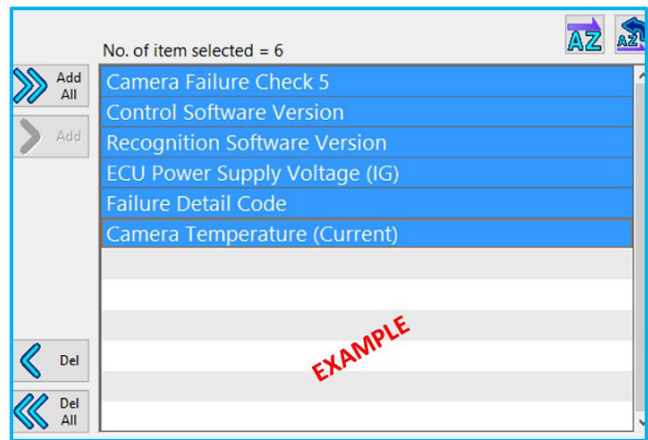
**STEP 2:** Confirm the following Data Monitor Values prior to any attempt to reprogram:

1. Camera Failure 5 is “**0000000B**”
2. Control Software Version is “**0421011E**”
3. Recognition Software Version is “**07210004**”
4. ECU Power Supply Voltage (IG) is **13.5 Volts**
5. Failure Detail Code is **C213**

**NOTE:** If Failure Detail Code C213 is not displayed, check the fault freeze frame data (FFD) of B28A6. If C213 is listed in the FFD, the parameter has been met.

6. Camera Temperature is less than **176 degrees Fahrenheit (80 degrees Celsius)**

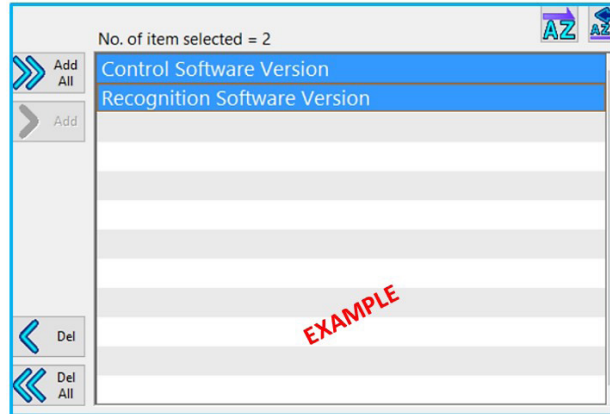
**STEP 2:** Confirm the following Values:

- 1. Control Software Version is “04210801”
- 2. Recognition Software Version is “07210802”

**IMPORTANT:** If the reprogramming procedure is unsuccessful, **ONLY** one additional reprogramming attempt is to be made. Refer to the table below if an error code is displayed. If the reprogramming procedure is unsuccessful after **TWO** attempts, the EyeSight® stereo camera will require replacement.

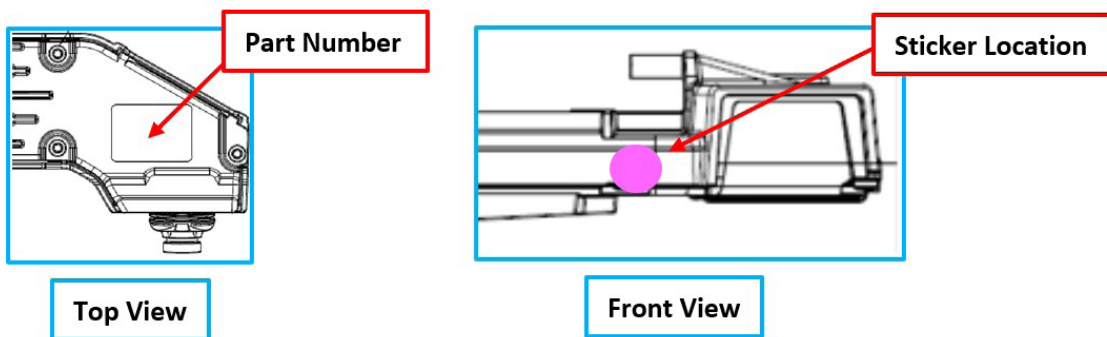
If EyeSight® Stereo Camera assembly replacement is required for any reason, it is important to confirm the replacement parts contain the updated software. This can be confirmed by the pink colored sticker located on the camera assembly. If the sticker is present, the software has been updated.

Part Description	Part Number
CAMERA ASSEMBLY	87501SJ410
