PRODUCT CAMPAIGN BULLETIN

APPLICABILITY: 2015-2021 MY WRX STI

NUMBER: WRE-22

SUBJECT: Safety Recall – Back-Up Lamp Switch Failure

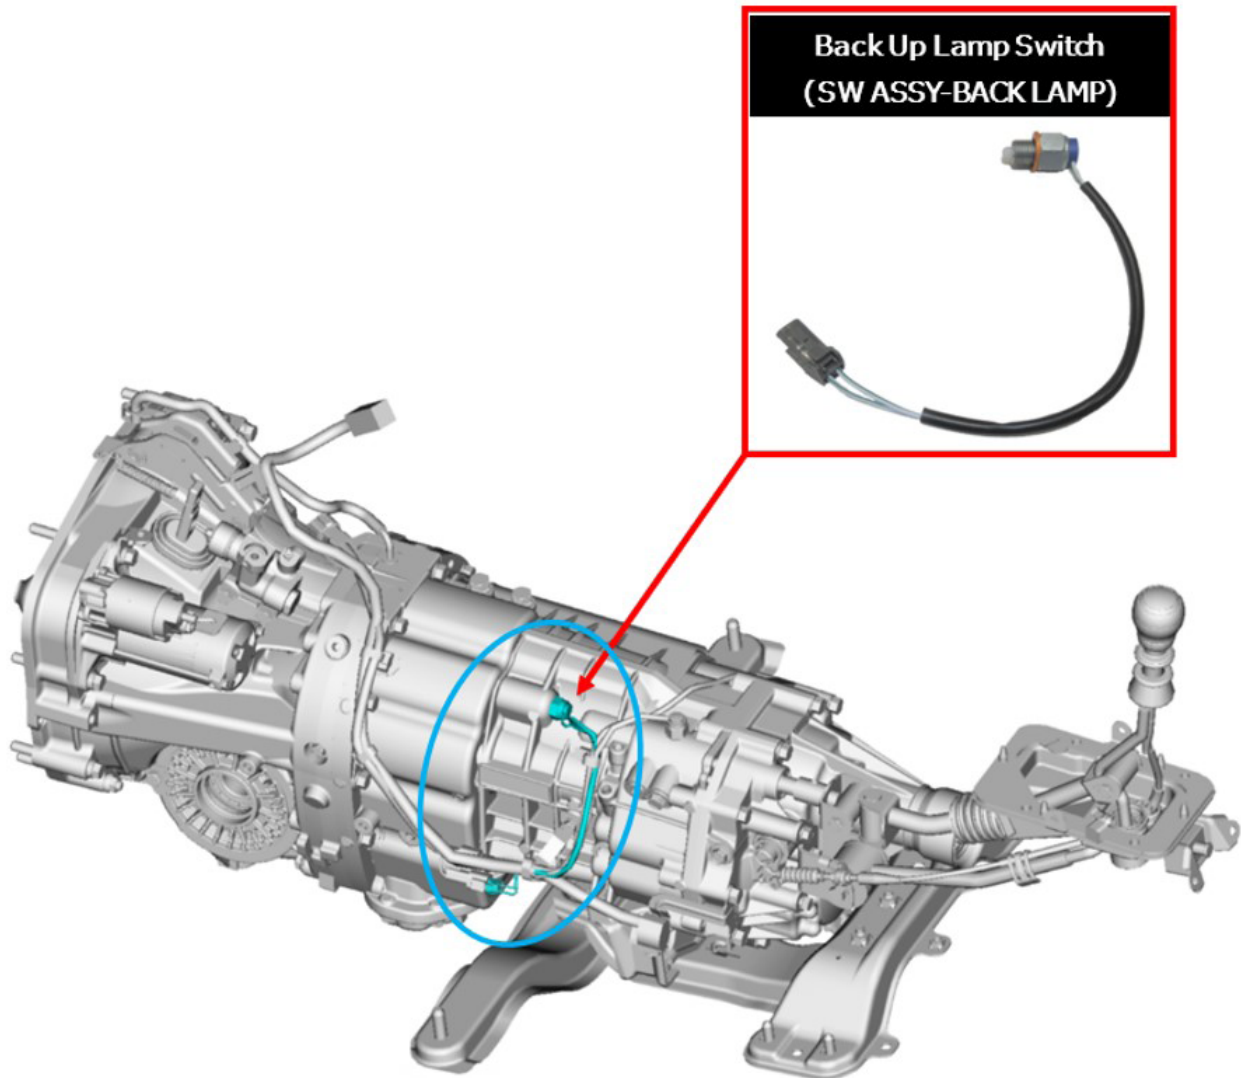
COMPONENT DESCRIPTION:

The operating environment of the back-up lamp switch may expose the internal switch contacts to heated oil. When heated, sulfur in the oil may cause a chemical reaction with the materials used on the switch terminal contact surfaces and plate spring. This chemical reaction may cause corrosion and a non-conductive film to form on the contacts resulting in poor electrical conductivity.

For all potentially affected vehicles, Subaru retailers will conduct an inspection and replace the back-up lamp switch with improved one, if necessary, at no cost to the customer.

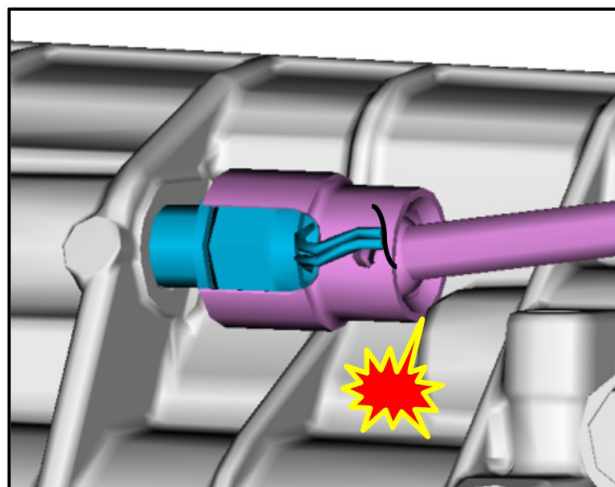
STEP 29: Loosen the back-up switch from the transmission case. Rotate the switch harness while turning the socket to prevent any excessive tension. The switch and the special tool cannot be removed together due to interference with the transmission case. Remove the tool before removing the switch.

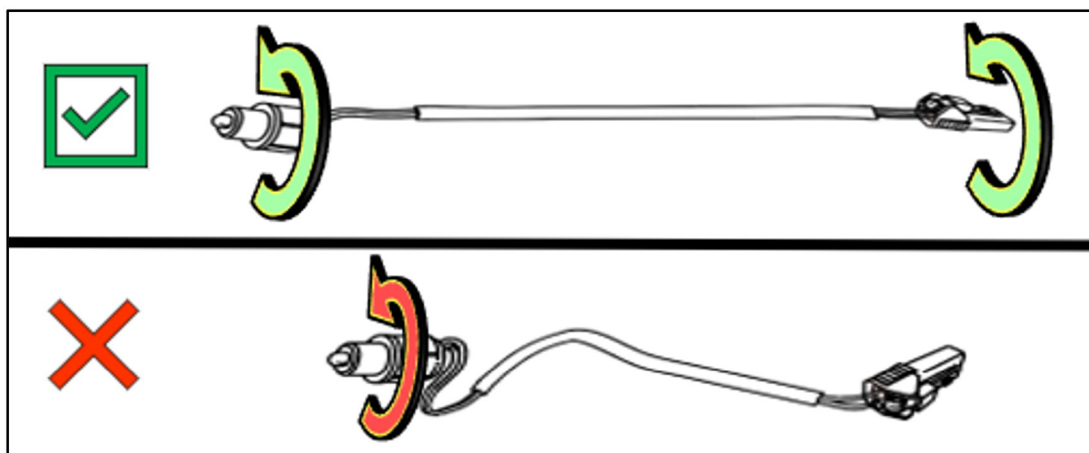
STEP 30: Install the new back-up switch with the new gasket. Rotate the switch by hand while turning its connector in order to avoid any twisting of the harness.

STEP 31: Using the same precautions practiced in the switch removal, tighten the new switch and set the torque to **32Nm (23.6 ft-lb)**.
