SERVICE BULLETIN

APPLICABILITY: 2019-21MY Forester

NUMBER: 03-89-22

SUBJECT: DTC B280B VDC Brake Fluid Pressure

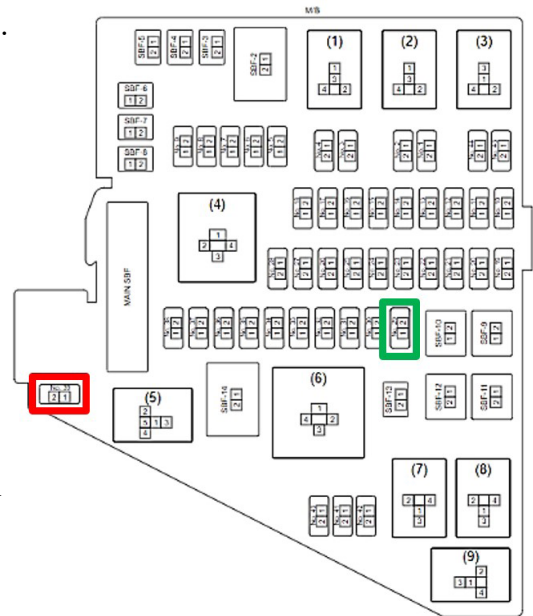
After reprogramming the VDC system, the Auto Headlight Leveler Control will be in the fail-safe status. Follow the procedure outlined below for proper initialization. If this procedure is not followed, the steering responsive headlights and headlamp leveling features may become temporarily unavailable.

- A. Confirm the vehicle is parked on a flat and level surface.
- B. Turn the ignition switch to the “OFF” position.
- C. Remove the 30 Amp transport fuse from the #29 (GREEN) position of the main fuse box located under the hood.
- D. Insert the removed fuse into the #39 (RED) position and switch the ignition switch to the “ON” position.
- E. Wait at least three seconds, then turn the ignition switch to the “OFF” position.
- F. Return the fuse to the original position (#29).
- G. Start the engine and run for at least three seconds. Using the Subaru Select Monitor (SSM), clear any fault codes that might have been set during the procedures listed above.
- H. Perform a function test of ALL the operations of the headlight system.
