## SERVICE BULLETIN

**APPLICABILITY:** 2020-21MY Legacy & Outback  
2019-21MY Forester  
2021MY Crosstrek

**NUMBER:** 09-80-21R

**SUBJECT:** DTC # P2682 & P26Ax\*\* / Thermo Control Valve – Design Change

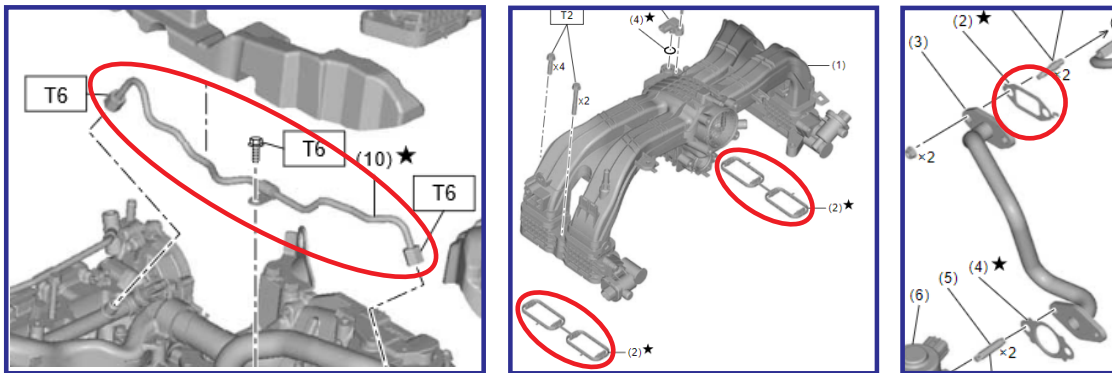
- The Service Manual uses a black star (★) in the component breakdown illustrations to indicate one-time use parts. The high-pressure fuel delivery pipe, intake manifold gaskets, and EGR cooler gaskets are one-time use parts (shown below).
