Advanced Technical Information

Bulletin #: 2227

Taycan - Squeaking Noises from Front Seats

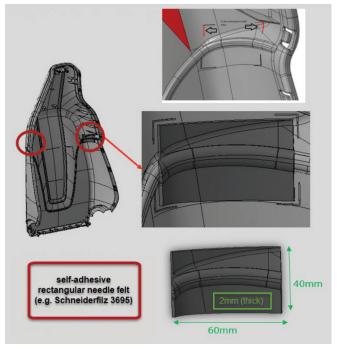
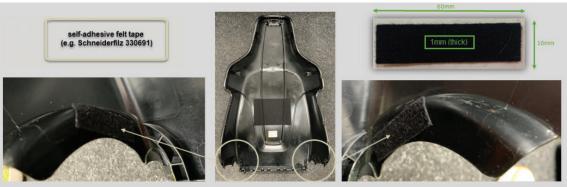
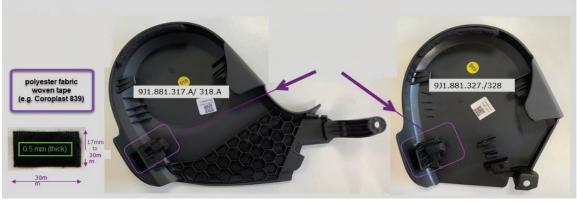
Figure 1 - Felt Application Points

Customer concern of squeaking noises from the front seat.

This may be caused by multiple contact points within the seat assembly.

Please apply insulating material to the locations indicated in the photos.
