TECHNICAL SERVICE INFORMATION BULLETIN

TSIB 22-08 Rev A		September 26, 2022
TO:	All Operators	
TITLE:	<i>Application of silicone paste on charge rails to avoid isolation faults</i>	
APPLICABILITY:	All New Flyer/MCI E-buses equipped with overhead charging.

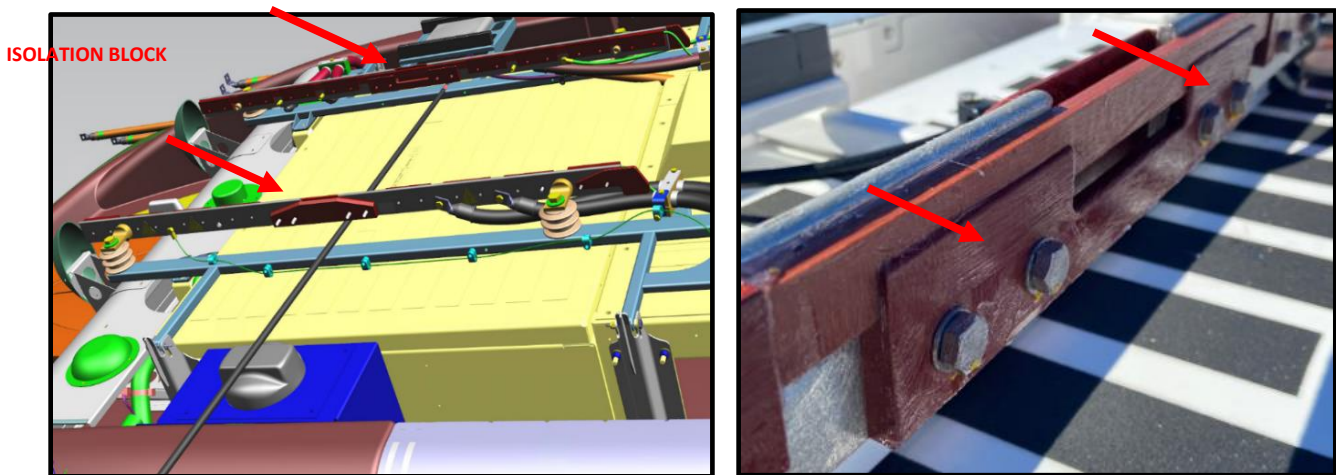
Issue - It has been determined that water/residues collecting on the surfaces of overhead charge rails may create an isolation fault when attempting to charge during heavy rains. If an isolation fault is present the charger will automatically shutdown and will not charge the vehicle. Accumulation of a continuous water film on the surfaces of overhead charge rails may create a ground path for electrical current between the positive rail and the ground rail, causing the isolation fault.

Figure 1: Application of Silicone paste on Isolator Block

Remedy – Application of a special silicone paste to the charge rails every 3 months of service will result in the water beading and draining off the charge rails. This beading will eliminate a continuous electrical path between the positive and ground rails, and elimination of associated isolation faults when charging.
