Service

149/22 ENU WNK7

WNK7 - Replace Connectors for Antenna Cable (Workshop Campaign)

Model Series: Taycan

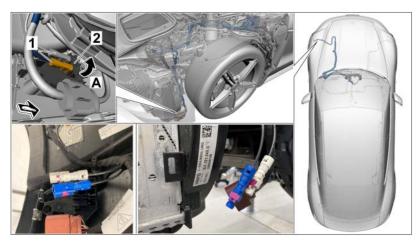
- 3.1 Unclip plug connections \Rightarrow Replacing front connector housing -1- from \Rightarrow Replacing front connector housing -2- the holder \Rightarrow Replacing front connector housing -arrow A-.
- 3.2 Release electric plug connections and disconnect them.
- 3.3 Check whether the coupler connection ⇒ Checking connector-Arrow- has visible traces of corrosion on both plug connections.

If traces of corrosion are visible on the coupler, document this by taking a photograph using a digital camera and repair the antenna cable. For this purpose, continue with \Rightarrow Technical Information '536919 Replace antenna cable and repair plug connection'.

- 3.4 Replace connector housing (on body).
 - 3.4.1 Lever off secondary lock on the connector housing ⇒ Disassemble connector housing -1- using a small screwdriver ⇒ Disassemble connector housing -arrow A-.
 - 3.4.2 Lever off primary lock ⇒ Disassemble connector housing -Arrow

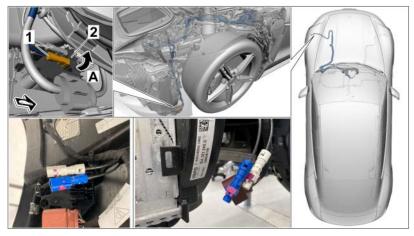
Replacing front connector housing

2.3 Check whether the coupler connection ⇒ Checking connector-Arrow- on both plug connections has visible signs of corrosion.

If traces of corrosion are visible on the coupler, document this by taking a photograph using a digital camera and repair the antenna cable. For this purpose, **continue with** \Rightarrow *Technical Information* '50561903 Replace antenna cable and repair plug connection'.

- 2.4 Replace connector housing (on body).
 - 2.4.1 Lever off secondary lock on the connector housing ⇒ Disassemble connector housing -1- using a small screwdriver ⇒ Disassemble connector housing -arrow A-.
 - 2.4.2 Lever off primary lock ⇒ Disassemble connector housing -Arrow
 B- and ⇒ Disassemble connector housing -Arrow C- pull connector housing out of the antenna cable.

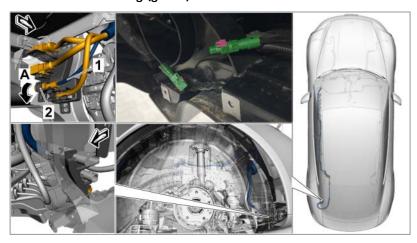
- Unclip \Rightarrow Replacing rear connector housing -1- plug connection \Rightarrow Replacing rear connector housing -2- from the holder \Rightarrow Replacing rear connector housing -arrow A-.
- 2.2 Release plug connection and disconnect it.
- 2.3 Check whether the coupler connection ⇒ Checking connector-Arrow- on both plug connections has visible signs of corrosion.

If traces of corrosion are visible on the coupler, document this by taking a photograph using a digital camera and repair the antenna cable. For this purpose, continue with \Rightarrow Technical Information '536919 Replace antenna cable and repair plug connection'.

- 2.4 Replace connector housing (rear bumper).
 - 2.4.1 Lever off secondary lock on the connector housing ⇒ Disassemble connector housing -1- using a small screwdriver ⇒ Disassemble connector housing -arrow A-.
 - 2.4.2 Lever off primary lock ⇒ Disassemble connector housing -Arrow
 B- and ⇒ Disassemble connector housing -Arrow C- pull connector housing out of the antenna cable.

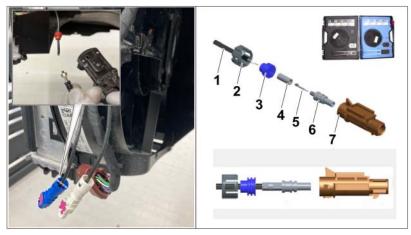
After stripping, make sure that no corrosion (copper rust) is visible in the antenna cable. Shorten the cable as required until there is no corrosion any more.

- Cable seal
- 4 Crimping sleeve
- 5 Inner conductor
- 6 Connector/coupler
- 7 Connector housing
- 3.1 Disconnect plug connection as close as possible to the coupler ⇒ Repairing plug connection
 -Magnifier-.
- 3.2 Replace plug connection according to repair instructions in the **Repair kit for antenna lines (VAS6720)**. ⇒ *Workshop Manual '912841 Repairing antenna cable'*
