MAZDA DEALER EMAIL

Subject: Dealer Rework (DRW) 51 – 2022MY MX-5 Rear Differential Noise Concern

DRW51 – Rear Differential Concern - 2022 MX-5

Dealer Rework DRW51

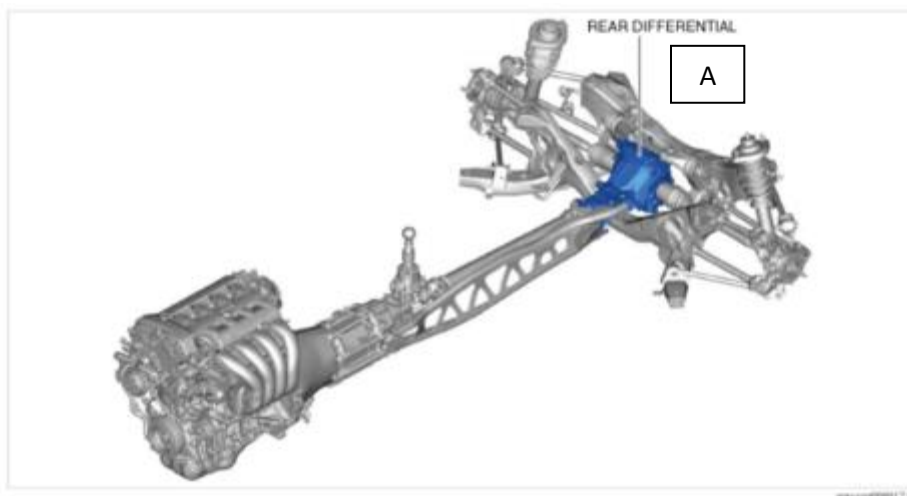
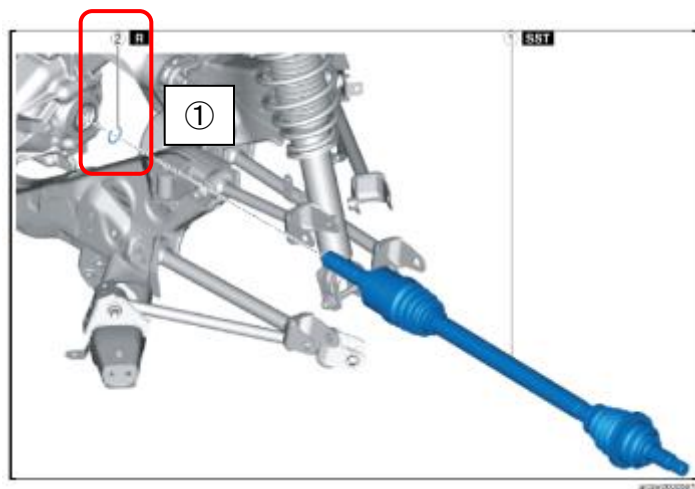
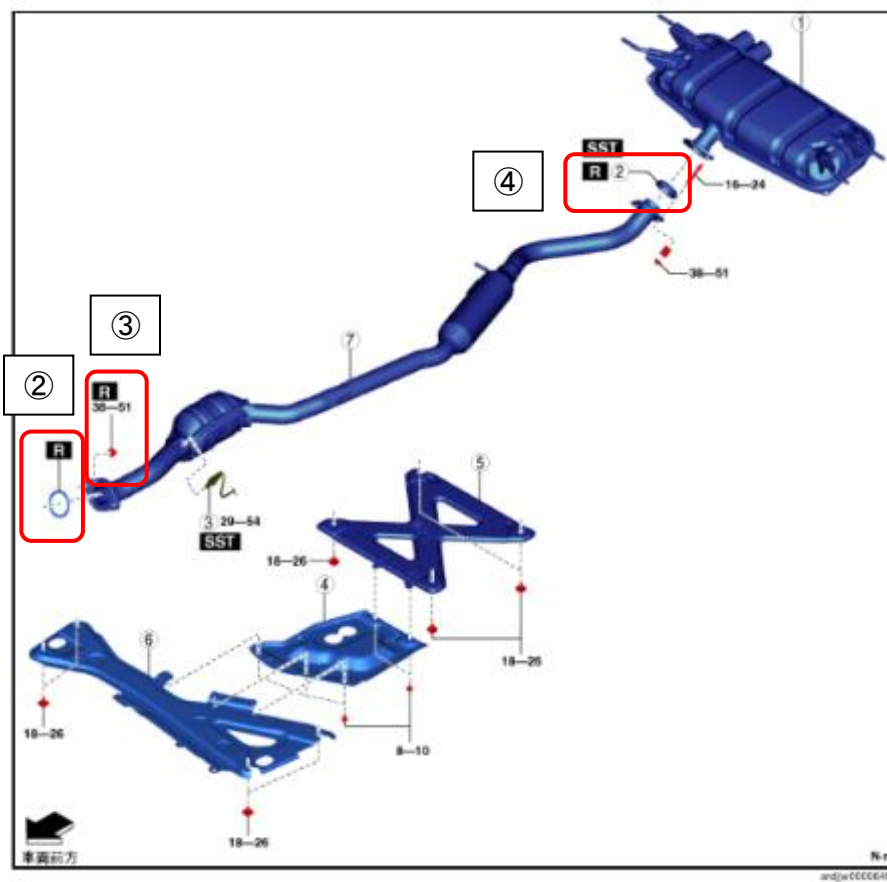
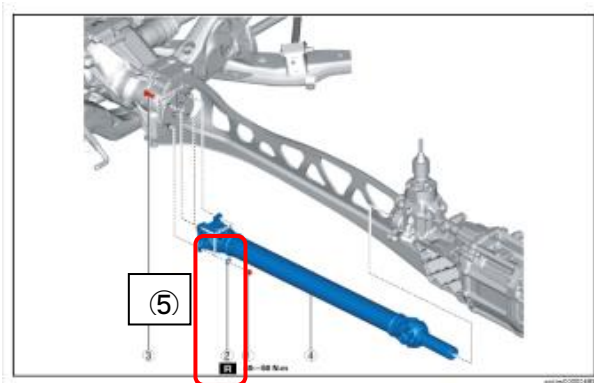
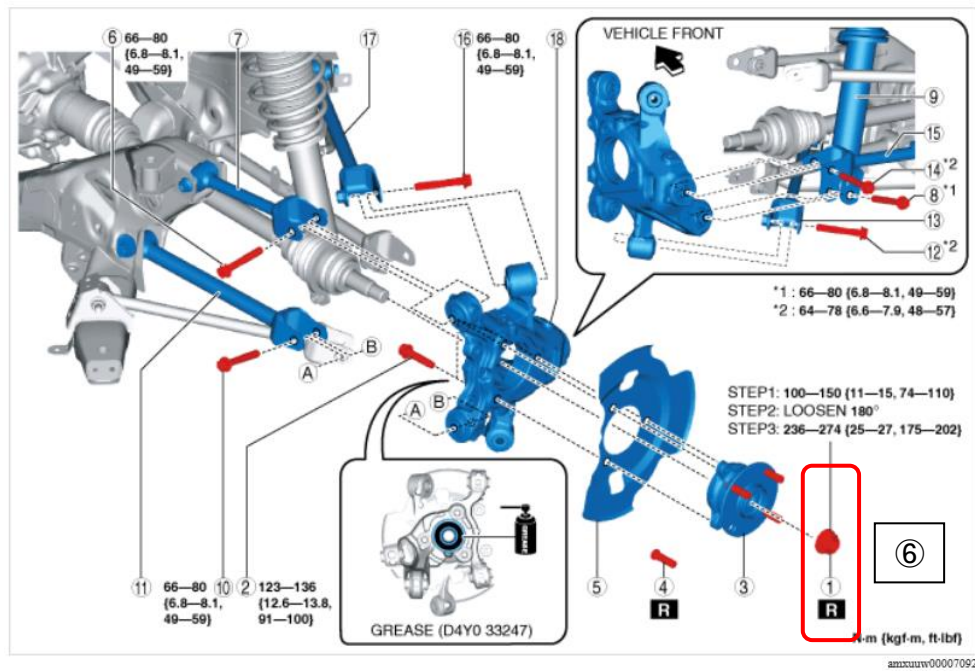
PARTS INFORMATION (refer to photos below for parts identification)

No.	Description	Part Number	Quantity	Note	Scrap
A	Driving & Differential	MA56-27-100A	1		Yes
①	Clip	G054-25-421	2	Required when replacing the differential	Yes
②	Gasket	PE23-40-305	1		Yes
③	Nut	99946-1000	2		Yes
④	Seal Ring	RFK2-40-581	1		Yes
⑤	Spring Washer	99971-1000	4		Yes
⑥	Nut	D651-33-042A	2		Yes
N/A	Fill Plug Washer, if replaced during level check.	995641800	1		Yes
