Model Series167: Noises From Area Of Instrument Panel

Topic number	LI68.10-P-075301
Version	1
Function group	68.10 - Instrument panel
Date	9/12/22
Validity	SOP to 31.10.2022
Reason for change

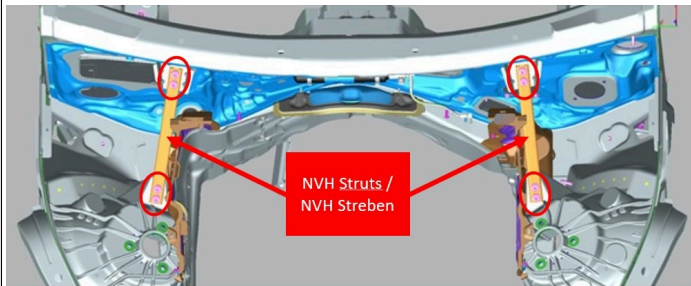
Attachments	
File	Description
NVH Struts - NVH Streben.jpg	NVH Struts - NVH Streben

Metallic noises from area of instrument panel

Due to a possible drop in torque at the screw connection of the NVH struts in the engine compartment (see picture in the attachment), noises may be perceived in the area of the instrument panel.

Replacement of the 8 screws of the NVH struts in the engine compartment.
