206 295 297 Trunk Lid/Tailgate Unlocks But Does Not Open

Topic number	LI72.20-P-075232
Version	1
Function group	72.20 - Tailgate, rear door
Date	9/14/22
Validity	MODEL 206 with code 881 or 890 up to manufacturing date July 30, 2022 MODEL 295 with code 881 up to manufacturing date July 30, 2022 MODEL 297 up to manufacturing date July 30, 2022
Reason for change	Added information regarding function of interior trunk.

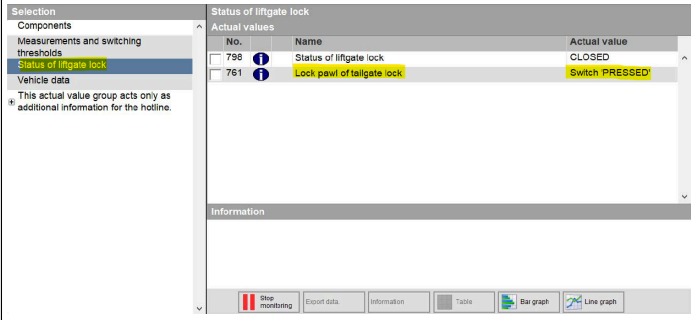
Attachments	
File	Description
XENTRY Still.png

Faulty microswitch signal at trunk lock.

In the event of a problem, the status of the trunk lock (picture 1) does not change during opening/closing of the trunk lid or tailgate.

Actual values		
No.	Name	Actual value
798	Status of liftgate lock	CLOSED
781	Lock pawl of tailgate lock	Switch_PRESSED

Replace trunk lock (A85/5).
