# ***SERVICE PROCEDURE***

22520  
SEPTEMBER, 2022

**SUBJECT:**     **SAFETY RECALL**  
Tie Rod End Clamps on certain International® HV™ and HX® Series trucks built 11/18/2021 thru 08/04/2022 with feature code 02ARU, 02ARY, 02ARZ, 02ATB, 02AUR, 02AVB, 02AVC, 02AVD, or 02AVE (Meritor Steer Axle) and an additional steering axle installed by Navistar's Truck Specialty Center (TSC).

# REPLACING TIE ROD END CLAMPS WITH KIT FRK-22-1002

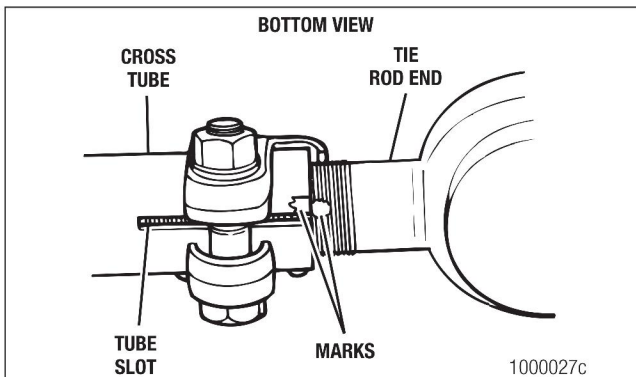
Figure 1

3. Use a paint pen to mark the position of both tie rod ends as shown. Be sure to mark it well so the tie rod end can be screwed back into the exact same position on the threads. Also count the amount of visible threads to confirm proper depth upon re-installation. Figure 1.

10. Thread the tie rod end back into the same position utilizing the paint pen marking. Exposed threads should match the value noted in Step 3.
11. Be sure that the clamp tab is firmly seated against the end of the cross tube. Align the clamp opening with the cross tube slot as shown in Figure 1. Tighten the clamp bolt nut to 150-175 lb-ft (203-237 Nm).

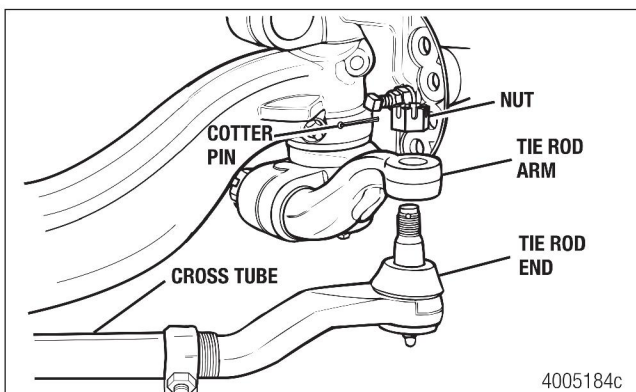
Figure 2

4. Remove the cotter pin and nut that fastens the tie rod end to the tie rod arm. Figure 2.

5. Disconnect the cross tube assembly from the tie rod arm. If available, use a tie rod end puller to separate the tie rod end from the tie rod arm. Figure 2. If necessary, use a leather or plastic mallet to tap on the end of the tie rod arm.
