PIVI – Loss of GPS location and clock time

20-23MY Defender 21-23 MY Discovery, Discovery Sport, Range Rover Evoque, New Range Rover, New Range Rover Sport, Velar, E-Pace, I-Pace, F-Pace, XF

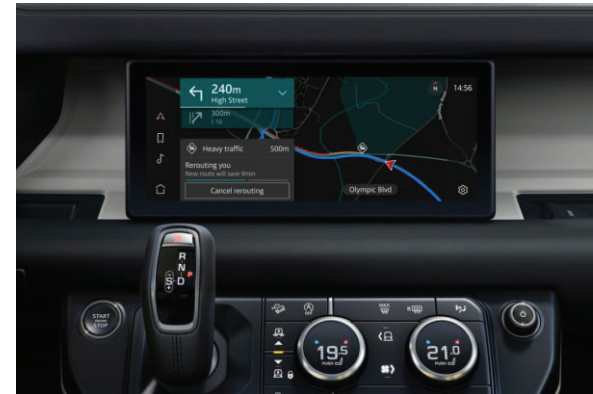
- 1) Navigation system has defaulted to a location in Berlin, Germany
- 2) Clock may not show the correct time
- 3) Apple CarPlay/Android Auto maps may not show correct position

This is caused by a GPS firmware bug

1. Run the PIVI Recovery application in TOPIx Cloud, even if PIVI is already on the latest software level.
2. Check the following on a 10-minute drive outside in an open space to allow GPS to calibrate and receive data from satellites. **Note – this is necessary as a good satellite signal cannot be guaranteed inside a workshop.**
 - Vehicle position shown in the correct location
 - Clock displaying correctly
 - Local weather location is correct
3. If GPS/ clock is still not working properly, then read out GPS firmware number from Engineering screen which is accessed by a 5 second press and hold in the small gap between clock and the top corner of the screen whilst on home page (Please see attachment).
4. If this is reading v 0.09.99 or nothing/blank, then please raise a TA for attention of EES_200 Infotainment.
5. Refer to SSM75848, SSM75849 for further details.
