## Low Speed Front end driveline clunk

22MY Range Rover,  
Range Rover Sport- V8**Customer Voice:**

Refer to SSM75837

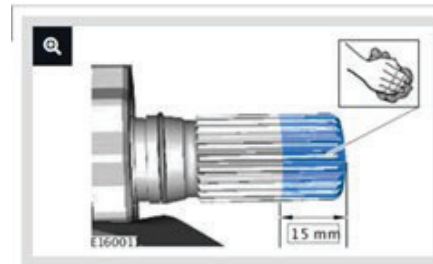
- A customer may express a concern that a driveline clunk is heard and felt through the floor of the vehicle. This is reported at low Speeds (0 to 20 mph) when on/off the throttle or during low speed braking.

Clean the 15mm of the spline at the end of the axle pinion.
