AJ20 P6 Water Pump – PRR request

19-22MY Range Rover, RR Sport, Defender, Velar, Range Rover(L460), Jaguar F-PACE

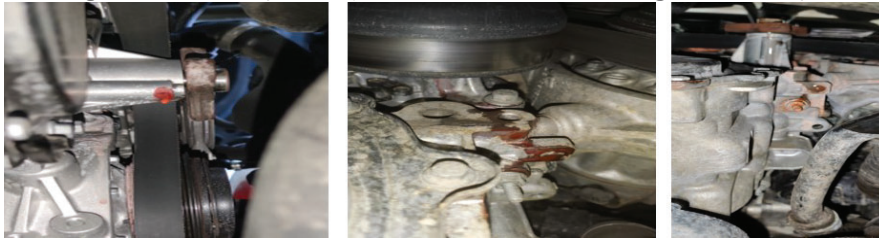
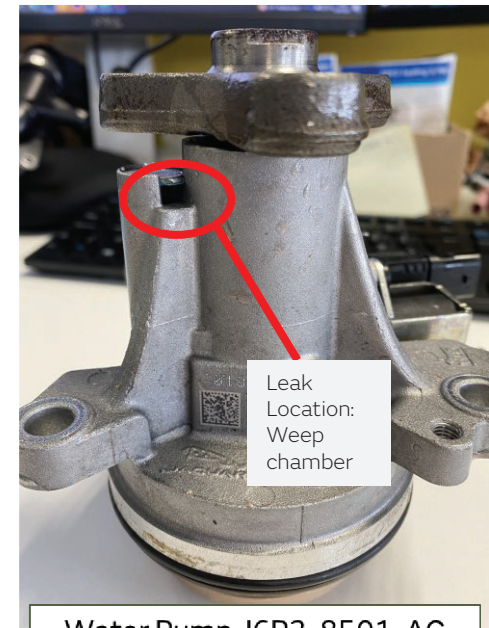
- Water Pump to be replaced due to leakage at water pump weep chamber.

Example Leaking Water Pumps, Any observation of leakage to be reported

Leak Location: Weep chamber

- Raise an EPQR to support the ongoing investigation.
- Take 1 quart Coolant sample before repair.
- Remove Water Pump and package with coolant sample for collection via PRR.
- Refer to TOPIx 303-03C: Engine Cooling - INGENIUM I6 3.0L Petrol for diagnostic and repair instructions.
