Malfunction Indicator Lamp (MIL) Activates Together With Fault Memory Entry “P045600 / P044200” or a Smell of Fuel Around the Cap (150/22)

Vehicle Type: **Carrera (992)
Panamera (971)
Macan (95B)
Cayenne (9YA/9YB)**

Model Year: **As of 2021 up to 2022**

Concerns: **Cap for fuel tank**

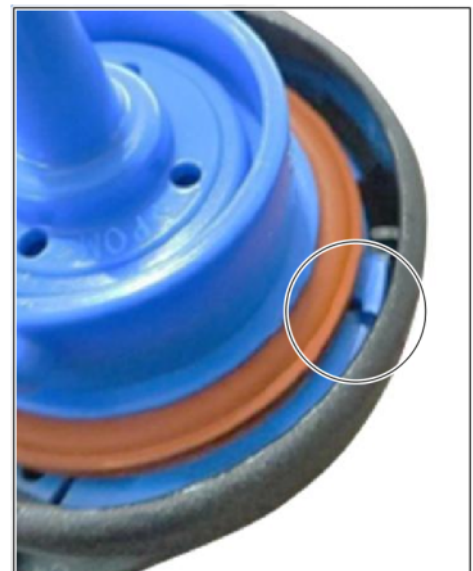
Damaged cover

This may be caused by a defect in the cap on the fuel tank.

- 2 Open the cap and check for damage ⇒ *Damaged cover.*

Action required: In the event of a customer complaint, check the cap for damage and replace it if necessary.

Assessment		Action
(✓)	There is no visible damage to the cap.	Fault finding must be continued otherwise. Close the cap.
(✗)	Damage is visible on the cap.	Replacing the cap. Continue with Step 3.
