CAMPAIGN 000-046

Vicinity Motor Corp.

CAMPAIGN NUMBER	DESCRIPTION	CHARGE TO		TIME
		LABOR	PARTS	
000-046	35' Bus floor frame crack inspection and repair campaign	VMC	VMC	8 HR

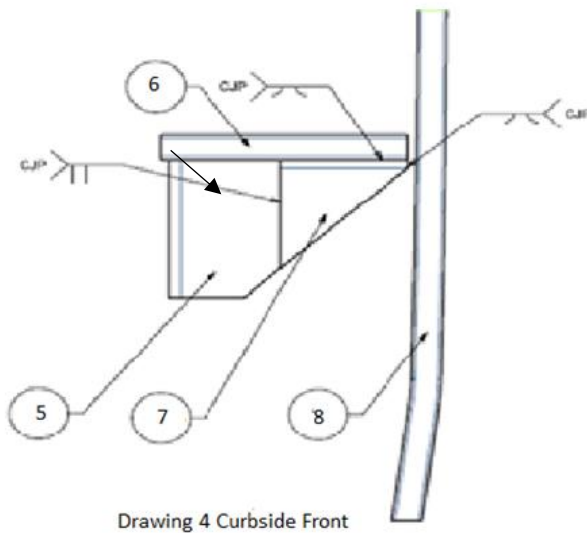
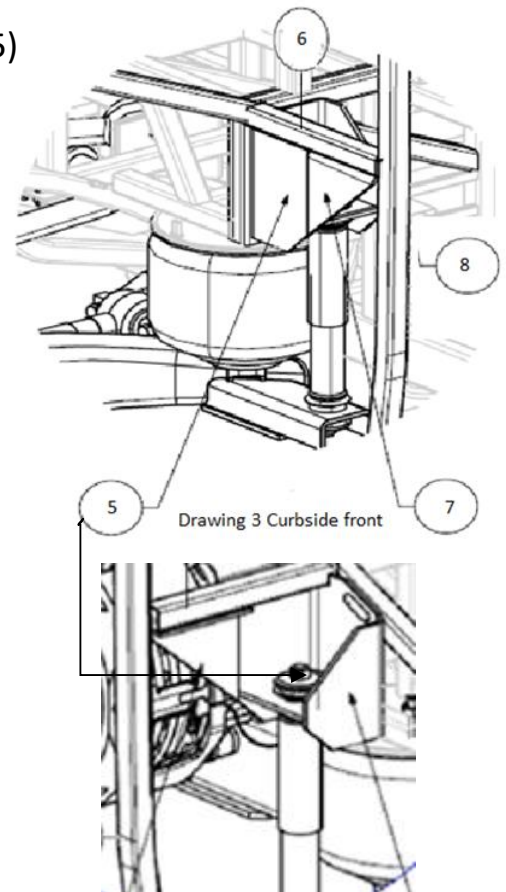
2. Refer to drawings 3 and 4 to locate and identify the following components of the Curbside front shock tower.
 - The upper shock anchor bracket plate (Item 5)
 - The floor frame horizontal beam (item 6)
 - The side frame pillar (item 8)

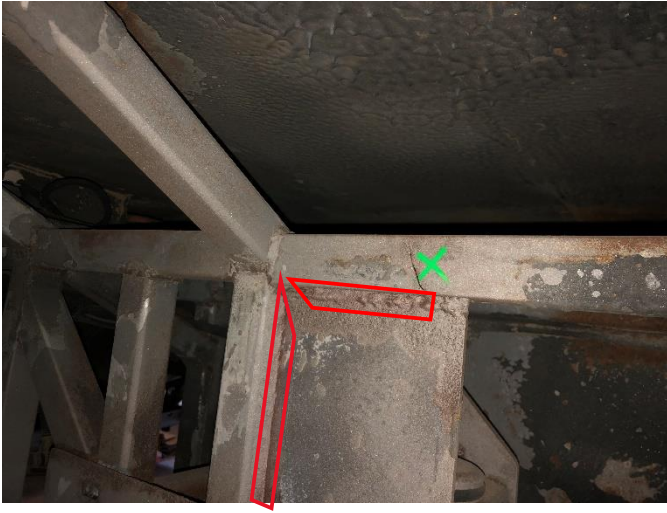
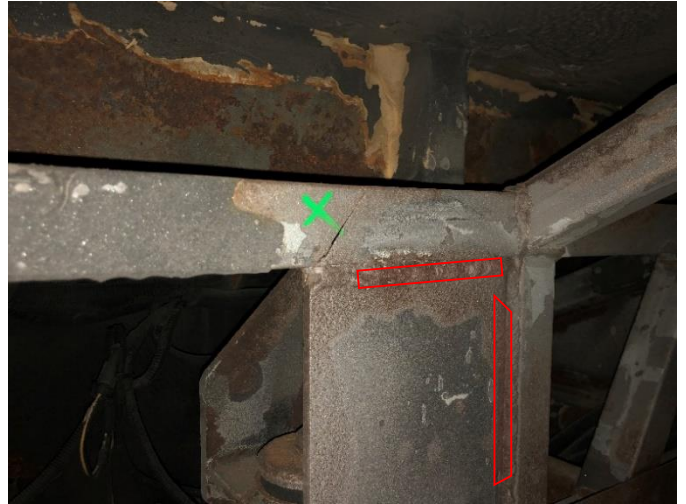
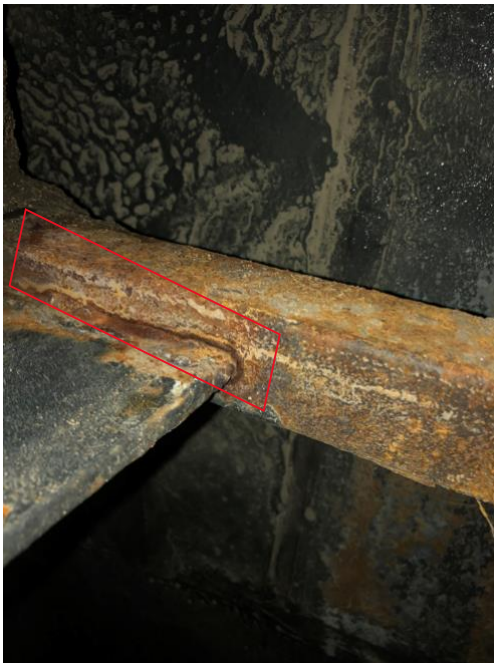
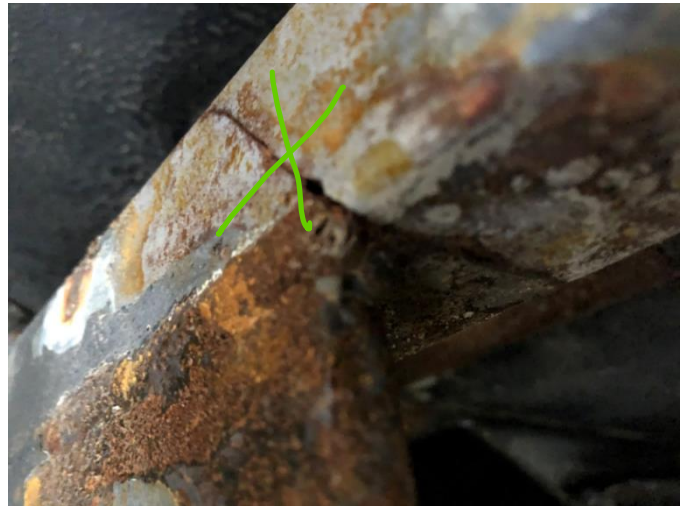
3. Locate and inspect the same structural points on the curb rear shock tower opposite side.
4. Inspect shock towers brackets weld for signs of cracking (Area framed in Red). Do NOT repair cracks in the floor frame horizontal beam (pictures below with a green X). If this item is cracked, it MUST be REPLACED with a new beam.
