**Y1B, Y1C Taycan - Glass Roof Stress Cracks**

Models	Model Year	Model Type	VIN Range	Vehicle-Specific Equipment
Taycan	2021 - 2022	Y1B, Y1C	n/a	n/a

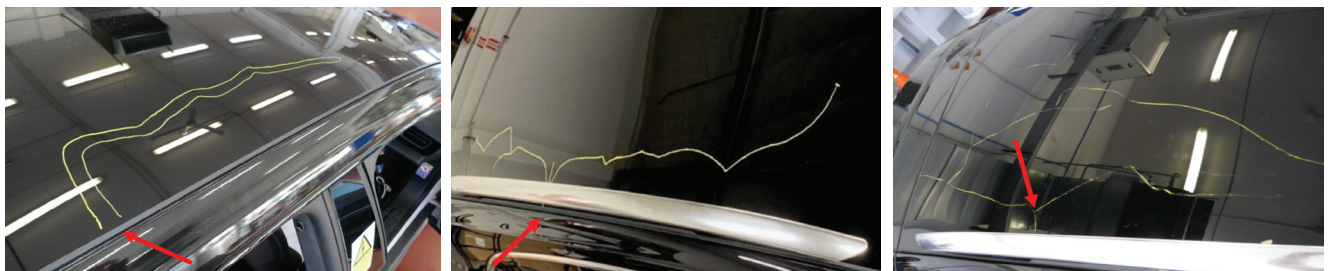
The customer complains of a crack in the fixed panoramic roof. The workshop cannot find evidence of outside influence.

**This condition may also be noticed at PDI or during transport.** The cracks may originate on either side of the glass roof.

**Figure 1: Examples of Stress Cracks**

Too large of an air gap between the mounting flange for the glass roof panel and the roof frame may cause stress cracks to develop during tightening of the mounting screws, or during vehicle operation.

1. Please document all stress cracks with pictures, and attach all pictures to the PCSS job.
2. Replace the glass roof assembly as instructed in WM 600655 Replacing roof assembly.
  - a. **NOTE: Please record all air gap measurements (Step 6, section on Installing roof assembly) and attach the measurements to the PCSS job.**
