Service Alert

Subject:	
MAZDA CONNECT SYMPTOM TROUBLESHOOTING (7TH GENERATION VEHICLES)	Service Alert No.: SA-004/22
5_11_15.11.51X 1_1.11.51_5 ,	Last Issued : 09/08/2022

2019-2022 Mazda3 2020-2022 CX-30 2021-2022 CX-5 2021-2022 CX-9 2022 MX-30 2023 CX-5

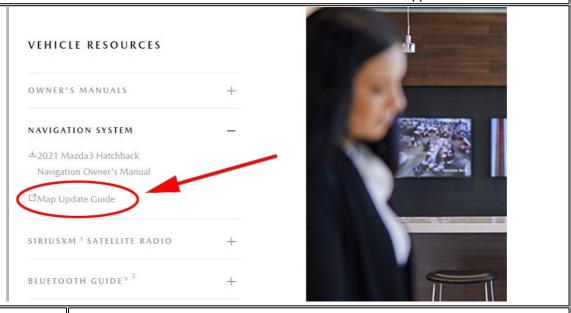
License Error message in Mazda Toolbox

Customer is locked out of map update on Mazda Toolbox due to unauthorized or counterfeit navigation SD card.

How to unlock the customer account in Mazda Toolbox

- 1. Purchase a Genuine Mazda Navigation SD card.
- 2. Customer or dealer must contact NNG helpdesk by email at piracy@nng.com and request customer account unlock.
