Subject: POWER LIFTGATE WILL NOT OPEN AND DTC B145D:12 STORED	Service Alert No.: SA-060/22
	Last Issued : 09/12/2022

2023 CX-50

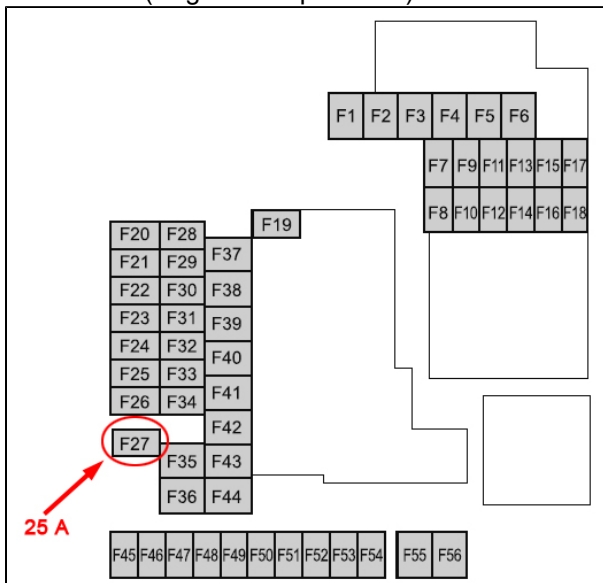
Fuse Block (Engine Compartment)

- 12V battery is disconnected and liftgate is closed rapidly
- 12V battery is connected, fuse F27 (PDI fuse) is removed and liftgate is closed rapidly
