# Service Alert

<b>Subject:</b> <b>BLIND SPOT MONITORING (BSM) MALFUNCTION DUE TO REAR SIDE RADAR SENSORS INSTALLED FACING WRONG DIRECTION</b>	<b>Service Alert No.: SA-061/22</b>
	<b>Last Issued : 09/29/2022</b>

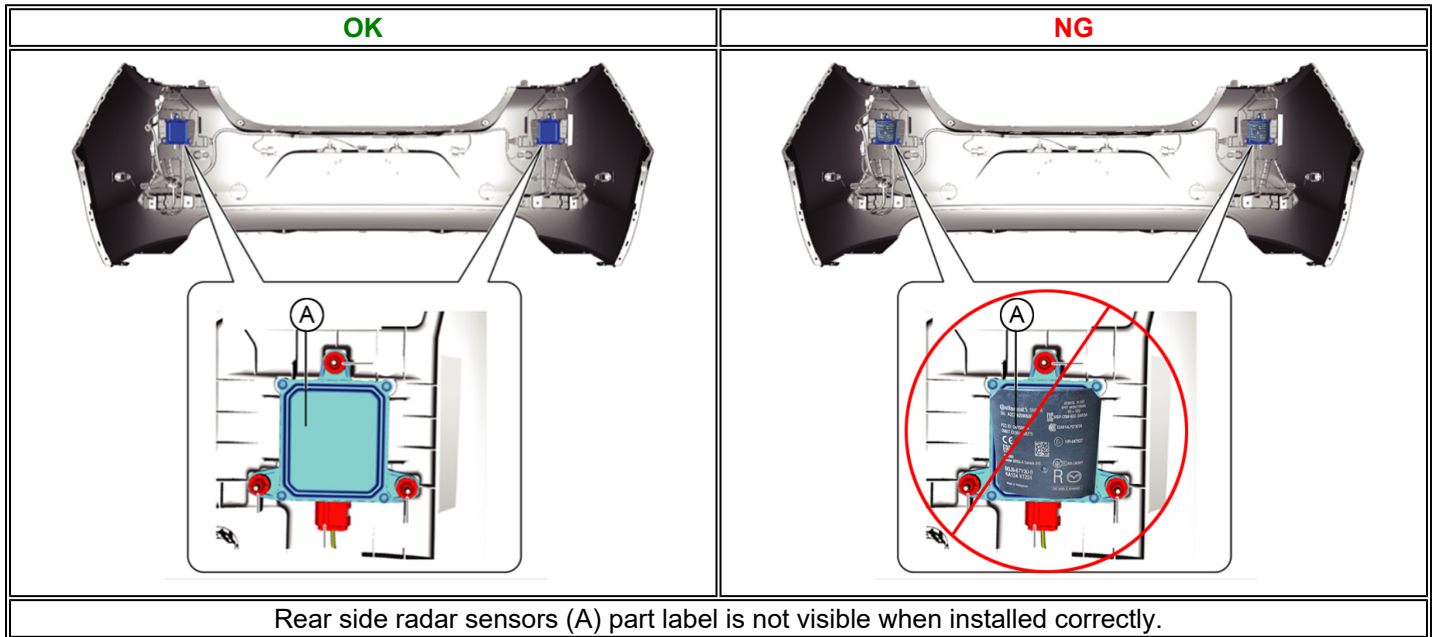
1. Verify customer concern.
2. Inspect the rear side radar sensors.

### Is the part label visible?

- **Yes:** Remove the rear side radar sensor(s) and install it correctly.
- **No:** This service information does not apply. Continue with normal diagnosis on MGSS.
