Technical Service Bulletin

Subject: AIR BAG WARNING WITH DTC B1126:13 OR B1127:13	Bulletin No.: 08-002/22
	Last Issued : 09/13/2022

2020-2022 CX-30 with VINS lower than 3MVDM*****430409 (produced before June 8, 2022)

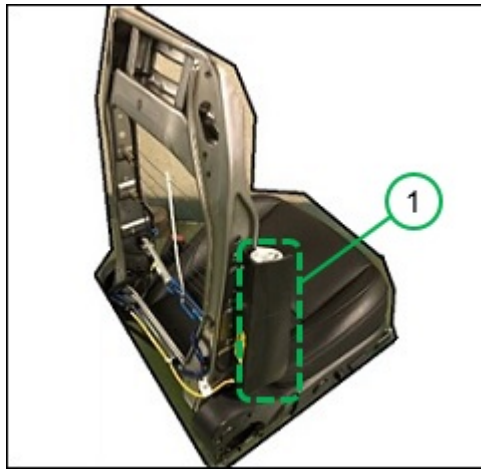
- When the driver or passenger moves, a load is applied to the seat back and the load may cause displacement of the mating terminals in the side air bag module connector, resulting in insufficient contact and higher resistance.
- The DTC detection level is too sensitive.

1. Verify the customer concern.
2. **[For 2020-2022 CX30 with VINs lower than 3MVDM*****414338 (produced before Feb. 27, 2022)]** Replace the affected side of the side air bag module(s) (1) with modified one(s) according to instructions on MGSS.
 - US/Canada spec: (SIDE AIR BAG MODULE REMOVAL/INSTALLATION [TWO-STEP DEPLOYMENT CONTROL SYSTEM - US/CANADA SPEC.]).

- Mexico spec: (SIDE AIR BAG MODULE REMOVAL/INSTALLATION [STANDARD DEPLOYMENT CONTROL SYSTEM - MEXICO SPEC.])
