Technical Service Bulletin

Subject: FRONT DOOR INTERFERES REAR DOOR GARNISH (MAZDA3 5-DOOR HATCHBACK)	Bulletin No.: 09-014/22
	Last Issued : 09/12/2022

2019-2020 Mazda3 5-door HB (Japan built) with VINS lower than JM1BP*****158118 (produced before November 29, 2019)

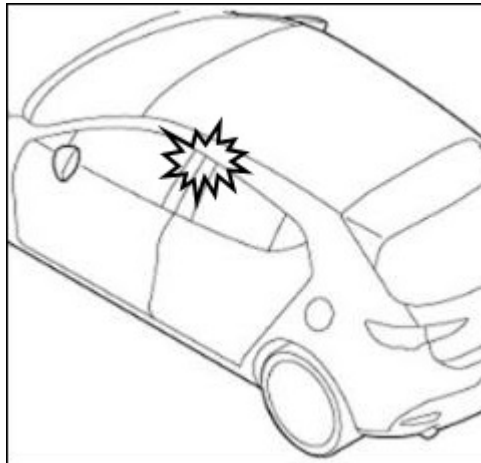
Some vehicles may exhibit that the glass run channel of the front door interferes with the rear door garnish.

Since the front door glass run channel is not fixed to the door strongly enough for the following situations, cycles of door operation may result in interference and lead to damage on the seal rubber at the rear door.

- When the front door glass is closed, the glass run channel may be forced to move to the B pillar side.
- In very hot climates, the glass run channel may expand to the B pillar side.

Customers having this concern should have their vehicle repaired using the following repair procedure.

1. Verify customer concern.
2. Replace the front door glass run channels with modified ones, regardless if the other side is damaged or not.

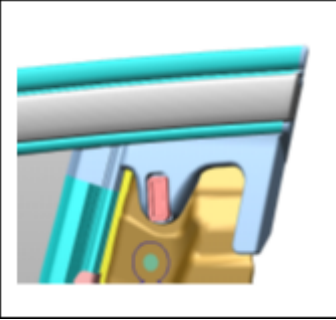
Old	New
Clip

- Phase 1
 - Adhesive has been added between the front door glass run channel and the door panel.
- Phase 2
 - The shape of the front door glass run channel has been changed so as not to make contact with the rear garnish.
 - The shape of the clip at the rear side of the front door glass run channel has been changed for stronger fixing and the hole at the door panel has been changed accordingly.

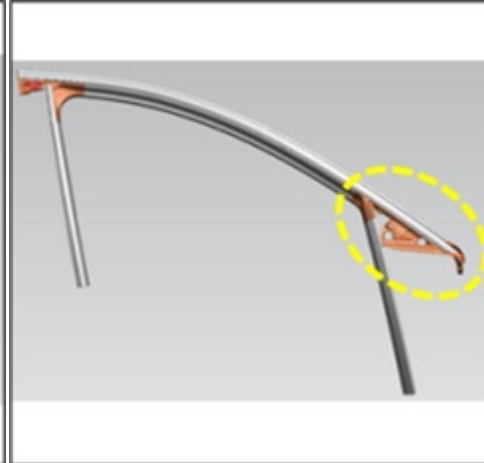
Front door glass run channel and sail garnish are integrally formed

- If the front door glass run channel obtained is BDMT-58/59-60ZJ or later level, remove and discard the sail garnish (1), which is originally installed on the vehicle according to the instructions on MGSS (SAIL GARNISH REMOVAL/INSTALLATION), before installing the front door glass run channel.

Discard
(1) Sail garnish
(BCJH-58-621)

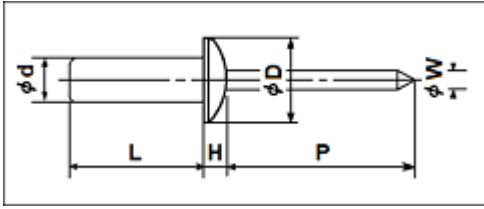
Sample size of rivet (90257-4810)

d	L	H	D	P	W
4.8 mm	9.9 mm	1.8 mm	9.6 mm	27 mm	2.9 mm
