FUEL- FILLER / CHARGE LID OPENS UNINTENTIONALLY WHEN UNLOCKING FRONT DOORS

Bulletin No.: 09-022/22

Last Issued : 06/14/2022

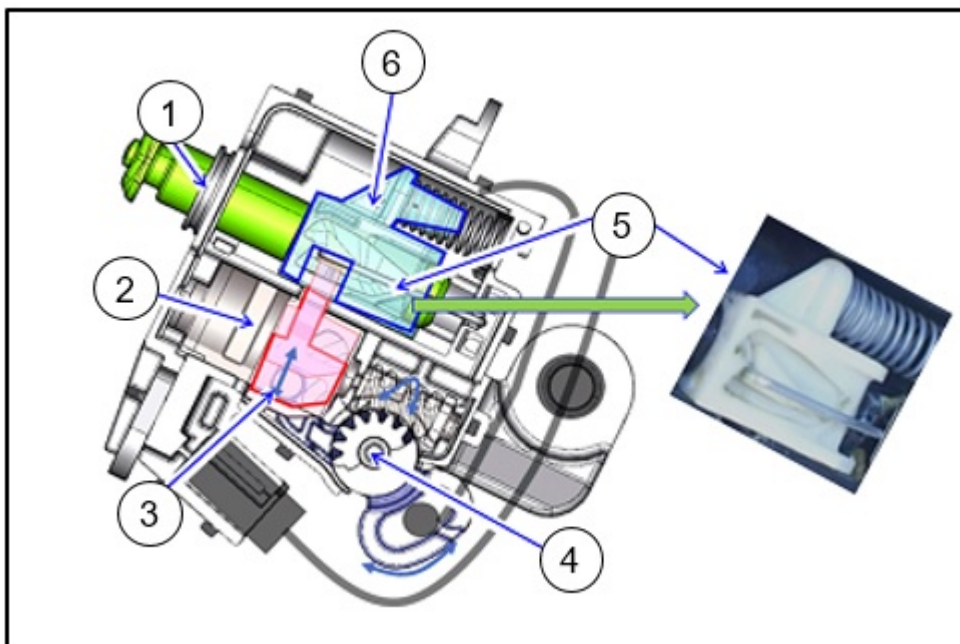
This is caused by a mechanical issue at the actuator of the fuel-filler/charge lid (when the fuel filler/charge lid is pushed hard, the guide pin in the actuator comes off).

- (1) Lifter pin
- (2) Motor
- (3) Lock lever
- (4) Helical gear
- (5) Guide pin
- (6) Cam

To eliminate this concern, the durability of the guide pin in the actuator has been improved.

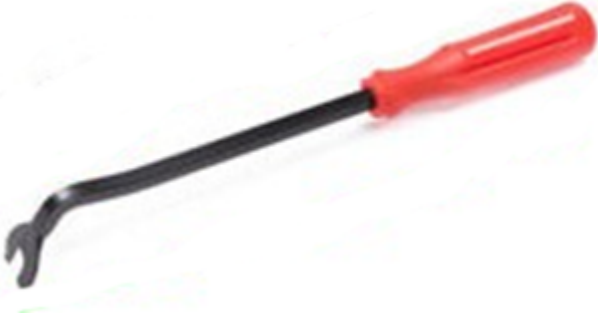
NOTE: It is recommended to use a steep angle trim removal tool (45 to 90 degrees) as shown to successfully remove this clip due to the deep location and lack of working space.

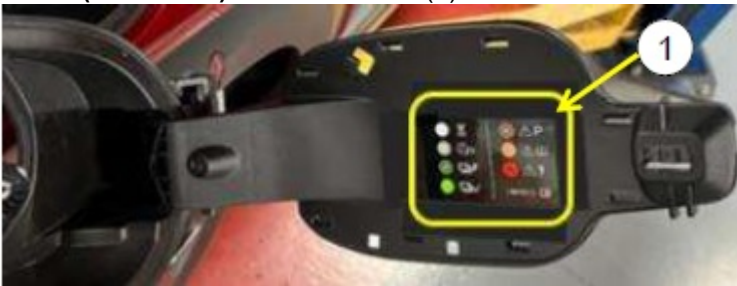
NOTE (For MX-30): Place a sticker (1) behind the lid.
