Technical Service Bulletin

Subject: BATTERY DISCHARGED DUE TO SEAT VENTILATION MALFUNCTION	Bulletin No.: 09-032/22
	Last Issued : 09/28/2022

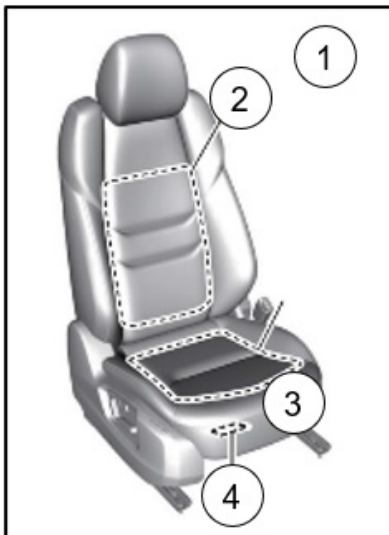
Some vehicles may experience the seat ventilation system still on after the engine has been turned off, in some cases this causes the battery to be completely discharged and not rechargeable. This is caused by a deterioration in the seat ventilation control unit. To eliminate this concern, the material for the circuit of the seat ventilation control unit has been modified.

- (1) Passenger side
- (2) Seat ventilation unit (Seat back side)
- (3) Seat ventilation unit (Seat cushion side)
- (4) Seat ventilation control unit

2. Replace the front seat warmer control unit according to the instructions on MGSS (FRONT SEAT WARMER CONTROL UNIT REMOVAL/INSTALLATION).

NOTE: The front seat ventilation control unit is integrated with the front seat warmer control unit located on the bottom of the passenger side front seat.
