# Broken Longitudinal Torque Rod Mounting Stud in Axle Spring Seat

M-652-002

(November 2008)

Certain CXU,CXP,CXN,GU,CTP,TD with Mack axles and AL suspension.

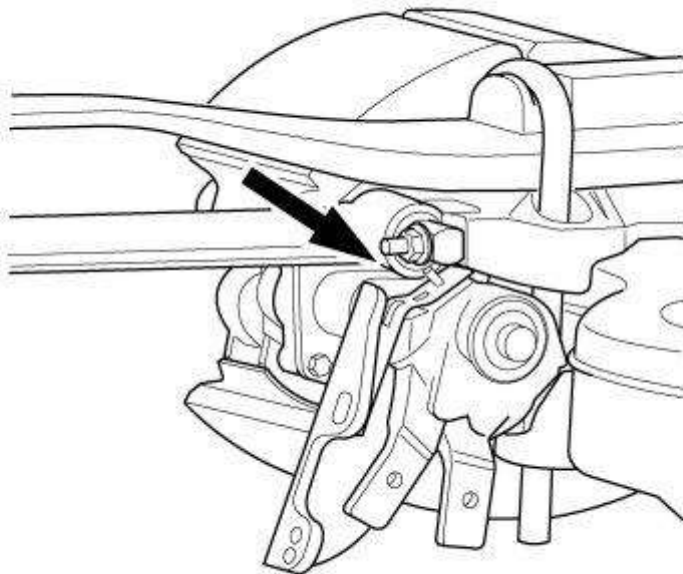
### Interference Between Brake Cam Tube Wing Bracket and Longitudinal Torque Rod

On certain CXU, CXP, CXN, CHU, CHN, GU, CTP and TD model chassis equipped with the MACK AL suspension and MACK rear axles, an interference condition may exist between the brake cam tube wing bracket and the longitudinal torque rod on the right-hand side of the chassis at both the front-rear and rear-rear axles.

*Note: This interference condition occurs on the right-hand side of the chassis only. This condition is not seen on the left-hand side.*

Should this interference condition be encountered at either the front-rear or rear-rear axle positions, replace both existing brake spiders (front-rear and rear-rear) with brake spider part number 8235- A3211Z6734. This brake spider orients the brake chamber 3 degrees lower from its original position. When replacing the brake spider, new mounting hardware must be used. Refer to the following illustration and chart for the required part numbers:

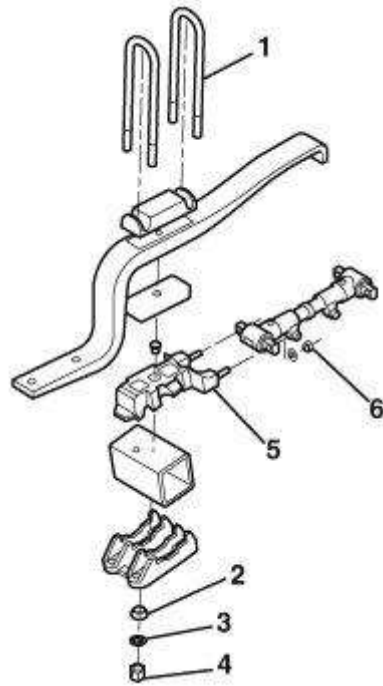
#### Spring Seat and Spring Clip (U-Bolt) Replacement

Contact between the brake cam tube wing bracket and the torque rod may eventually result in broken torque rod mounting studs. Should broken torque rod mounting studs be encountered, replacement of the spring seat(s) will be necessary. Disassembling the rear suspension for replacement of the spring seats requires replacement of the spring clips (U-bolts), washers and nuts. Part numbers are as follows:

- Retorque the spring clips (U-bolts) and torque rod fasteners on the left-hand side of the chassis.
- Measure and adjust the suspension ride height.
- Check and adjust the rear axle alignment

After any repair procedure that involved removal and replacement of the spring clips (U-bolts), the spring clips must be retorqued after a minimum of one day or a maximum of one week or 5 000 km/3,000 miles of service.
