Hood Insulation with Adhesive Backing

M-821-003

(June 2008)

Mack CXU models built before February 2008.

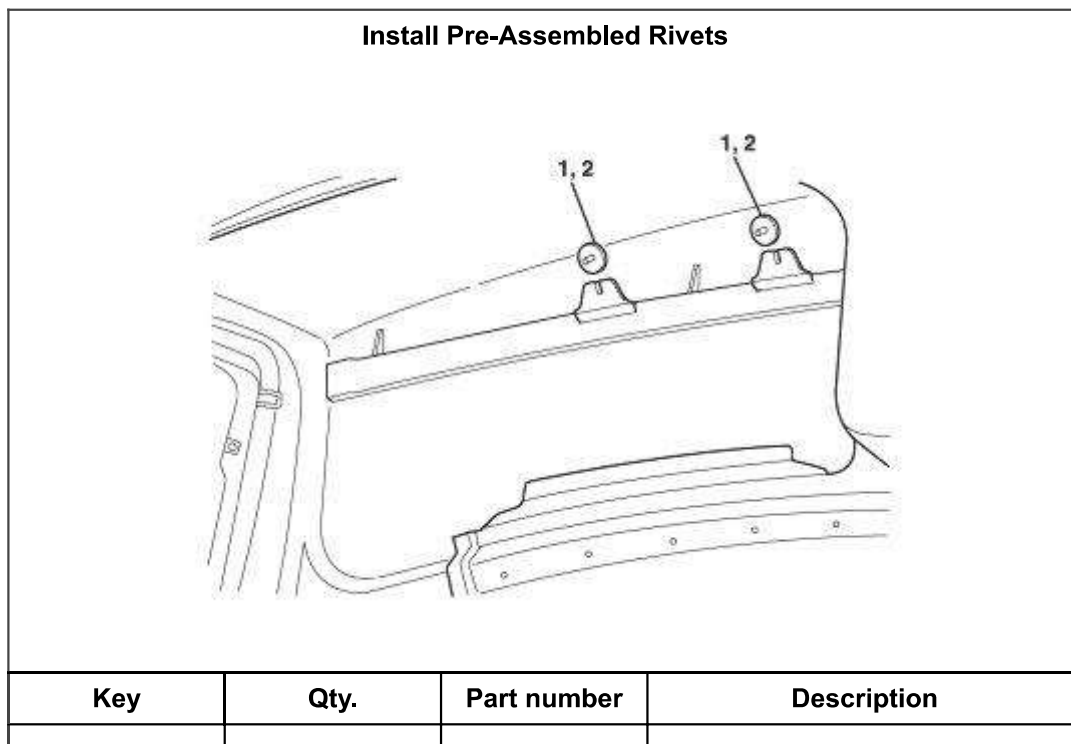
1	4	337AM7 (25087609)	Rivet
2	4	281AM5009 (25155206)	Washer, 7 mm inside diameter, 45 mm outside diameter

1. Secure the chassis for service, apply the parking brakes and block the wheels to prevent the vehicle from moving.
2. Open the hood, and then remove the existing sound insulation material and fasteners.
3. Using a clean rag, clean the underside surfaces of the hood where the adhesive on the sound insulation will be in contact. The surfaces must be clean and thoroughly dry. If the surface is contaminated with oil or grease, use a 50/50 mixture of isopropyl alcohol and water, or 3M Prep Solvent-70 to remove the oil and grease from the surface.
4. Pre-assemble the rivets (part number 337AM7 [25087609]) and washers (part number 281AM5009 [25155206]), and then insert the rivet assemblies into the slotted tabs located on both sides of the hood.

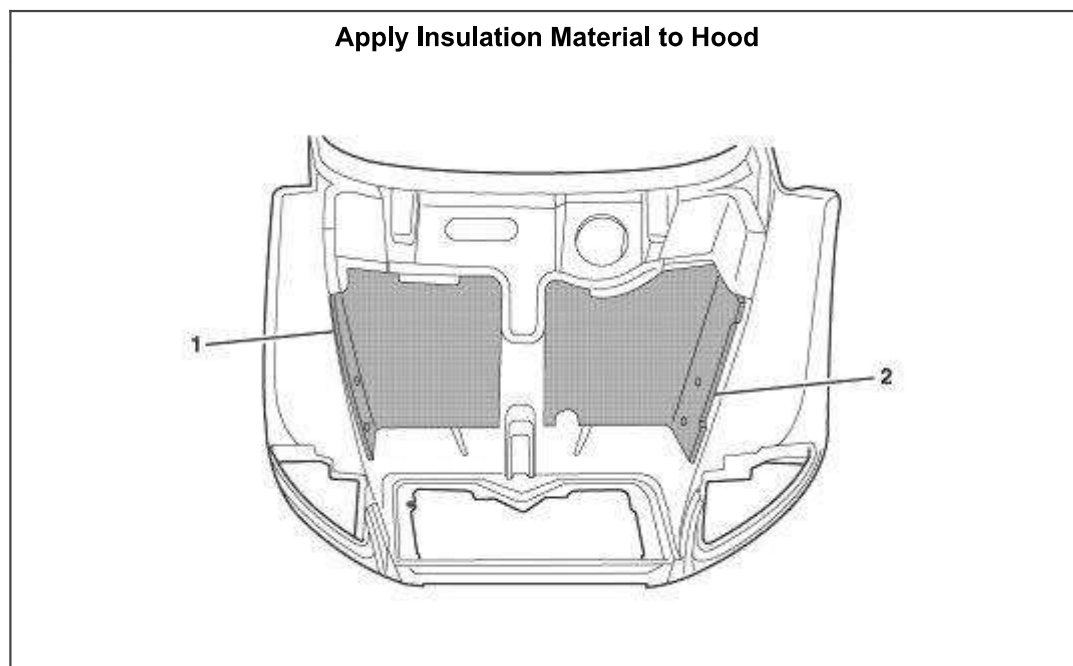
Key	Qty.	Part number	Description
1	1	9RU4223M (82197159)	Sound insulation, left-hand side
2	1	9RU4224M (82197161)	Sound insulation, right-hand side

6. Position the insulation material on the underside of the hood, and then apply sufficient force (approximately 7 kg [15 lbs]), preferably with a roller, to ensure good surface contact between the adhesive and the hood.

Note: The insulation must be applied to the hood within 10 minutes after the backing has been removed from the adhesive.

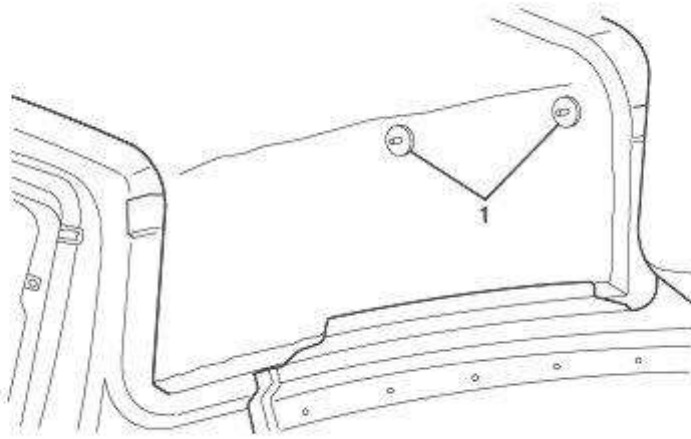
<p>Install Washers</p>

Key	Qty.	Part number	Description
1	4	281AM5009 (25155206)	Washer, 7 mm inside diameter, 45 mm outside diameter

7. Install the washers (part number 25155206) onto the rivets.
