# Rain Water Entering Thermal Regenerator, Non-Catalyzed DPF

M-258-000

(September 2008)

All MRU, LEU models equipped with a non-catalyzed DPF.

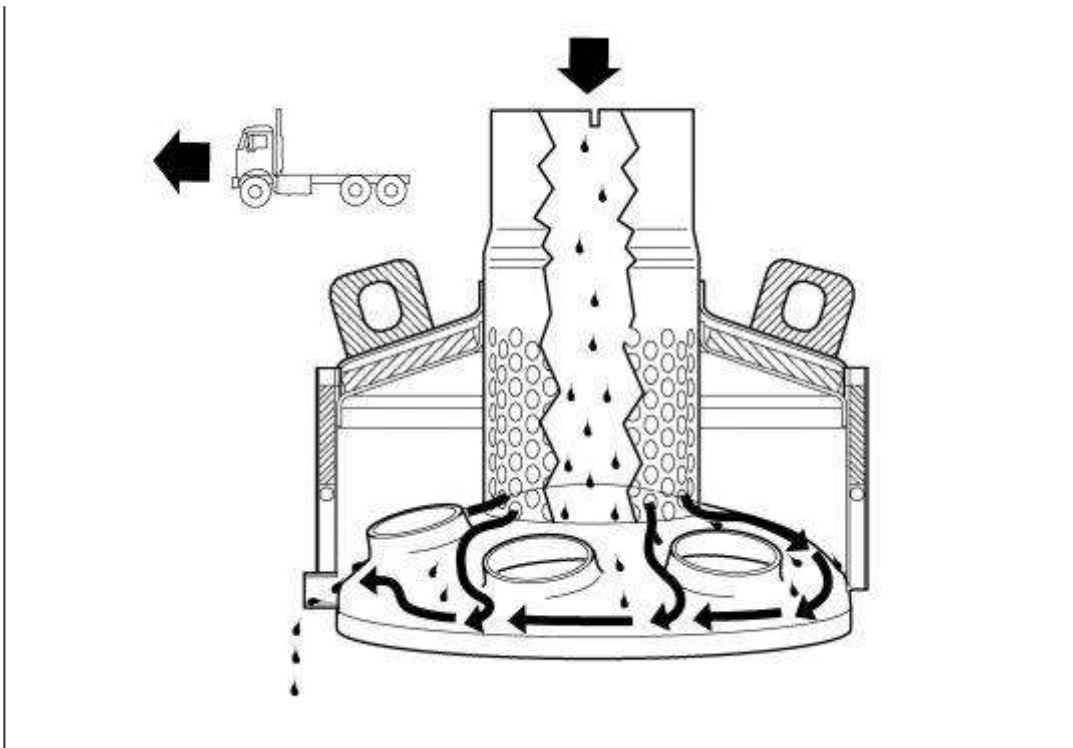
### Rain Water Path to DPF Drain Fitting

Rain water enters the DPF outlet housing through the exhaust stack where it flows down the baffle to the channel around the outside circumference (formed where the baffle is welded to the wall of the outlet housing). The water will then flow around the channel and exit the DPF unit through the drain fitting located on the side of the unit.

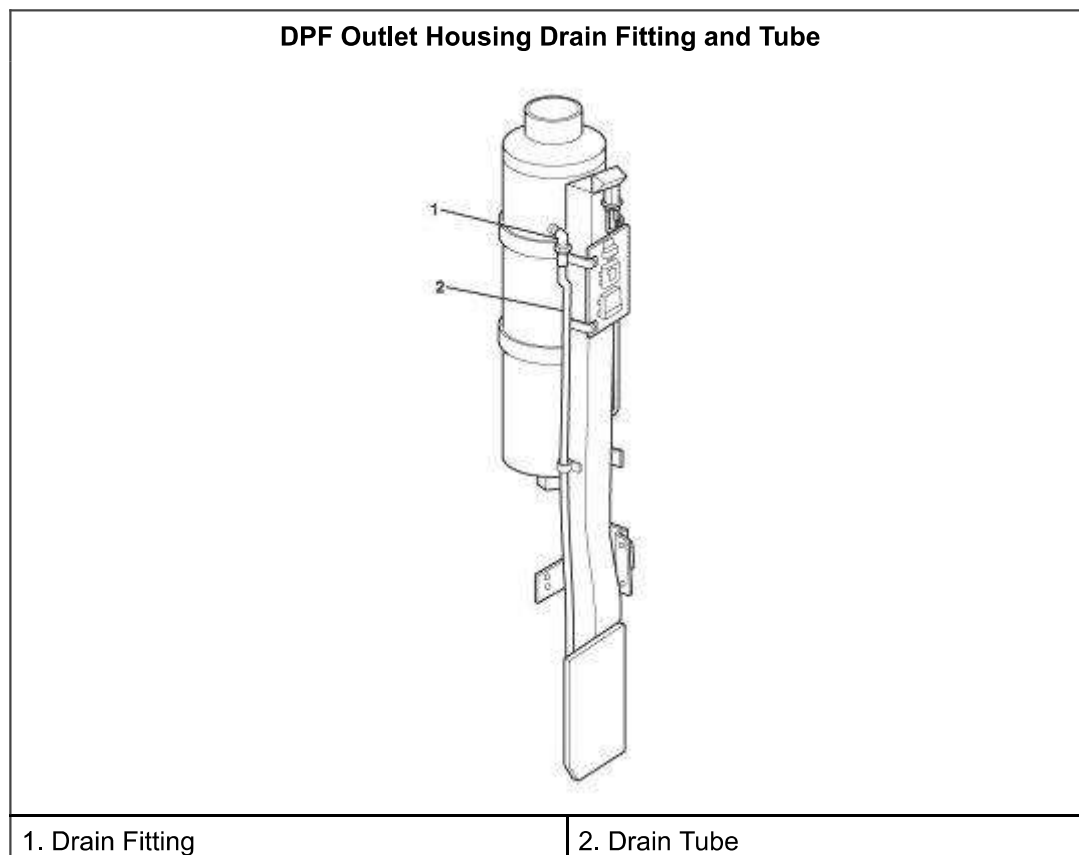
- **Plugged drain fitting/drain tube** — A plugged drain fitting or drain tube will not allow rain water to drain from the DPF outlet housing. If water infiltration into the thermal regenerator is evident, check the drain fitting and drain tube to ensure they are not plugged.

*Note: When checking for a plugged drain port (with the 90-degree drain fitting removed), note that the corner of the baffle flange will be visible in the drain port opening. Do not mistake this as being a blocked drain port.*

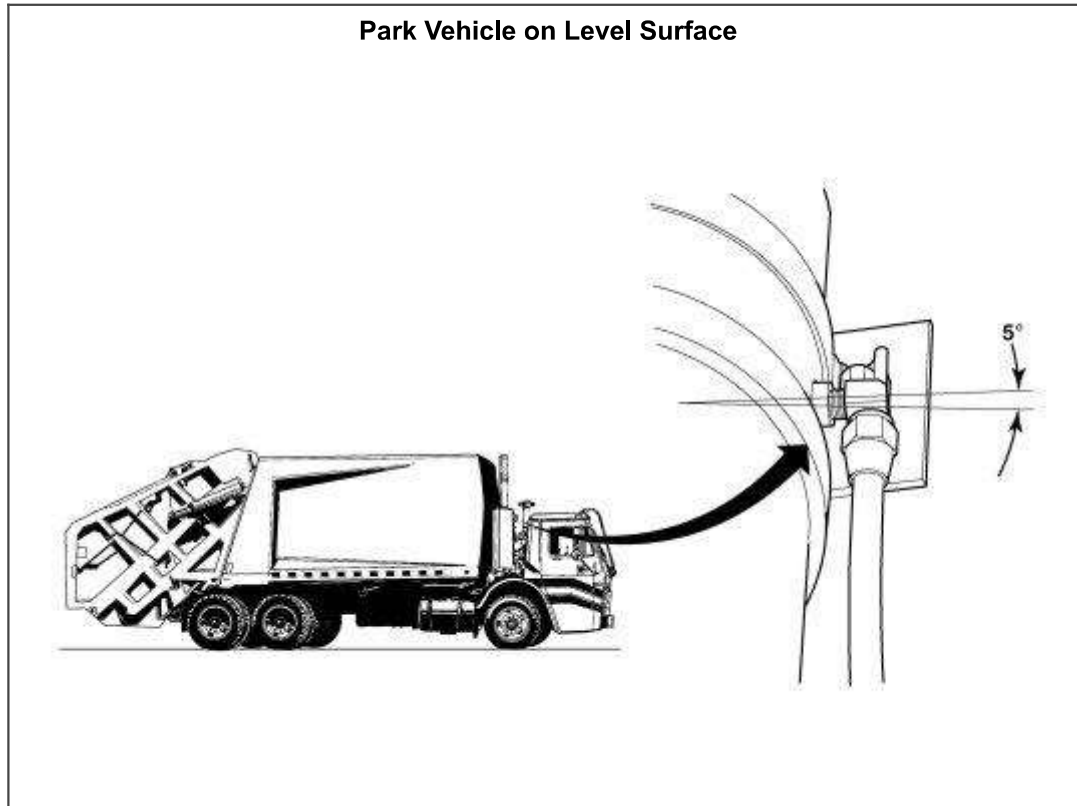
- Vehicle parked on an incline — The drain fitting is located on the front-side of the DPF outlet housing, facing the front of the vehicle. Water will not adequately drain from the outlet housing if the drain fitting is at an angle greater than 5-degrees above the level horizontal plane. If the vehicle is parked with the front end higher than the rear (either by being parked on a slope, hooked to a tow truck or decked for shipment) during periods of heavy rain, rain water will not drain from the outlet housing. To avoid water infiltration, the vehicle should be parked (or stored) as close to level as possible, or the exhaust stack should be covered to prevent rain water from entering the outlet housing.

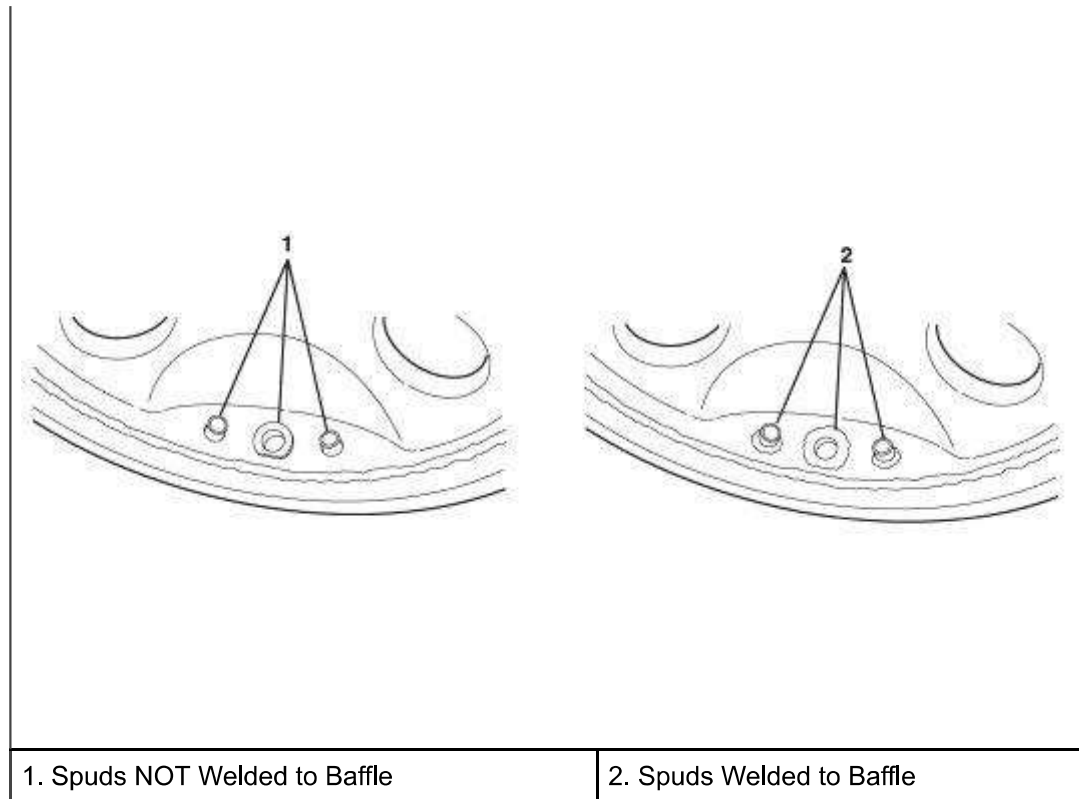
**Inspect Spud Welds**

- Leaking Sensor Spuds — The spuds for the NOx sensor, delta pressure tube and the filter outlet temperature sensor are not welded to the baffle on the inside of the housing. Consequently, the possibility exists for rain water to leak past the spuds, into the filter unit and eventually collect in the thermal regenerator. Effective with chassis manufactured January 12, 2008 and later (DPF unit part number 21031269 beginning with serial No. 02068809), the spuds for the NOx sensor, delta pressure tube and filter outlet temperature sensor are welded inside the housing to seal the spud to the baffle.

1. Remove the outlet housing from the DPF unit.
2. Inspect the welds around the spuds on the inside of the housing. There should be a solid bead of weld around the circumference of each of the spuds, and there should not be any gaps in the welds.

If water is leaking past the spuds, replace the outlet housing with outlet module kit part number 21277855. This kit contains outlet housing part number 21246965, a gasket and a V-band clamp. The outlet housing part number can be verified by checking the part number plate located on the side of the housing.

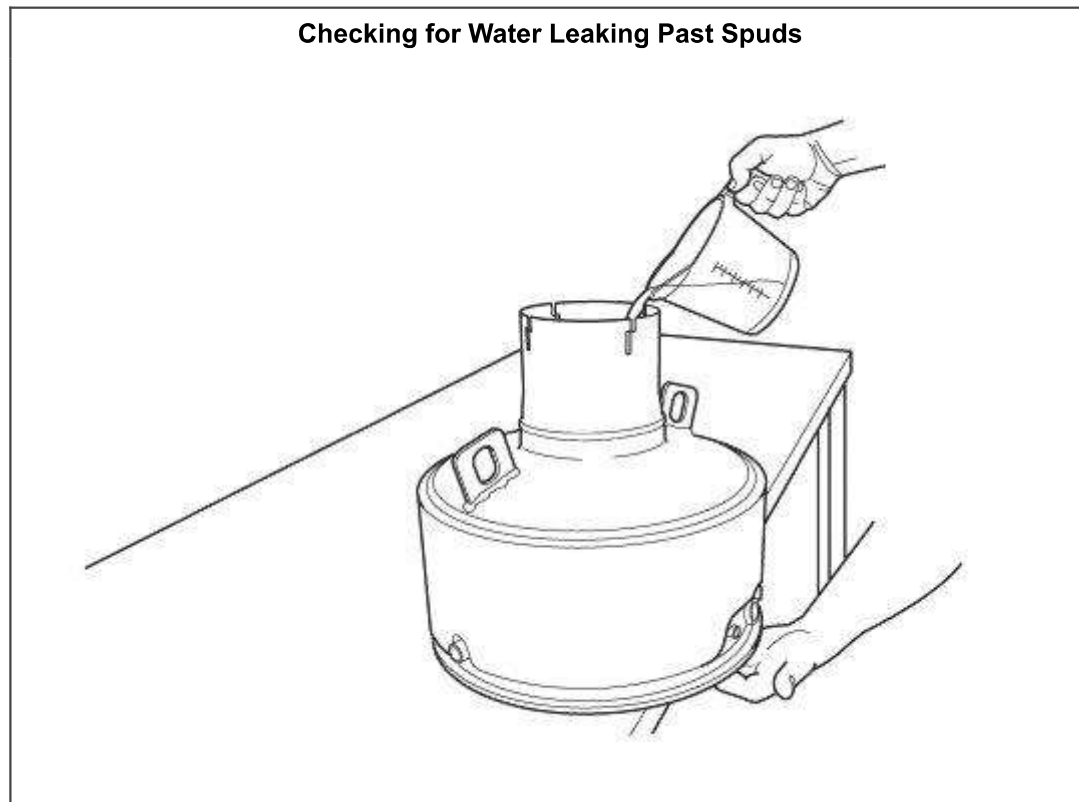
**Checking for Water Leaking Past Spuds**

- Slowly pour a small container of water into the exhaust stack, and then check for water leaking past the studs on the inside of the housing. This can be accomplished by holding your hand under the area of the spuds and feeling for dripping water, or by looking up into the housing to see if water is leaking around the spuds.

Torque specification for the V-band clamp is 17 N•m (150 lb-in).
