Service Update

N212356230 Front Camera Module Inoperative

Release Date: October 2022

Condition	Certain 2021-2022 model year Chevrolet Silverado LTD, GMC Sierra Limited, and 2022 model year Chevrolet Equinox, Silverado 2500/3500 HD, and GMC Sierra 2500/3500 HD vehicles may have a condition where the Front Camera Module (FCM) becomes unresponsive and generates a Diagnostic Trouble Code (DTC).
Correction	Dealers are to re-program the FCM with the latest software available.

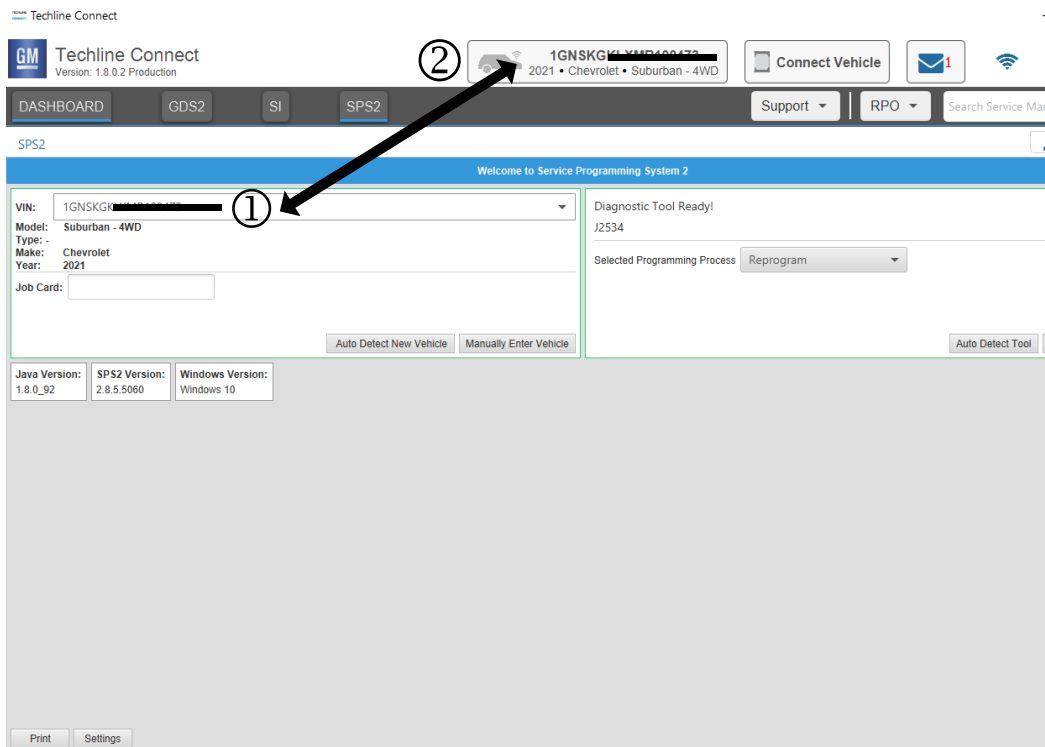
5743643

Caution: Be sure the VIN selected in the drop down menu (1) is the same as the vehicle connected (2) before beginning programming.
