Service Bulletin

Subject: Diagnostic Tip for Coolant Leak, Coolant Consumption and/or Low Coolant Message Being Displayed On the Driver Information Center (DIC)

Brand:	Model:	Model Year:		VIN:		Engina	Transmission:
		from	to	from	to	Engine:	
Chevrolet	Silverado	2017	2018				
	Silverado 2500/3500	2019	2023				
	Silverado 4500HD, 5500HD and 6500HD	2019	2023			Equipped with 6.6L Diesel Engine (RPO L5P, L5D)	
GMC	Sierra	2017	2018				
	Sierra 2500/3500	2019	2023

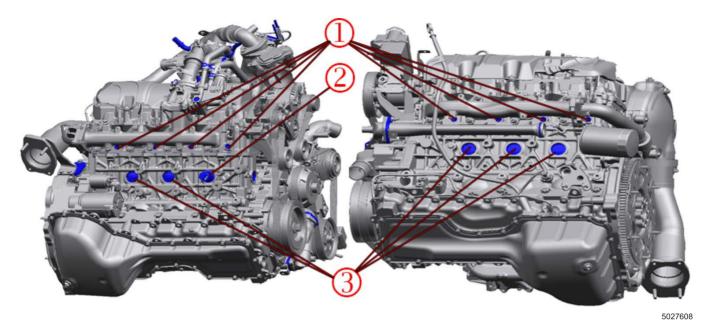
5027641

- 1. Plugs in Cylinder Head (PLUG, CYL HD CORE HOLE) (Qty 8)
- 2. Block Heater (HEATER, ENG COOL)
- 3. Cup Plugs in Block (PLUG, ENG BLK COOL DRN HOLE (OD=40MM) (Qty 5)

- 1. Coolant Hose and Clamp
- 2. Thermostat Housing (SEAL, ENG COOL THERM (O RING)
- 3. O-Ring for Bypass Pipe (SEAL, THERM BYPASS PIPE (O RING))
- 4. Flange with Gasket for Bypass Pipe (GASKET, THERM BYPASS PIPE)
- 5. O-Ring Seal (Front Cover to Water Pump) (SEAL, W/PMP CVR)

- 6. Seal-Water Pump to Pipe (GASKET, W/PMP OTLT PIPE)
- 7. Coolant Hose and Clamp
- 8. Cup Plug on Block (PLUG, ENG BLK COOL DRN HOLE)

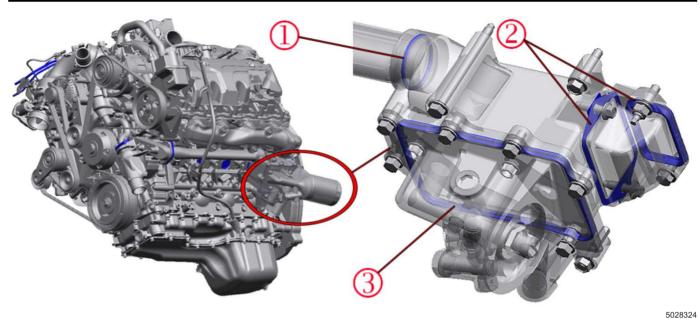
5028324

- 1. O-Ring (Water Pipe to Oil Cooler) (SEAL, W/PMP OTLT PORT)
- 2. Either end of the Oil Cooler Adapter (Elbow) (GASKET, ENG OIL CLR ADAP)
- 3. Seal in the Oil Coolet (GASKET, ENG OIL CLR)

Note: Ghost view of the Oil Cooler to reveal O-ring and cover gasket and 2 adapter gaskets (Oil Filter not shown).

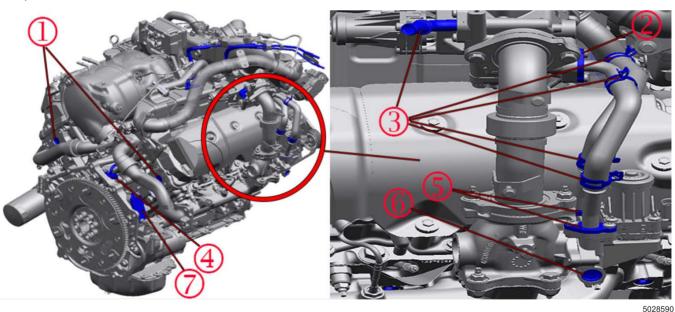
- 1. Cup Plugs (Qty 2)(One per side in rear of Cylinder Head) (PLUG, CYL HD CORE HOLE)
- 2. Gaskets under Flange, 1 location on EGR Bypass Valve (Serviced with VALVE, EGR VLV CLR BYPASS)
- 3. Hose Clamps, 5 locations

- 4. Turbo Coolant Feed Pipe (GASKET, TURBO COOL FEED & RTN PIPE)
- 5. Gaskets under Flange, 2 locations on EGR Valve (Service with VALVE, EGR)
- 6. Cup Plug in Bypass Valve (Service with VALVE, EGR)
- 7. Cover on Flywheel Housing (GASKET, FLYWHL HSG CVR)

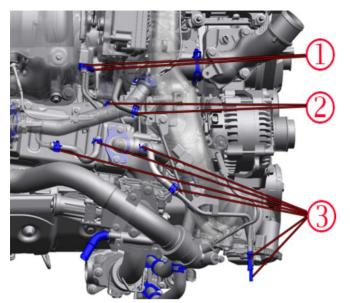
5028593

- 1. Gasket for Turbo coolant pipes (GASKET, TURBO COOL FEED & RTN PIPE) (Qty 2)
- 2. Ghost view of Upper Intake Manifold and ERG Coolant Pipe. Inlet Adapter removed to reveal EGR Coolant Return Pipe.
- 3. Hose Clamps for Turbo Coolant Pipes and DEF Coolant Pipe (Qty6)

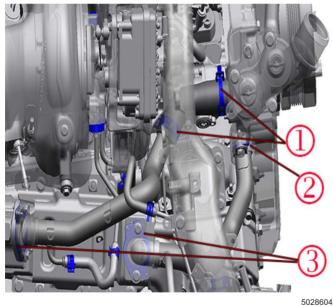
Note: A leak on the top of the engine will trail down the back of the engine and appear as a rear cover leak.

- 1. Hose Clamps on the EGR Coolant Return Hose (Qty 2)
- 2. O-Ring for EGR Coolant Return Pipe (SEAL, EGR COOL FEED PIPE) (Qty 2)
- Gaskets under Flanges for EGR Coolant Feed and Return Pipes (SEAL, EGR COOL FEED PIPE) (Qty 2)

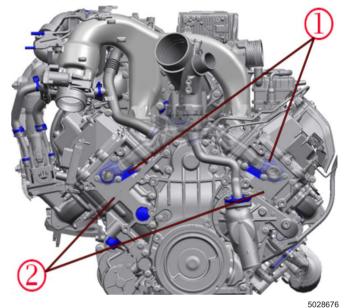
- Gaskets between Cylinder, Heads and Water Crossover Housing (GASKET, ENG COOL THERM HSG) (Qty 2)
- 2. Head Gaskets (GASKET, CYL HD)
