Service Bulletin

Bulletin No.: 19-NA-187

Subject: Diagnostic Tip to Identify Engine Misfiring and/or Malfunction Indicator Lamp (MIL) Illuminated - DTC P0300 Setting

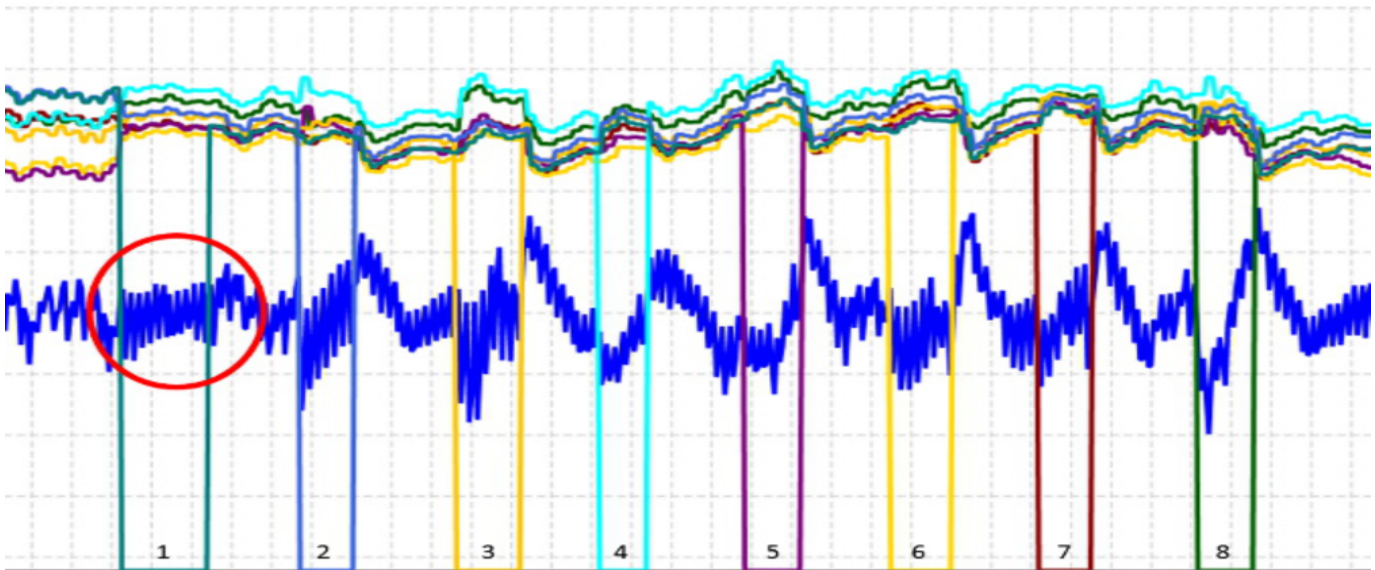
5394706

The most important thing is that the RPM line is visible and not covered by the injector command lines. All three graphs below, each injector was canceled in order, 1 – 8.

Note that cylinder #1 does not drop the RPM when canceled, when compared to the other cylinders.

- ⇒ RPM recovery is limited after the cancellation has ended.
- ⇒ Other cylinders do not have as much of a RPM drop when they are canceled, however the RPM does jump after the cancellation has ended.

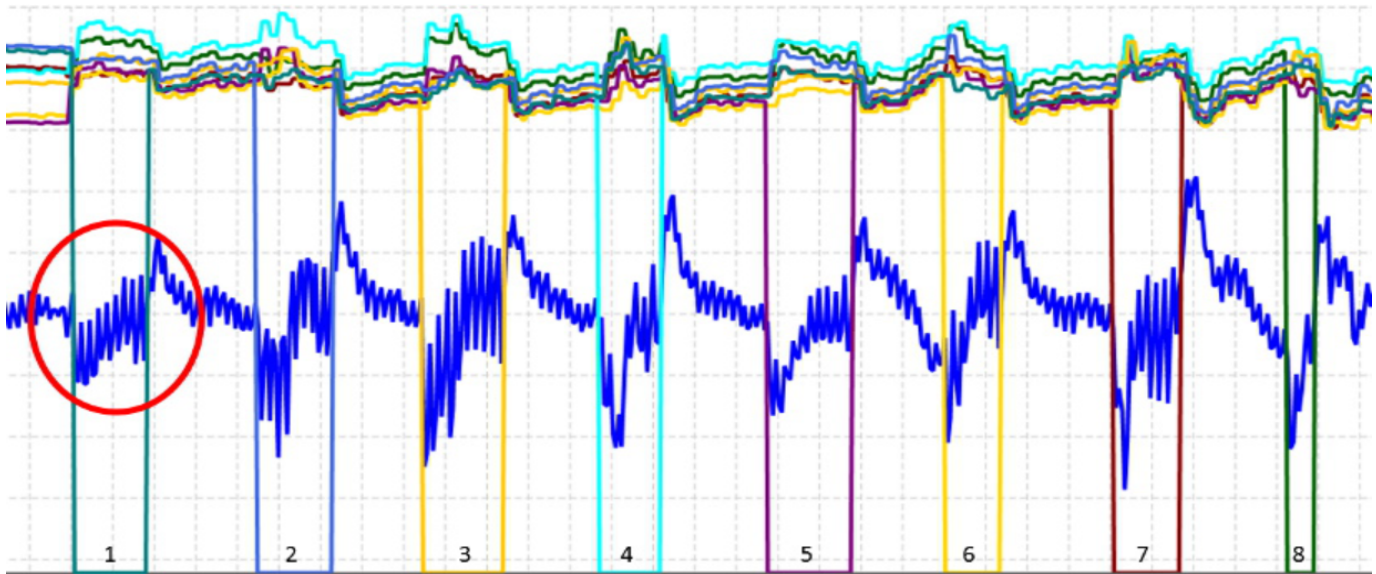
5394746

During this second balance test, it appears like cylinder #1 is contributing, however it is less than any of the other cylinders.

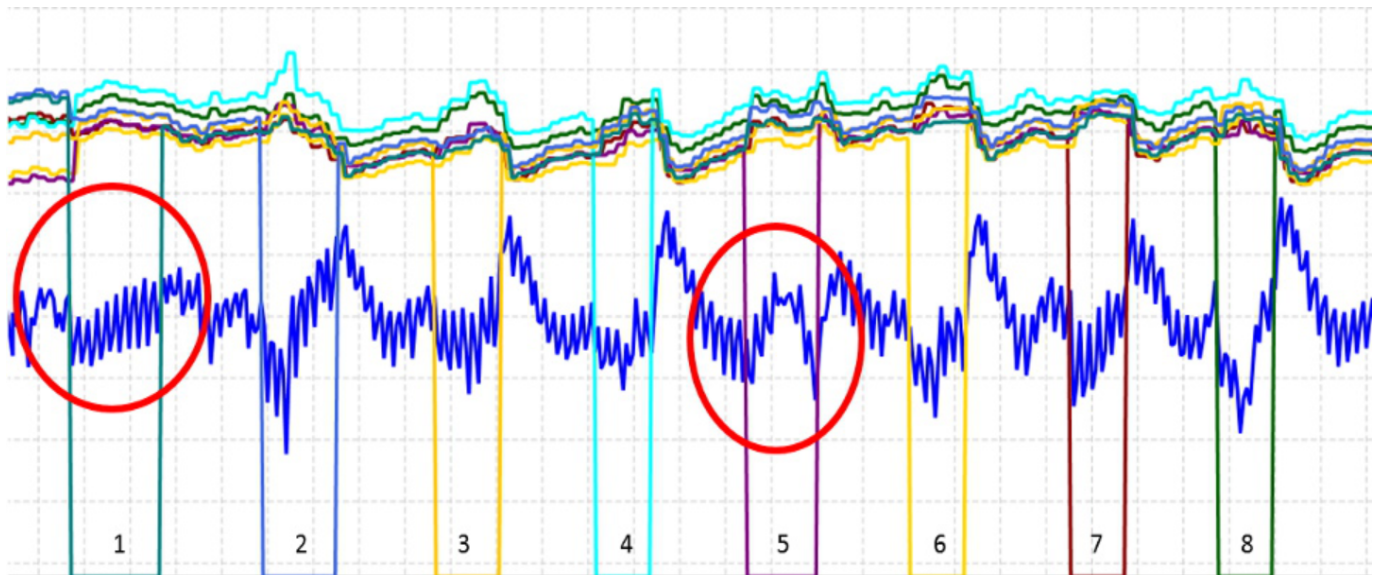
5394869

During this final test, it appears that cylinder #5 is not contributing as well as #1. This is one of the main reasons that we must repeat the test to find consistency.

⇒ This vehicle was repaired by replacing #1 fuel injector.
