Service Bulletin

Bulletin No.: 22-NA-170

Subject: Information on Possible Crank No Start or Extended Crank with DTC P12A6 or Service Safety Restraints message on DIC, with B0073

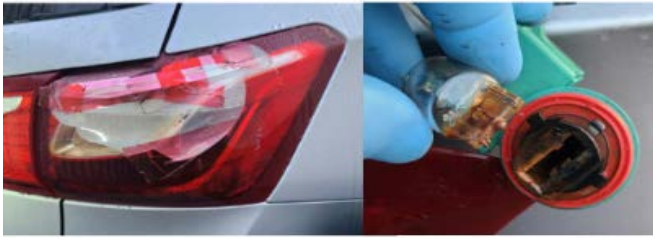
6144660

1. Inspect the right tail lamp for signs of damage or standing water. If there is damage or standing water, inspect the tail lamp bulb connectors for signs of corrosion or water. Replace the tail lamp and bulb connector, if corroded, to prevent a repeat concern.

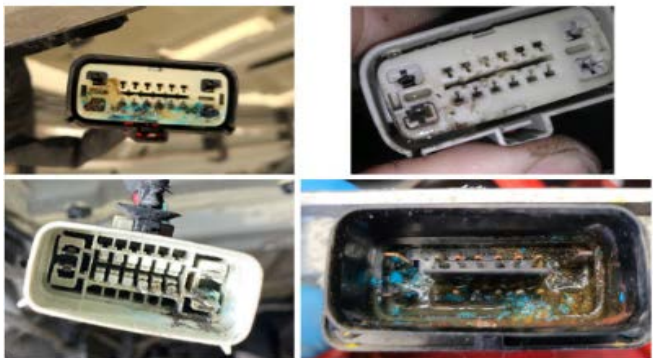
6144661

2. If the tail lamp and connector are damaged, continue with next step. **If the tail lamp and connector are ok, continue with diagnosis following SI for the appropriate DTC.**
3. For DTC P12A6, inspect connector X350 for signs of water intrusion or corrosion. X350 is the Fuel Tank Harness to Body Harness connector, under the vehicle.

Note: Examples above of corrosion which can cause a poor connection resulting in no-start. The water intrusion can also short terminals together, which can keep the fuel pump running after key-off, draining the battery.

If water intrusion or corrosion is found, make repairs by replacing the connector with terminated leads on the body harness side, or by replacing the fuel pump control module harness, or both repairs if both sides show water intrusion, corrosion and/or damage.
