JLRTB02109NAS1

**TECHNICAL BULLETIN**

Air Conditioning (A/C) Inoperative

MODEL:	MODEL YEAR:	VIN:	ASSEMBLY PLANT:
I-PACE (X590)	2019 Onwards	Z00002 Onwards	Graz (Austria)

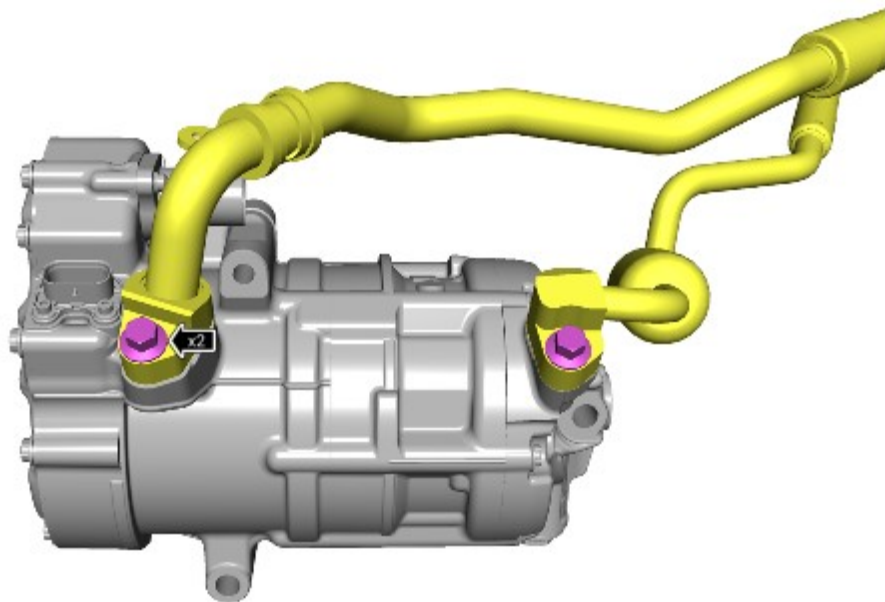
The Air Conditioning (A/C) does not blow cold and is found to be inoperative. Further investigation has found a leak on the A/C compressor inlet and/or outlet pipes. **New level service parts are available and even if only 1 pipe is found to be leaking, both pipes must be renewed.**

Low weld quality.

Disconnect both A/C pipes from the A/C compressor.

- Remove the 2 bolts.
- Torque: **24 Nm**
