TECHNICAL SERVICE BULLETIN

Classification: EM22-002A	Reference: ITB22-025A	Date: September 15, 2022
------------------------------	--------------------------	-----------------------------

ROARING NOISE FROM THE ENGINE COOLING FAN ASSEMBLY AND THE A/C IS NOT COOLING

APPLIED VEHICLES: 2019-2021 QX50 (J55)

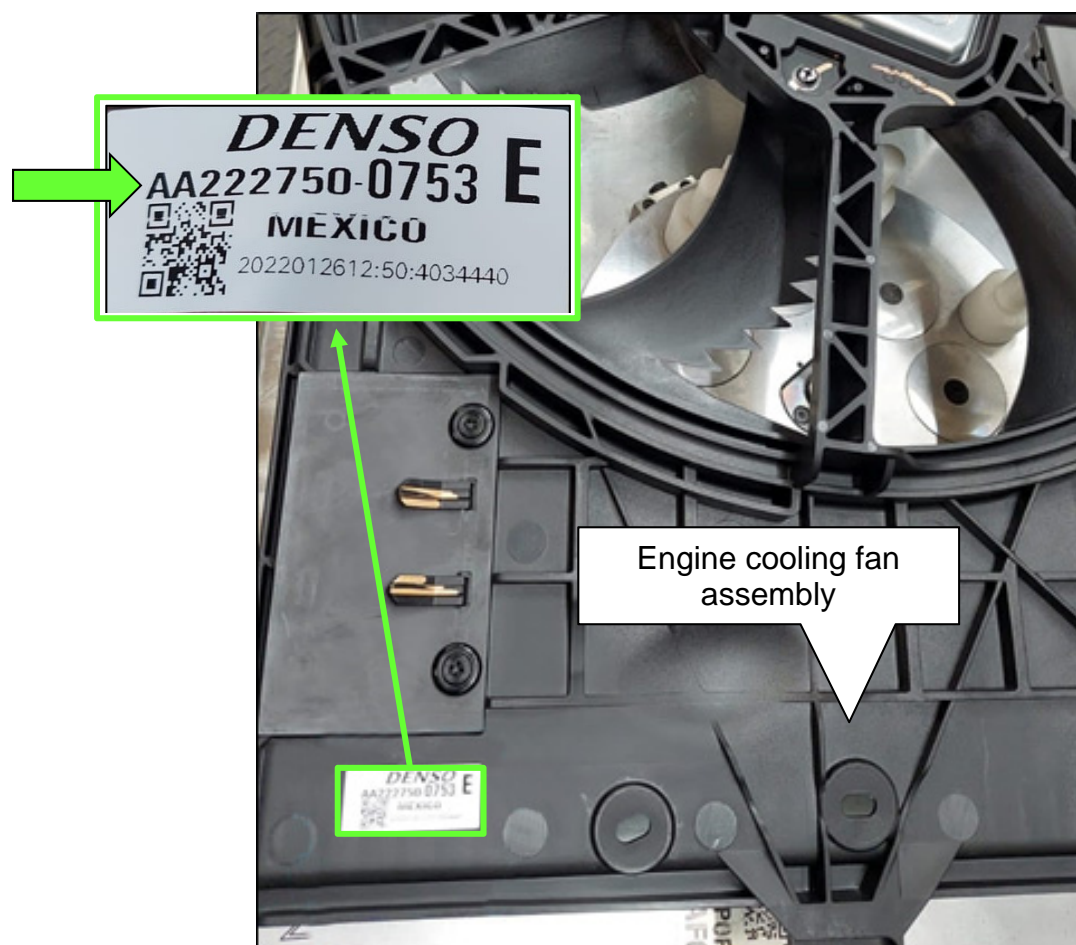
Figure 1

1. Inspect the Denso part number on the label of the engine cooling fan assembly that is currently in the vehicle (Figure 1).
 - If the current Denso part number is in **Table A**, this bulletin does not apply. Refer to the ESM for further diagnostic information.
 - If the current Denso part number is not in **Table A**, proceed to step 2.
2. After ordering the new engine cooling fan assembly, confirm that the Denso part number on the new part is in **Table A** before installing (Figure 1).
 - If the new Denso part number is in **Table A**, proceed to step 3 on page 3.
 - If the new Denso part number is not in **Table A**, reorder another new engine cooling fan assembly and confirm that the Denso part number is in **Table A** before proceeding to step 3 on page 3.

3. Replace the engine cooling fan assembly.
 - Refer to the ESM: **ENGINE > ENGINE COOLING SYSTEM > KR20DDET > REMOVAL AND INSTALLATION > COOLING FAN**
4. Replace the IPDM E/R with one listed in the **PARTS INFORMATION**.
 - Refer to the ESM: **ELECTRICAL & POWER CONTROL > POWER CONTROL SYSTEM > IPDM E/R > REMOVAL AND INSTALLATION > IPDM E/R (INTELLIGENT POWER DISTRIBUTION MODULE ENGINE ROOM)**
