TECHNICAL SERVICE BULLETIN

NTB19-105C

CLICKING/POPPING NOISE FROM FRONT AXLE AREA DURING TAKE-OFF/ACCELERATION AND/OR DECELERATION

APPLIED VEHICLES: 2018-2023 LEAF (ZE1)

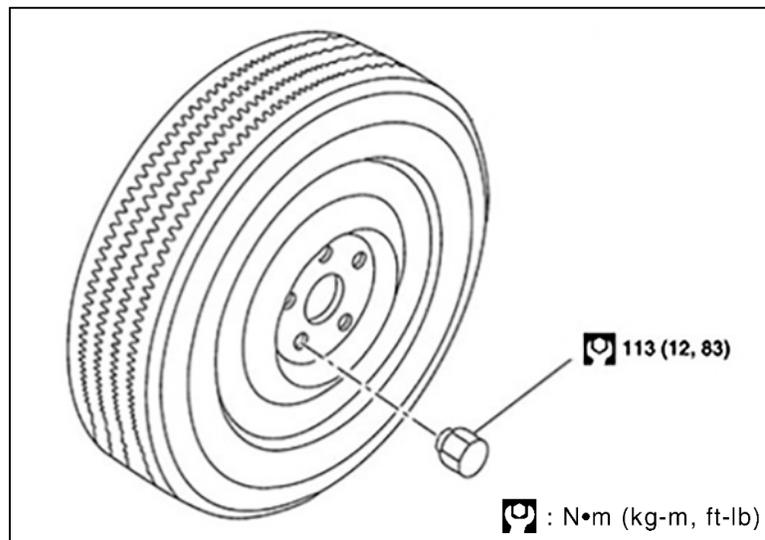
Figure 1

A clicking or popping noise is coming from the front axle area during take-off/acceleration and/or deceleration.

Before performing diagnostic procedures, torque the lug nuts for all four (4) wheels to 113 N•m (12kg-m, **83 ft-lb**), in a diagonal pattern.

- If the clicking/popping noise is still present after torquing the lug nuts, refer to the ESM for further diagnostic information.
