# SERVICE BULLETIN

Classification: EL21-014C	Reference: NTB21-081C	Date: September 21, 2022
------------------------------	--------------------------	-----------------------------

## AUTOMATIC BACK DOOR INOPERATIVE

- APPLIED VEHICLES:** 2022-2023 Pathfinder (R53)  
2021-2023 Rogue (T33)
- APPLIED GRADES:** SV with Premium Package, SL, Platinum

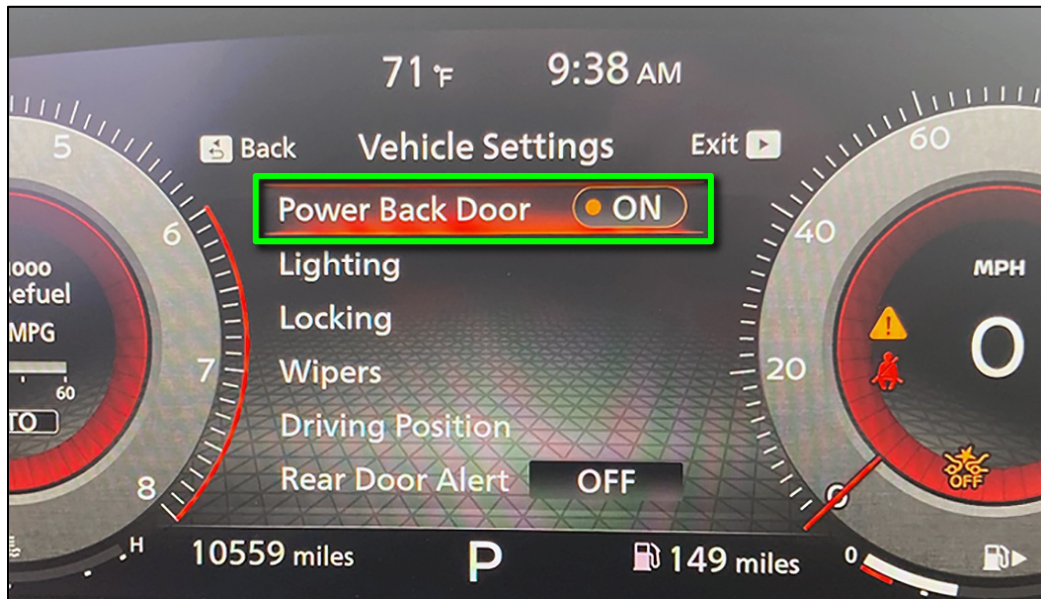
Figure 1

- Confirm **Power Back Door** is set to “ON” in the **Vehicle Settings** menu in the Vehicle Information Display (Figure 1).
  - To access/change the **Power Back Door** setting, use the scroll dial and ◀ ▶ buttons on the steering wheel to navigate to the **Vehicle Settings** menu.

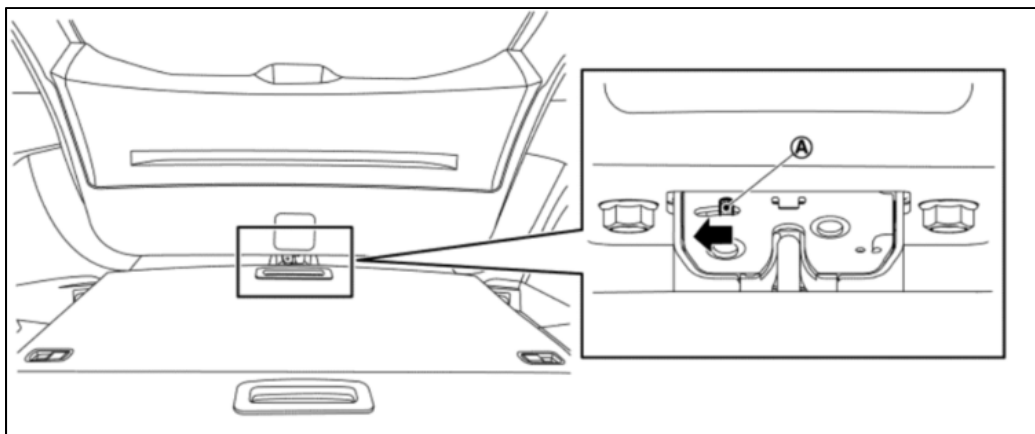
Figure 2

- If the back door lock will not release due to malfunction or battery discharge, the latch can be manually released from inside the vehicle using the opener lever.
  - The opener lever (A) is located on the metal portion of the latch (Figure 2). Push the opener lever toward the passenger (RH) side to release the latch.

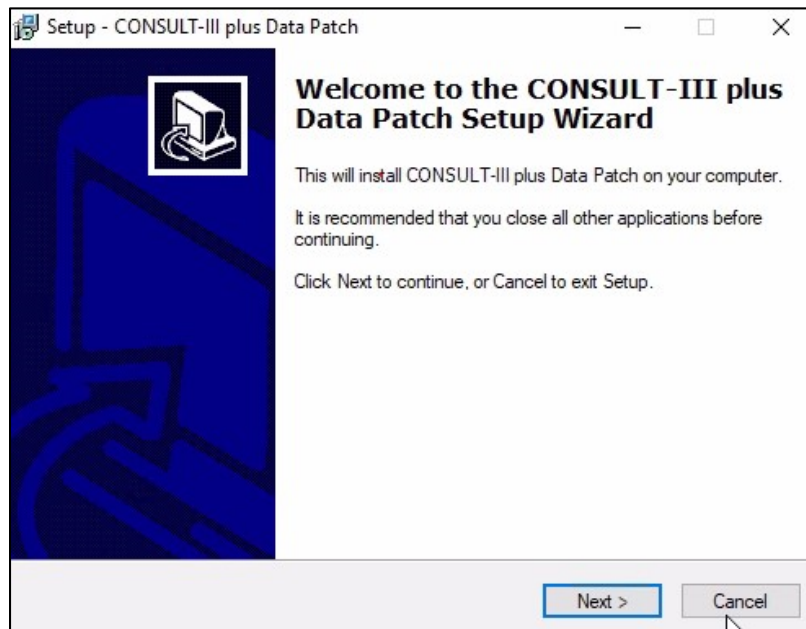
Figure 3

- Confirm CONSULT-III plus (C-III plus) is updated to the versions listed below.
  - 2022 **APPLIED VEHICLES:** C-III plus version 222.2 or later is required.
  - 2023 **APPLIED VEHICLES:**
    - Prior to October 4, 2022: C-III plus version 222.3 and installation of the data patch using the Setup Wizard pop-up (Figure 3) is required.
    - On or after October 4, 2022: C-III plus version 223.1 or later is required.

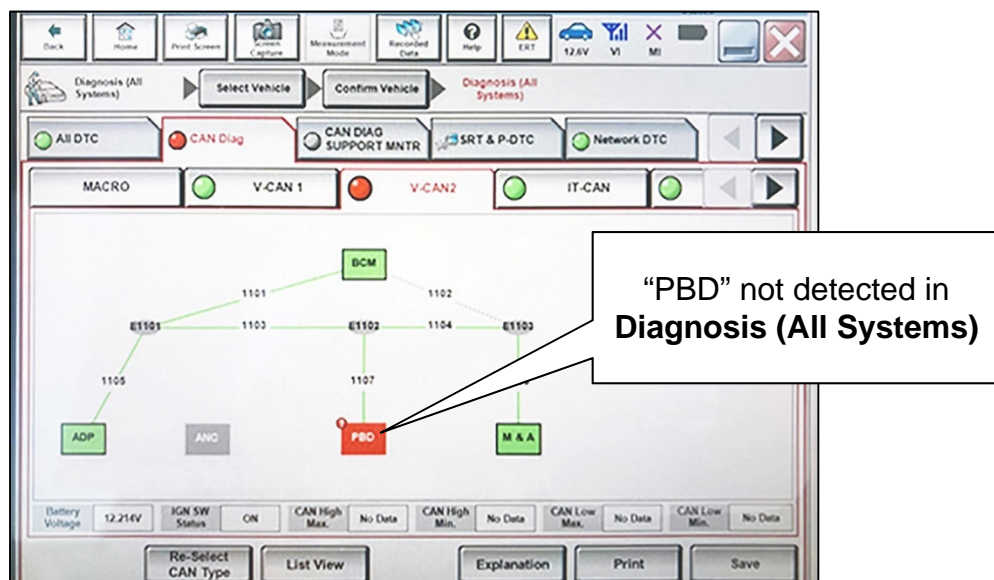
Figure 4

**NOTE:** If using an older version of C-III plus, the Power Back Door (**PBD**) system may be missing from **CAN Diag** (Figure 4), and AUTO BACK DOOR system DTCs may only be visible through **Diagnosis (One System)**.
