TECHNICAL SERVICE BULLETIN

Classification: AN22-004A	Reference: NTB22-029A	Date: September 30, 2022
------------------------------	--------------------------	-----------------------------

SOFTWARE UPDATE FOR INFOTAINMENT ISSUES

APPLIED VEHICLES: 2022 Frontier (D41) – S and SV only
2022 LEAF (ZE1) – S only

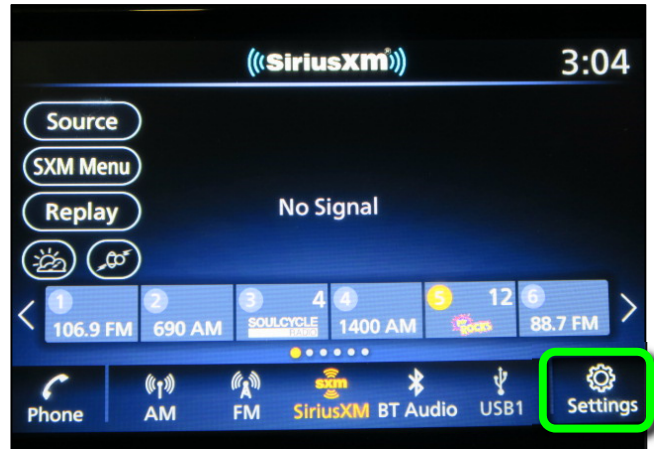
Figure 2

1. Select **Settings**, located in the lower right corner of the AV control unit display (Figure 2).

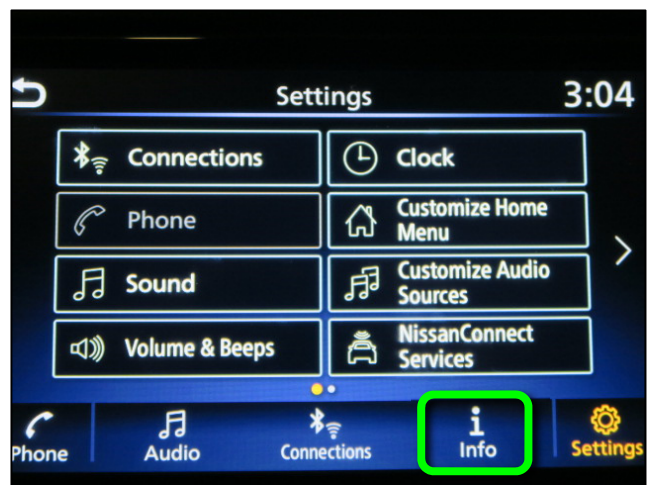
Figure 3

2. Select **Info**.

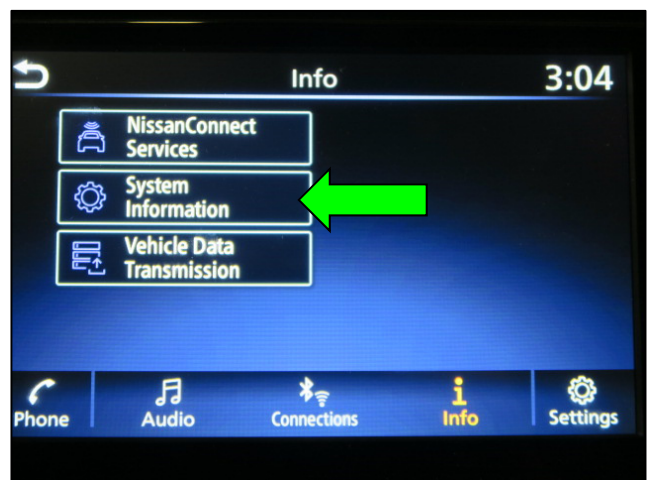
Figure 4

3. Select **System Information**.

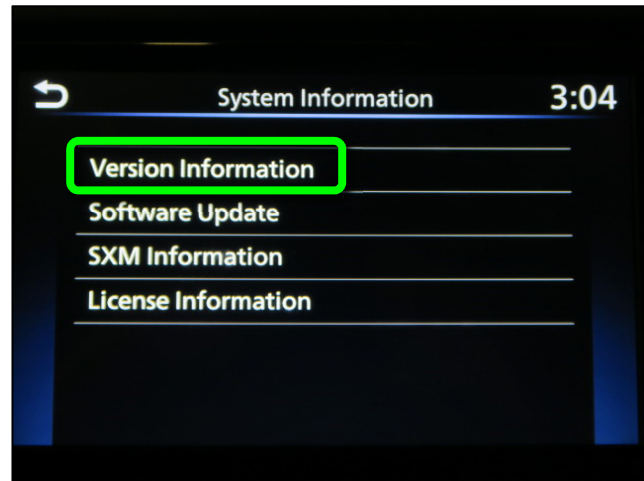
Figure 5

4. Select **Version Information**.

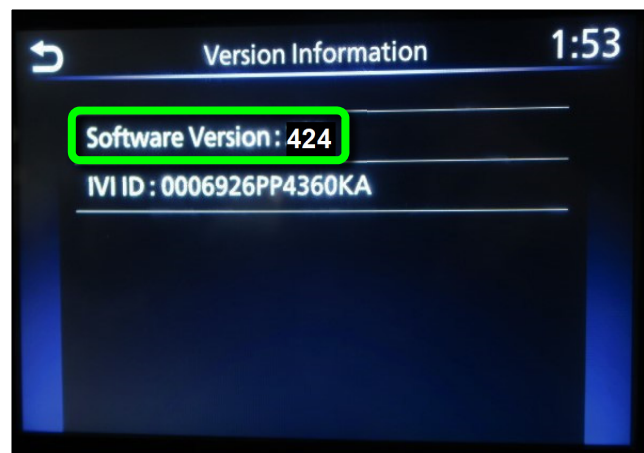
Figure 6

5. Verify the **Software Version** is numerically below "424".
 - If the **Software Version** is below "424", proceed to step 6 on page 5.
 - If the **Software Version** is not below "424", the **SERVICE PROCEDURE** is complete. Proceed to **CLAIMS INFORMATION** on the last page of this bulletin.

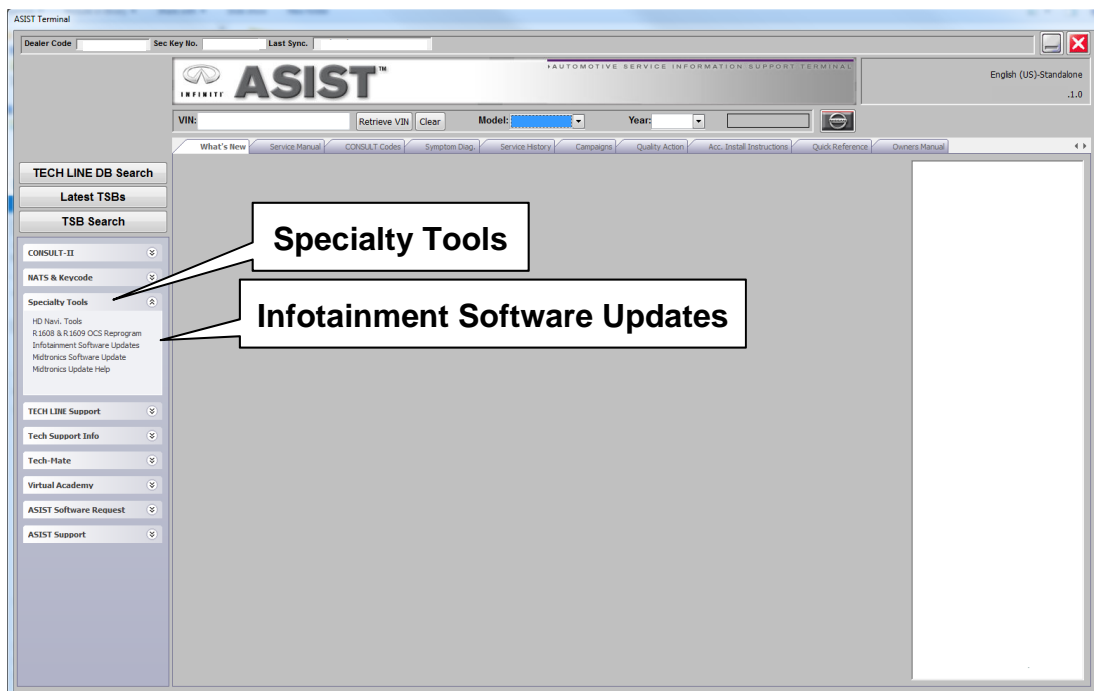
Figure 7

- The CONSULT PC is connected to the internet.
 - ASIST has been synchronized (updated) to the current date.
6. Insert the special tool USB drive into the CONSULT PC.
- If the update-software has already been downloaded onto the USB drive from a prior service procedure, skip to step 15 on page 8.
 - The special tool USB drive is the only USB drive approved for use with this procedure.
 - The update-software is estimated to take 10-15 minutes to download to the USB drive.
 - The update-software must be the only file on the USB drive.
 - The update-software only needs to be downloaded once and can then be used continuously on multiple **APPLIED VEHICLES**.
7. Open ASIST.
8. Select **Specialty Tools**, and then select **Infotainment Software Updates**.

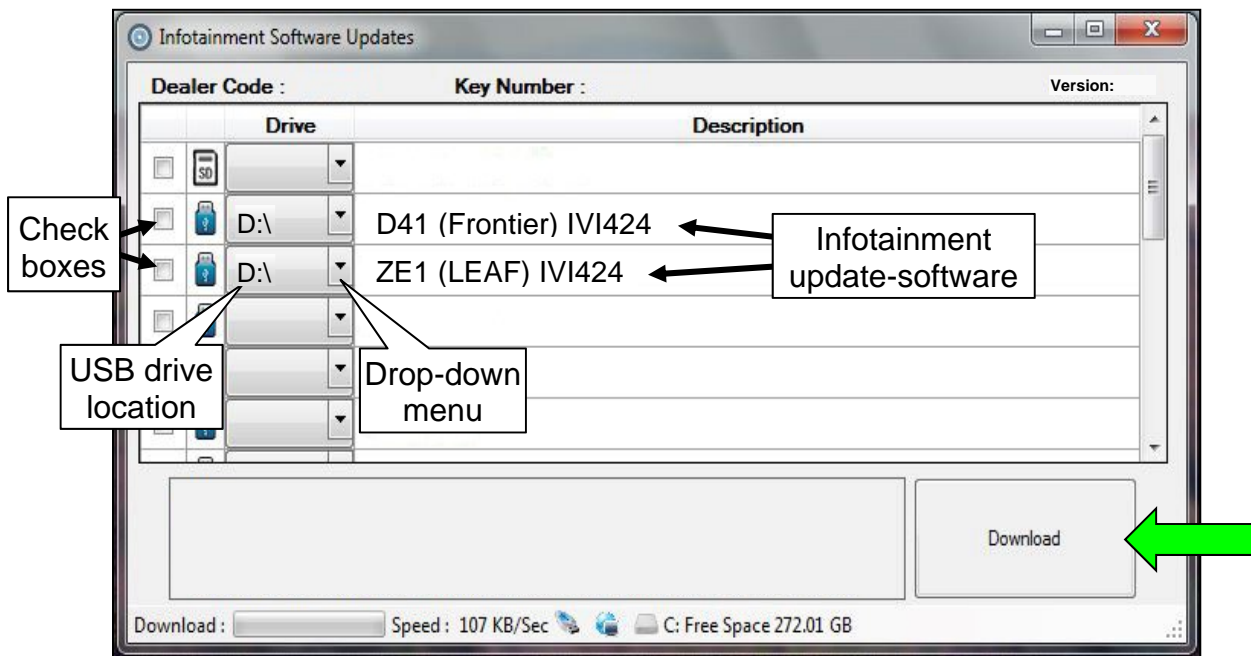
Figure 8

9. Select the check box next to one of the following model specific infotainment update-software descriptions:
 - D41 (Frontier) **IVI424**
 - ZE1 (LEAF) **IVI424**
10. Use the drop-down menu and select the location of the USB drive that was inserted in step 6.

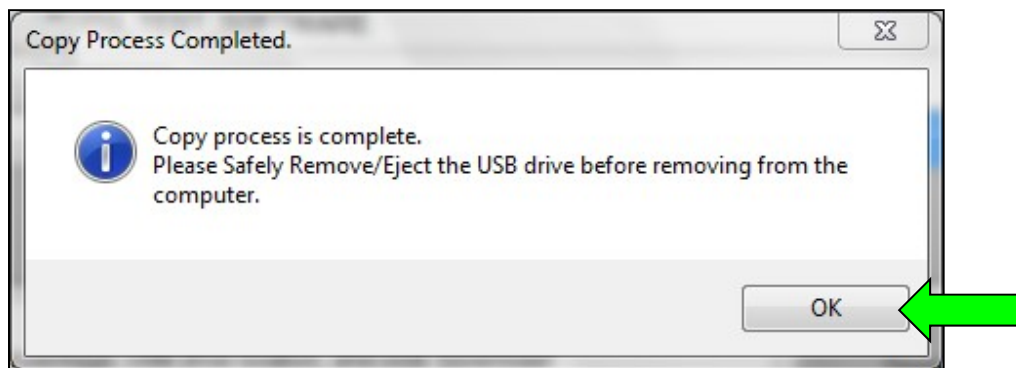
11. Select **Download**, and then wait for the download to complete.
HINT: The update-software is estimated to take 10-15 minutes to download to the USB drive.
12. Select **OK** when the message in Figure 9 is displayed.

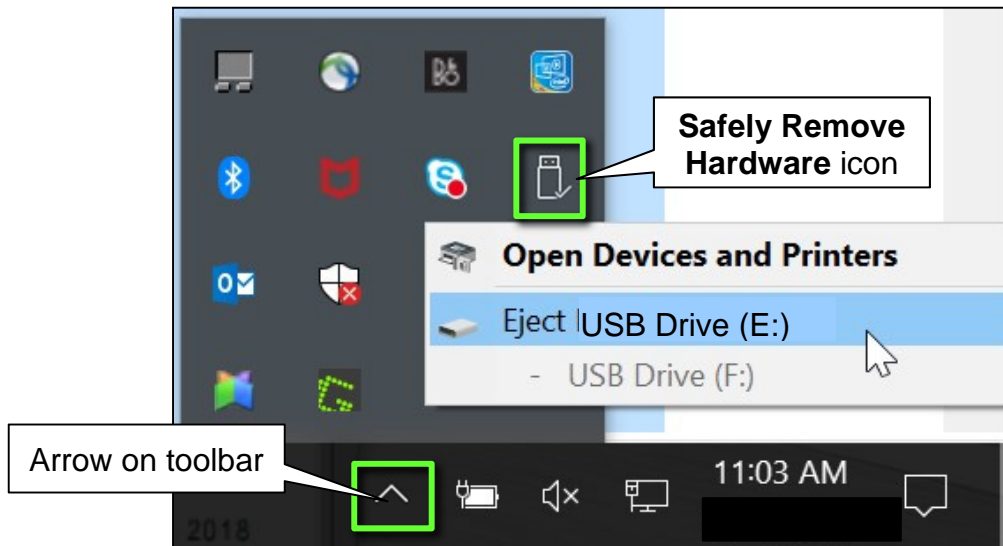
Figure 10

13. Once the transfer is complete, safely remove the USB drive from the CONSULT PC.
 - a. From the PC toolbar, select the **Safely Remove Hardware** icon.
 - o The icon is on the toolbar, or can be found after selecting the arrow.
 - b. Select the USB drive to be removed, and then remove the USB drive from the CONSULT PC.

Follow the steps to safely remove the USB drive. If not followed, the USB drive may corrupt the infotainment update-software.

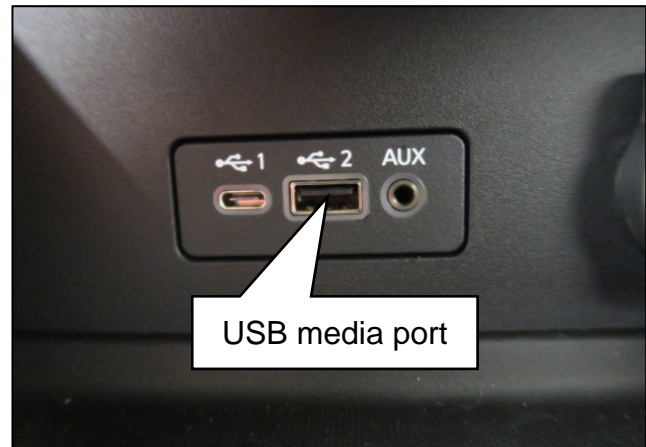
Figure 11

17. Insert the USB drive with the infotainment update-software into the vehicle's USB media port (Figure 11).
 - Do not remove the USB drive during the update to the vehicle until instructed to.

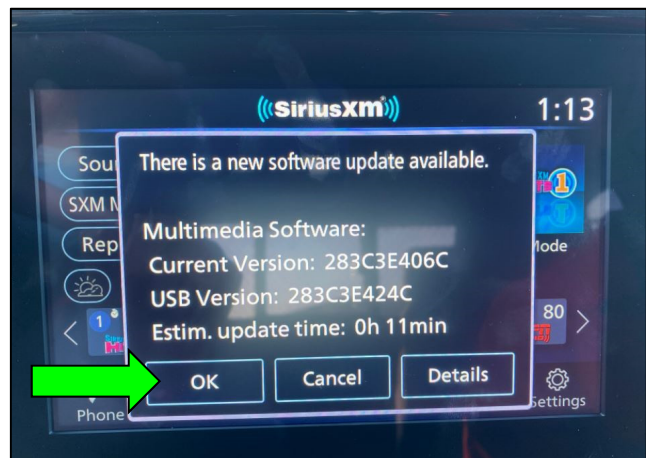
18. Wait approximately 10-30 seconds for the screen in Figure 12 to appear, and then select **OK**.

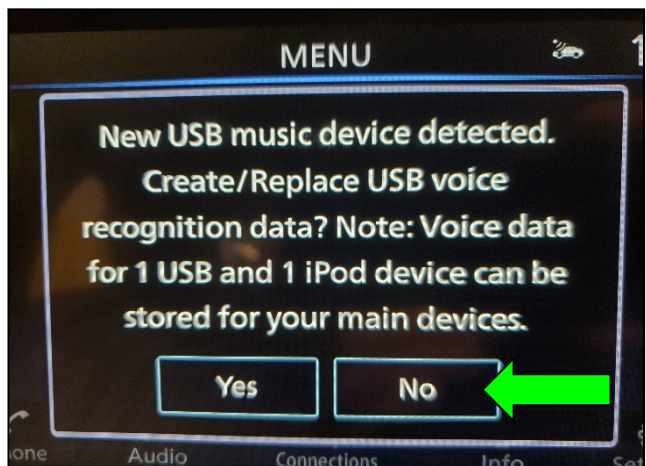
- If the screen in Figure 13 is shown, select **No**.

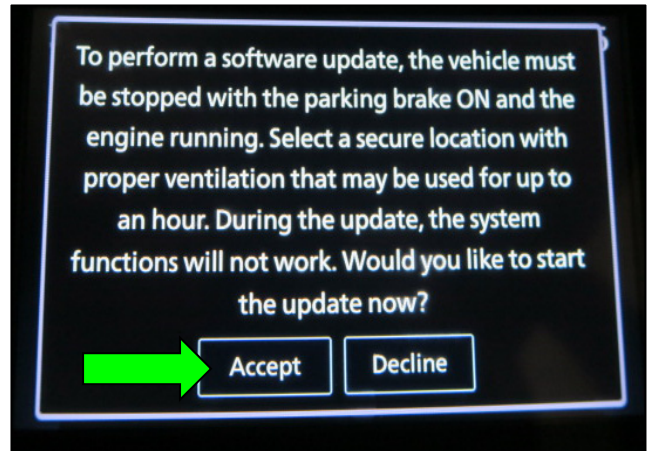
Figure 14

19. Review the software update requirements, shown in Figure 14, and then select **Accept** to start the reprogramming.

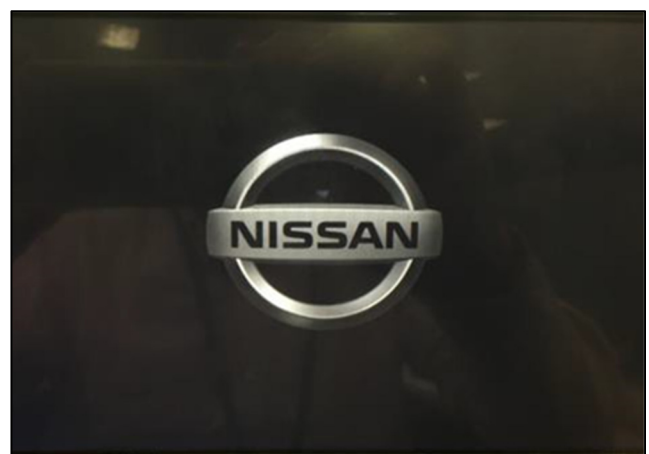
Figure 16

21. Turn the ignition OFF.
22. Open and close the driver door.
23. Restart the engine.
24. Allow the system to boot up completely (approximately 30 seconds).
 - The Nissan logo will be displayed during the reboot (Figure 16).

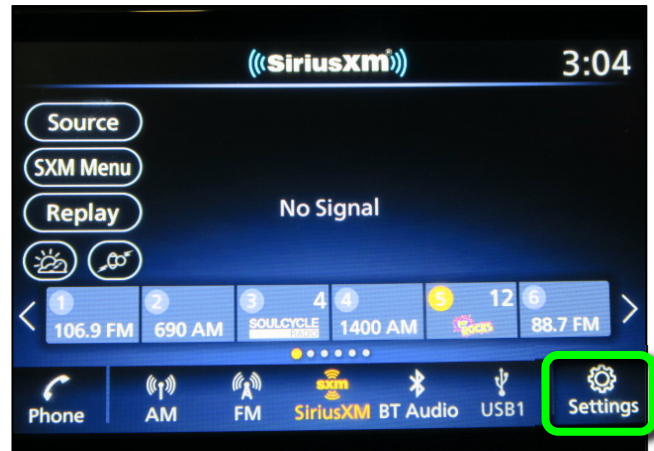
Figure 17

25. Select **Settings**, located in the lower right corner of the AV control unit display (Figure 17).

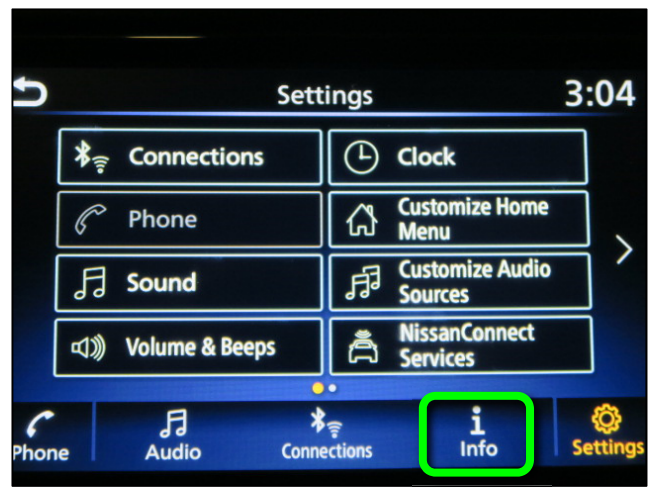
Figure 18

26. Select **Info**.

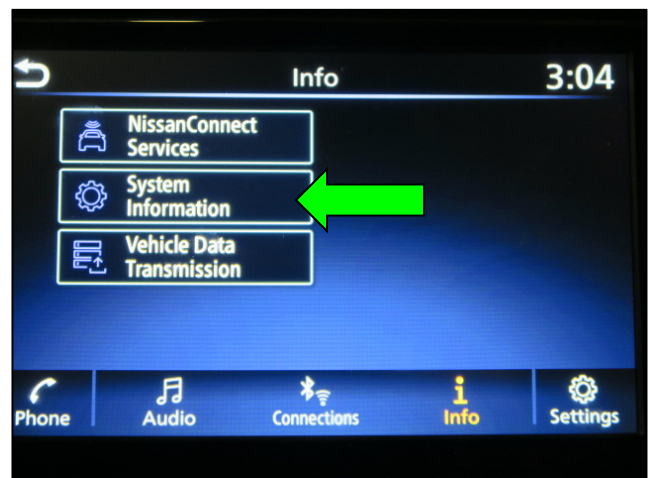
Figure 19

27. Select **System Information**.

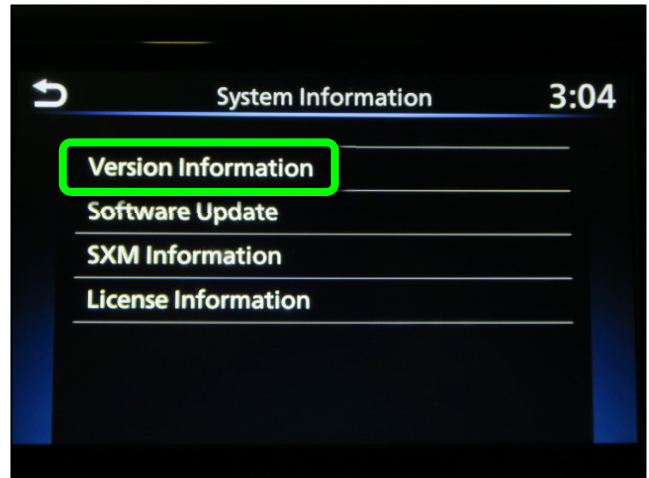
Figure 20

28. Select **Version Information**.

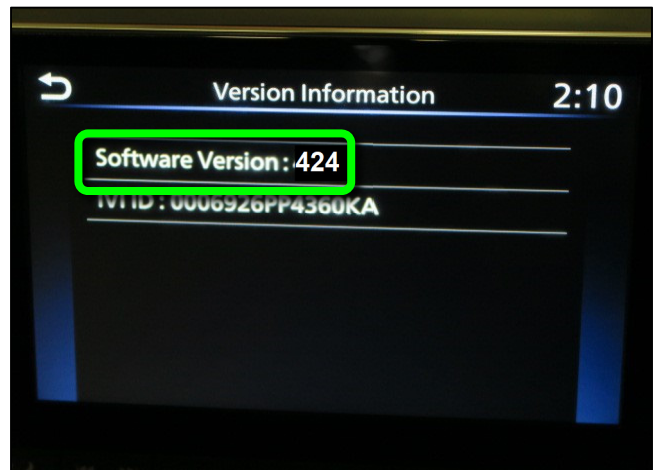
Figure 21

29. Verify the **Software Version** is now "424".

- If the **Software Version** is not "424", start this procedure over and verify that the correct software shown in step 9 on page 6 is downloaded.
- If the **Software Version** is "424", the reprogramming is complete.
