Service Action

Code: 97GE

Subject: Service Action 97GE – Air Conditioner Valve Block Wiring Harness

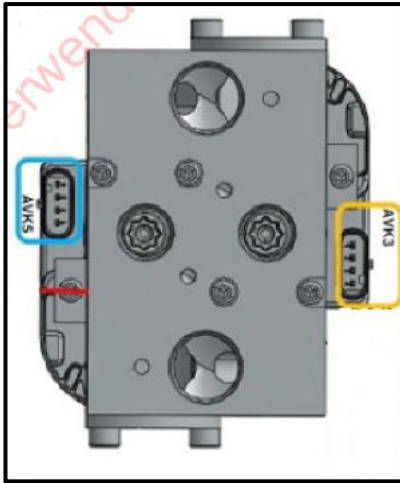
Repair Overview

- Check air conditioner valve block wiring and replace harness, if necessary.

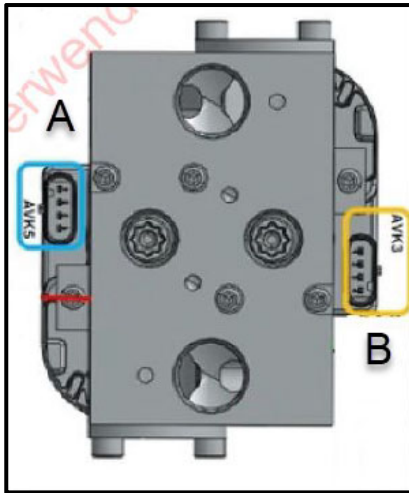
- Remove left front wheel.
- Remove left front wheel liner.
 - See ELSA Repair Manual:
- The wires on the N643 connector (A) and the wires on the N641 connector (B) must be checked.

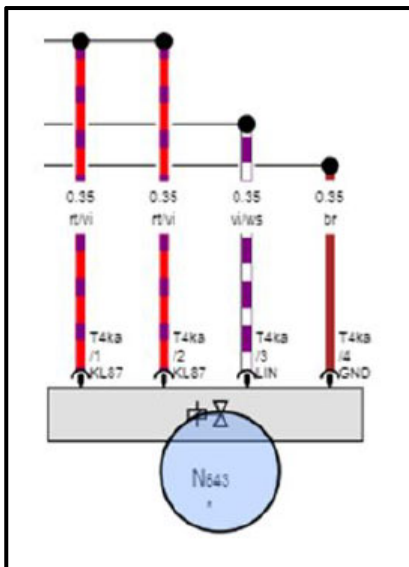
Checking N643 connector wiring:

- Check wire colors of N643 connector (refer to illustration).
- If all four wires of N643 connector are yellow, continue with – Replacing wiring harness –.
- If the wire colors match the illustration, N641 connector must be checked.

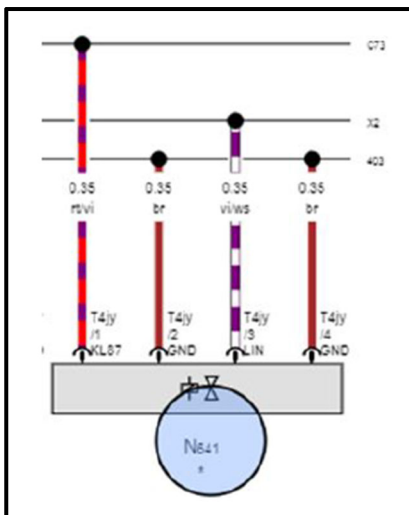
Checking N641 connector wiring:

- Check wire colors of N641 connector (refer to illustration).
- If the wire colors match the illustration:
 - No further work is required.
 - Proceed to Section C.
- If the wire colors do not match the illustration, continue with – Replacing wiring harness –.
