91-22-04 - No Audio from Infotainment System

Release date: 10/3/2022

Applicable Vehicles					
Model(s)	Year	Eng. Code	Trans. Code	VIN Range From	VIN Range To
Golf R, GTI	2022	All	All	All	All

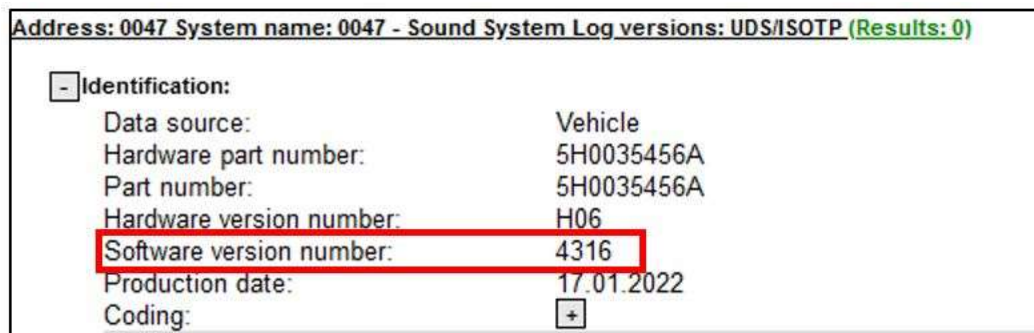
Figure 1.

1. Connect a MTRMSP0702 battery maintainer/charger to the vehicle's 12 volt battery.
2. Switch the ignition to the ON position.
3. Switch ON the Infotainment System.
4. Connect the ODIS tester and initiate Guided Fault Finding (GFF). Allow GFF to perform module interrogation of the vehicle.
5. Once module interrogation is complete, locate Address 47 – Sound System.
6. Check the software version of the Sound System Control Module - **J525**- (figure 1).

If the current Sound System Control Module software is lower than **4319**, proceed with this Technical Bulletin.

If the current Sound System Control Module software is greater than or equal to **4319**, this work procedure does not apply.

This procedure resolves the concern stated above by updating the Digital Sound System Control Module **-J525-** (amplifier) software to the latest level **4319**.
