Service Bulletin

Bulletin No.: 13-08-116-001H

Subject: Aftermarket ALDL or DLC Interface Devices Causing Multiple Issues

Models: 2023 and Prior GM Passenger Cars and Trucks

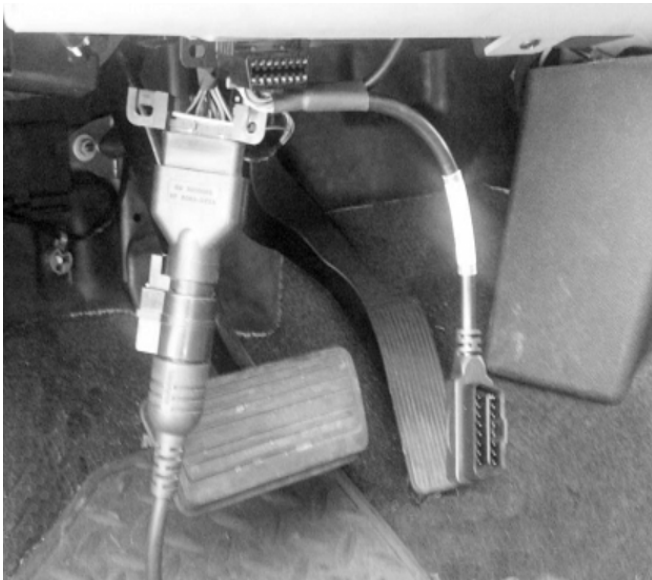
3346643

Device W/Secondary DLC Connector

This device has another DLC connector on it. The rest of the harness along with the device can be placed out of sight hidden from the technician, who may not notice the diagnostic connector is not in the factory location.

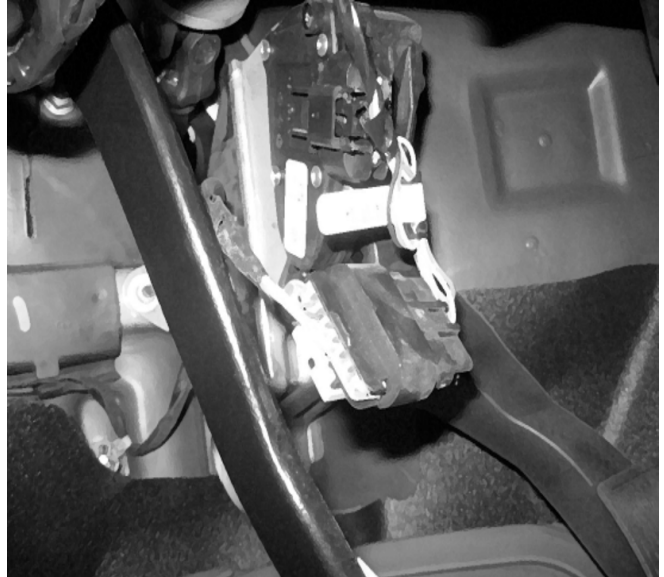
3346646

Pedal Mounted Aftermarket Device Interface

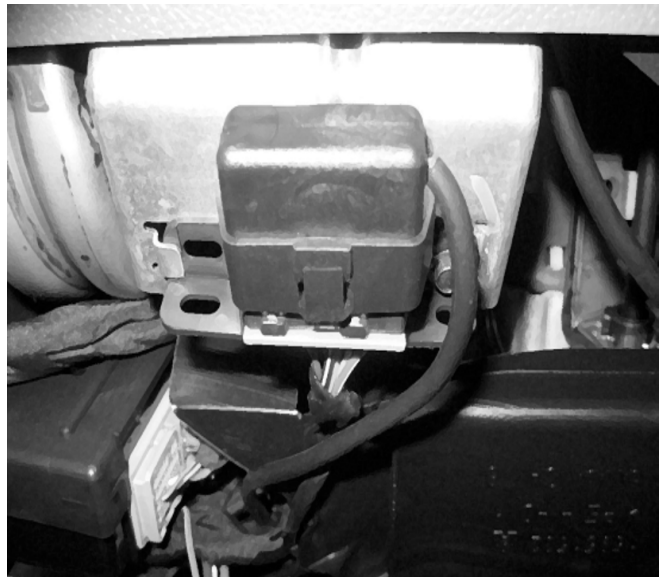
3346648

Aftermarket Device at ALDL

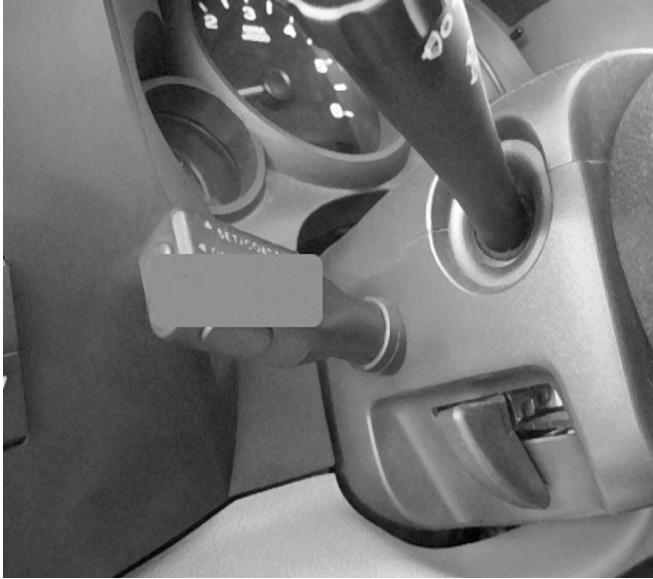
3346650

Aftermarket Device Switch

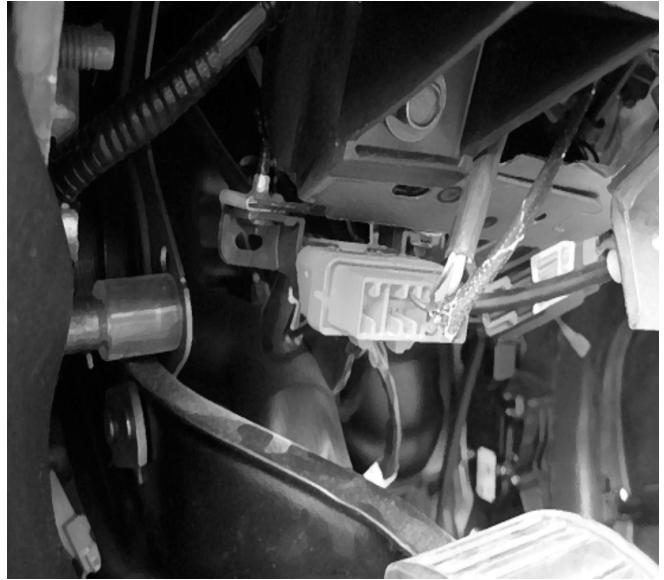
3346652

Fleet Tracking Device Interface (May Include Rental and Lease Vehicles)

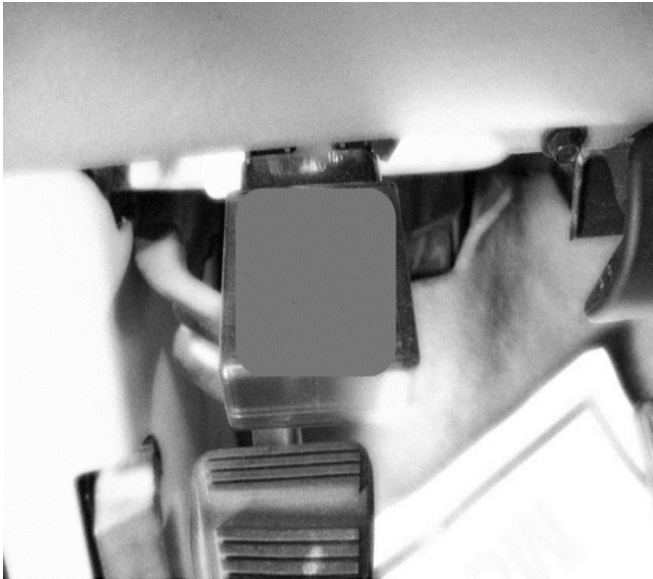
3346651

Monitoring Device Example

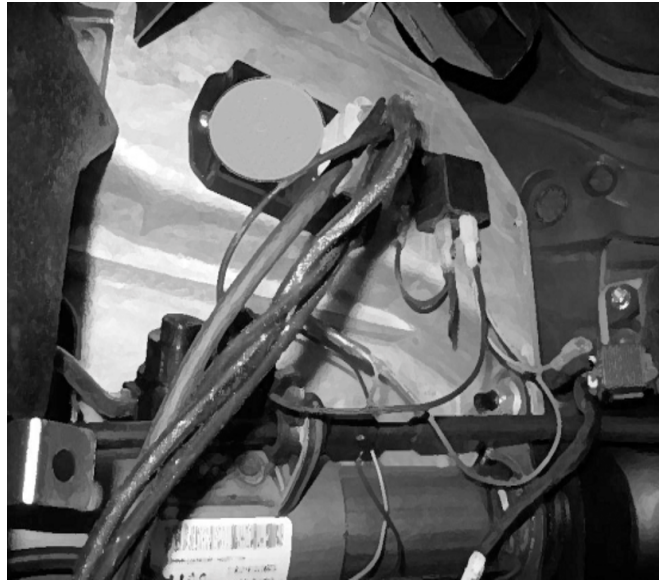
3346654

Fleet Tracking Module Plugged Into the DLC
