# Service Bulletin

Bulletin No.: 15-00-89-004E

Subject: Information Regarding the Differences Between Fluid Leakage and Seepage

Models: 2023 and Prior GM Passenger Cars and Trucks

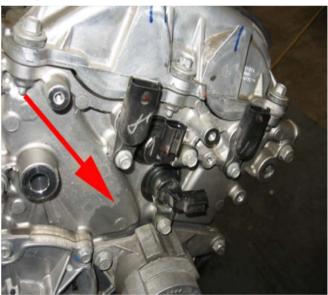
4170711

The engine illustrated above shows residual oil staining from assembly. There are no drips or leak paths present.

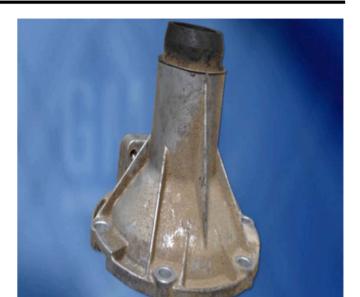
4164331

You can see the darker area where fluid has attracted dirt. There are no droplets at the bottom of the seal area.

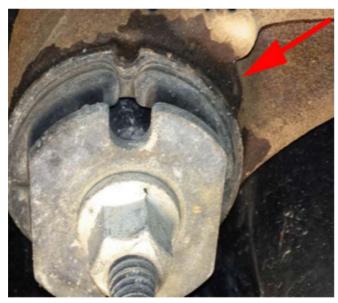
4164328

There is slight staining around the mount, but there are no droplets formed and fluid has not dripped onto other components.

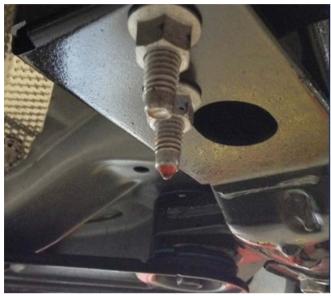
4164333

A droplet is formed on the end of the stud and the surrounding area is also covered with fluid.

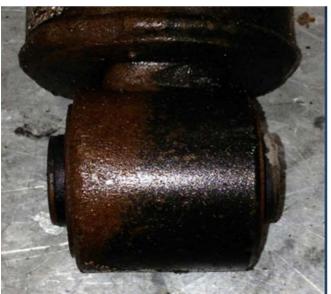
4164336

This shock is also leaking. The surface of the shock housing is wet and droplets formed at the bottom and dripped onto the ground.

For more information on the diagnosis and replacement of shock absorbers, refer to the latest version of Service Bulletin 05-03-08-002: Information on Diagnosis and Replacement of Shock Absorber and Strut Due to Fluid Leak.

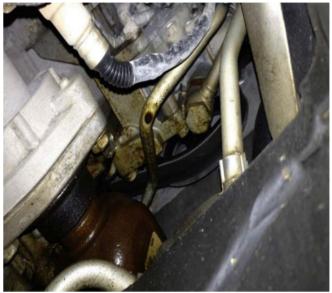
4164339

This is also a leak because there is a droplet formed on the bottom of the power steering line and fluid has dampened the drive axle.

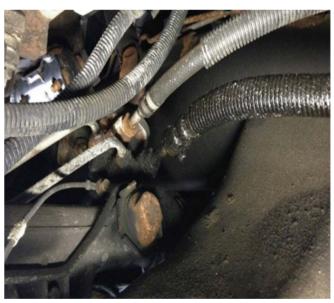
4164341

This would also be considered a leak because fluid has coated the fitting and hose. Although there were no droplets hanging from the component, it's obvious that a reasonable volume of fluid has been lost and when we followed the line to its low point, we did find droplets there.
