Service Bulletin

Bulletin No.: 21-NA-165

Subject: Rattle Noise/Vibration from Under Vehicle

Brand:	Model:	Model Year:		VIN:		Engine:	Transmission:
		from	to	from	to		
Cadillac	CT5	2020	2022	—	—	3.0L (RPO LGY)	—

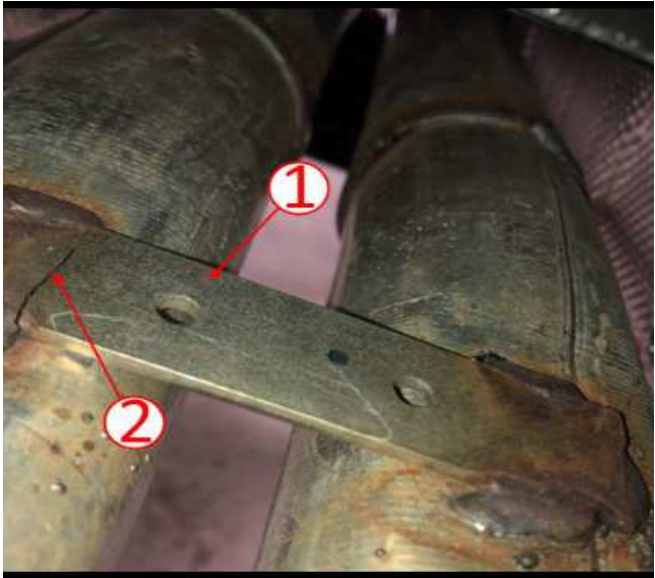
Involved Region or Country	North America, Europe, Middle East, Israel, Cadillac Korea, China
Condition	Some customers may comment that a rattle noise/vibration can be heard emitting from under the vehicle.
Cause

<p style="text-align: right;">5873316</p> <p>This condition may be caused by a crack (2) in the brace (1) used to space the exhaust system.</p>
Correction	<p>If the brace was found to be the cause of the noise or vibration, remove the brace from the exhaust pipe.</p> <ul style="list-style-type: none"> – The brace is only used to assist installing the exhaust system at the assembly plant and provides no other purpose.
